National Dam Inspection Program.
Ebenezer Dam (NDI Number PA-00599,
DER Number 38-8), Susquehanna River
Basin, Lebanon County, Pennsylvania.
Phase I Inspection Report.

**PHASE I REPORT
NATIONAL DAM INSPECTION PROGRAM
BRIEF ASSESSMENT OF GENERAL CONDITIONS
AND RECOMMENDATIONS**

Name of Dam: EBENEZER DAM, NDI NO. PA-00599
State & State No: PENNSYLVANIA, 38-8
County: LEBANON
Stream: CLARKS RUN, TRIBUTARY TO SWATARA CREEK
Date of Inspection: April 6, 1979

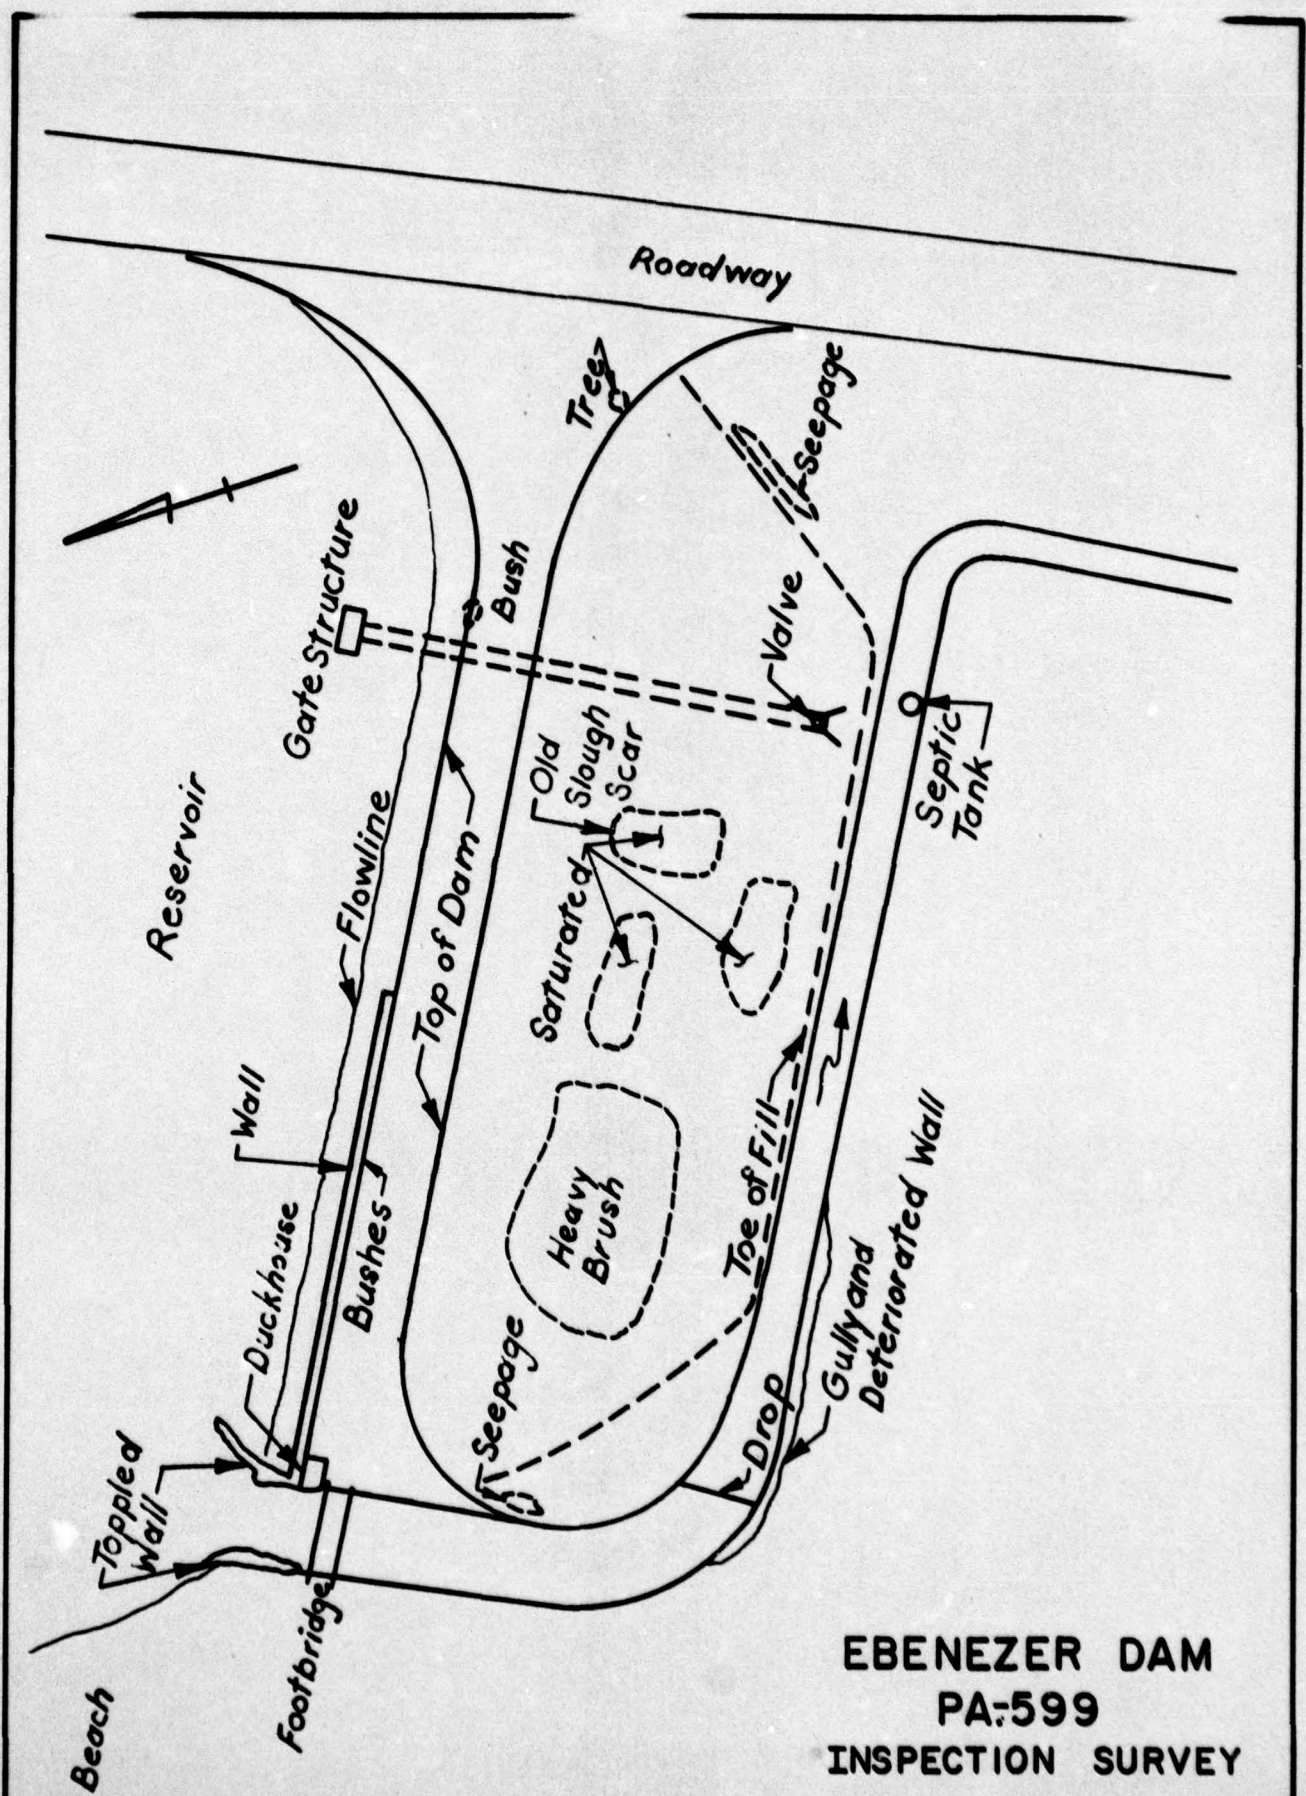
EBENEZER DAM
PA-599
INSPECTION SURVEY
4-6-79 **PLATE A-I**

C. SLOUGHING OR EROSION OF EMBANKMENT OR ABUTMENT SLOPES	The downstream slope is not uniform. There is evidence of sloughage and movement of the surface along the length of the embankment. Also several groundhog holes were noted on the downstream slope. One slippage occurred (see Plate A-I and A-III).

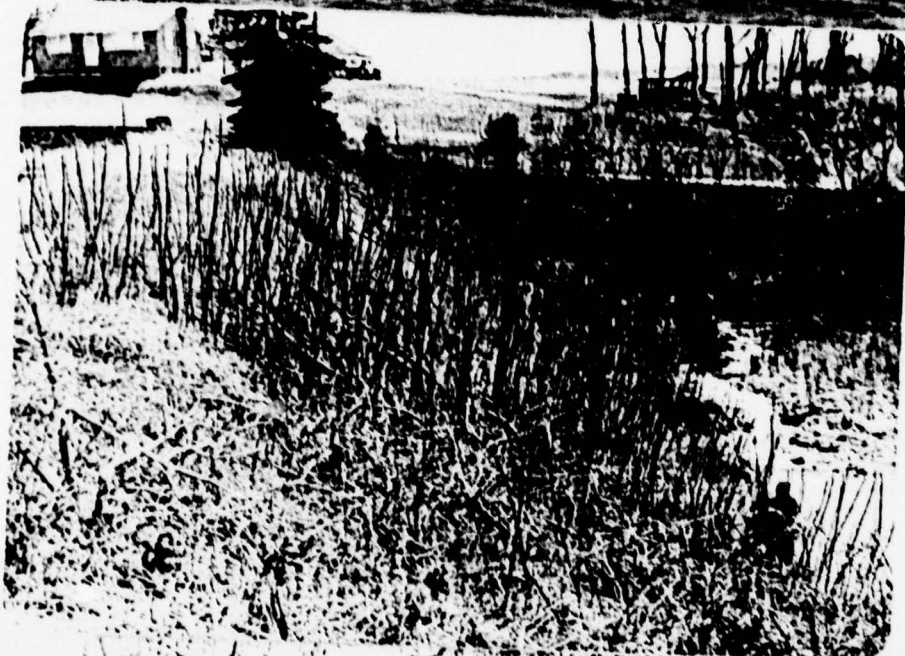
The downstream slope is in poor condition and has a large amount of weed, brush and sappling growth. Leakage through the embankment is evident along the entire slope. In several small areas the leakage is apparently limited to small horizontal layers within the embankment, showing no increase in seepage on the lower embankment face. In most cases, however, the "wet" zone shows marked increases in the water content in the lower limits of the embankment, becoming saturated at the toe, and immediately downstream. The saturated clay made a slippery surface to walk on and footprints would collect water. Undetermined amounts of leakage water were present at the left abutment and along the left spillway wall. The toe of the embankment is adjacent to the downstream discharge channel, preventing an evaluation of the amount of water seeping through the embankment.

Downstream Slope

1. Removal of all brush and trees from the downstream slope and establish procedures for regular maintenance of the embankment slopes and crest of dam.
2. Repair of downstream blowoff control valve.
3. Repair of the forebay walls and spillway chute.
4. Placing of riprap along the upstream slope.
5. Development of a formal surveillance and downstream warning system to be used during periods of heavy or prolonged precipitation.

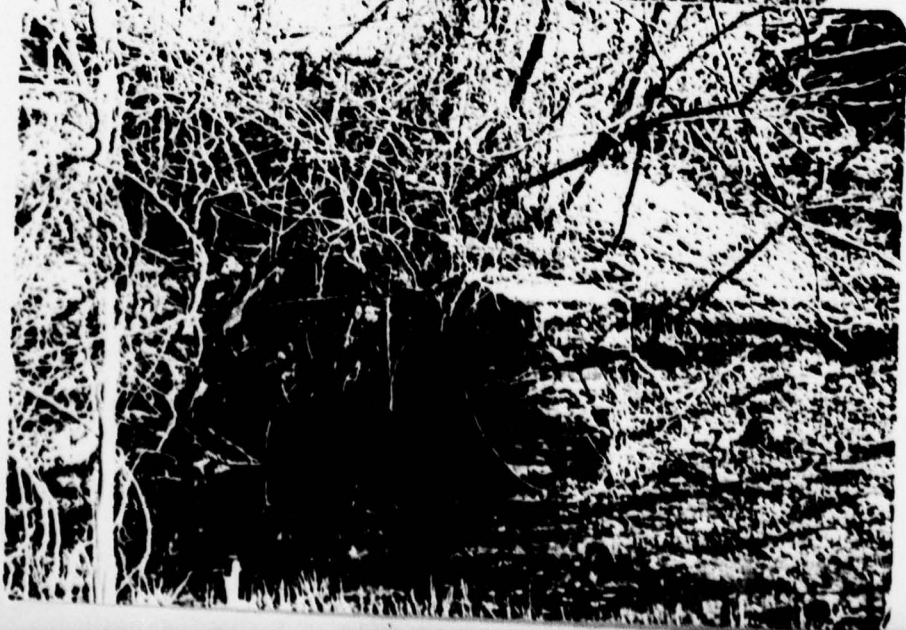
Conduit Outlet

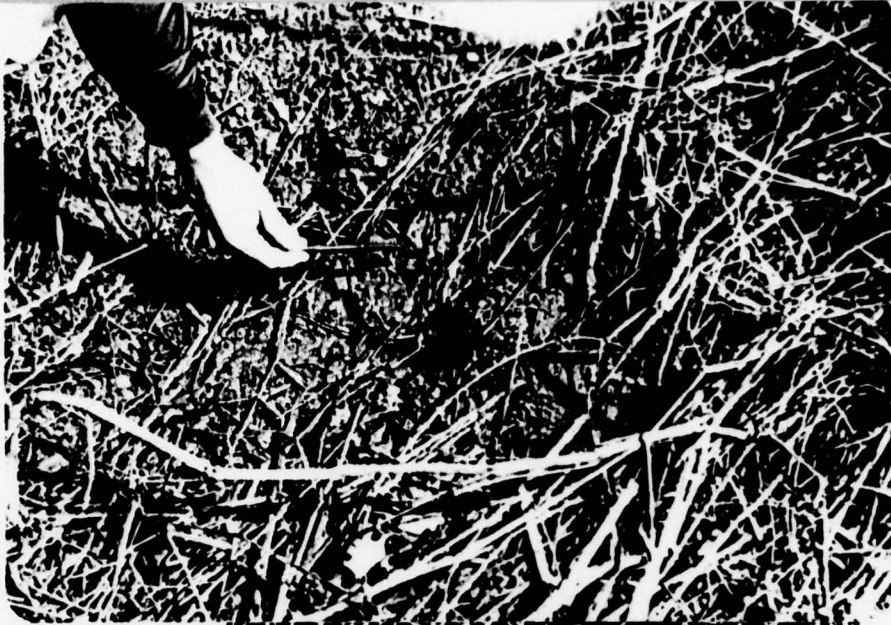
The visual inspection of the embankment indicates that serious problems exist on this 160 year old facility. The most serious condition is the saturation of the downstream slope. Although no flow of seepage water was detected except just to the left of the spillway, and at the left abutment, large areas of the downstream slope were very soft and slippery due to saturation. The brush, weeds and small trees made close observation of possible through-seepage difficult. The toe was wet at many places. The right hillside, beyond the spillway, also had several saturated areas. At the left abutment a steady seepage, estimated at 5 gallons per minute at the time of inspection, runs down the slope into the discharge channel. This water appeared to be clear. About 100 feet to the right of the left abutment a sloughage scar indicated that sloughage had occurred some time ago (see Appendix A, Plate A-I). The top of the dam is grassed. The upstream slope has a nearly vertical drop from the crest of the dam to just below flow line over the south half (left) of its length. The rest of the upstream slope has been protected from the flow line up by a masonry and brick wall (Refer to photographs, Appendix E).

Saturated
Downstream Slope

1. That a detailed engineering investigation be conducted by a professional engineer, experienced in the design and construction of dams, to determine the source and cause of the observed saturated condition on the downstream slope, including appropriate instrumentation and to assess the influence of this condition on the stability of the structure, and to determine what measures should be taken to improve the capacity of the spillway.
2. That a positive method of closure of the upstream end of the outlet pipe be established.
3. That the downstream blowoff valve be made operable and maintained on a regular basis and emergency drawdown procedures be established.
4. That brush be removed from the downstream slope and a procedure be developed and implemented to provide regular maintenance of the embankment slopes.

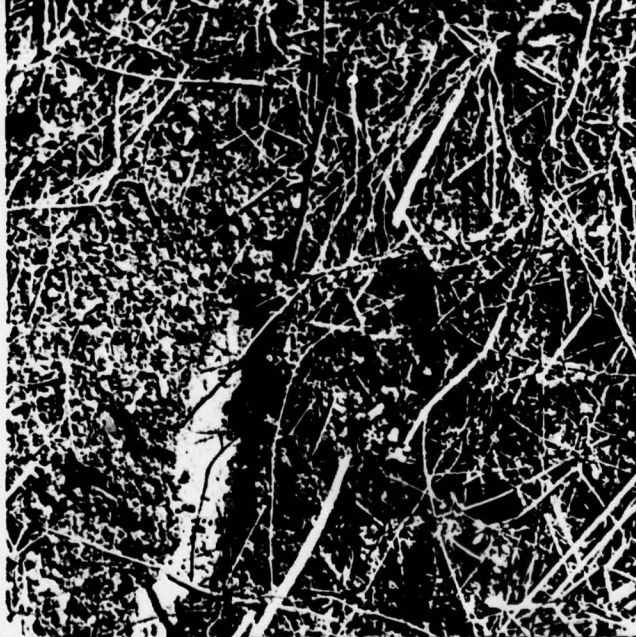
Downstream Toe

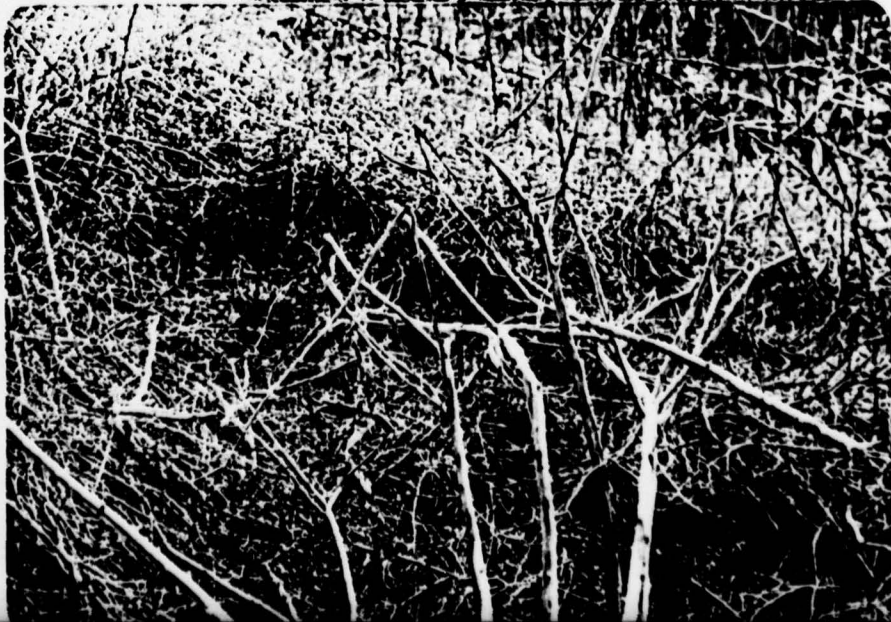
Slough on
Downstream Slope

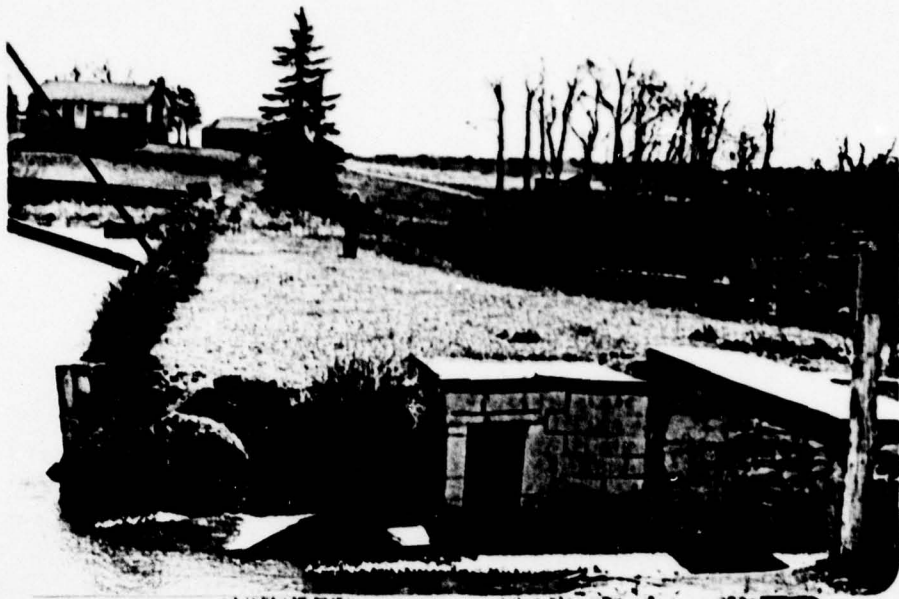
"Duck House" at
Spillway Bridge

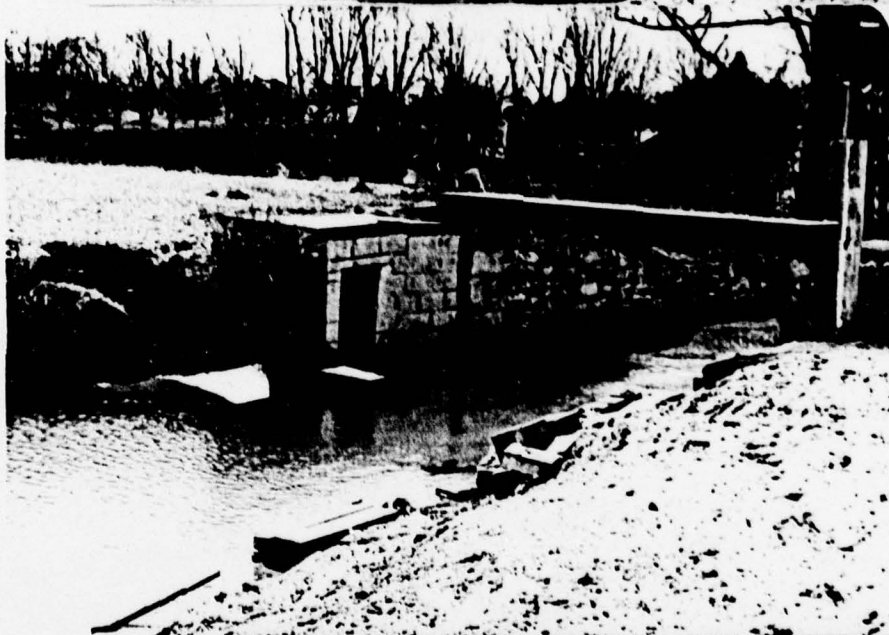
The broadcrested spillway is cut in original ground at the right abutment of the dam. The concrete block walls in the forebay area have fallen over into the approach opening (see photographs). The spillway channel is paved with concrete over the original flat stones. This channel makes a sharp bend to the left and then parallels the toe of the fill. The right wall of the chute, at this bend, is too low and has failed. Water flows over this wall and has caused considerable erosion in the soft shale behind the wall and failure of the wall over most of its length, beyond the bend.

The walls along the forebay wall have fallen over, partially blocking the spillway entrance. The spillway weir and walls are in good condition. However, about 50 feet below the weir crest, at a point just below where the chute makes a sharp curve to the left, the right spillway wall was severely damaged during the tropical storm Agnes. If water flows more than a few inches deep over the spillway crest, some of the discharge runs over this low wall thus causing erosion behind the chute wall. No deep erosion has occurred because of the underlying rock, but the right chute wall has practically disappeared.

Forebay

5. That the forebay and spillway chute walls be repaired.
6. That the upstream slope be protected with riprap.
7. That a formal surveillance and downstream warning system be developed by the owner to be used during periods of heavy or prolonged precipitation.

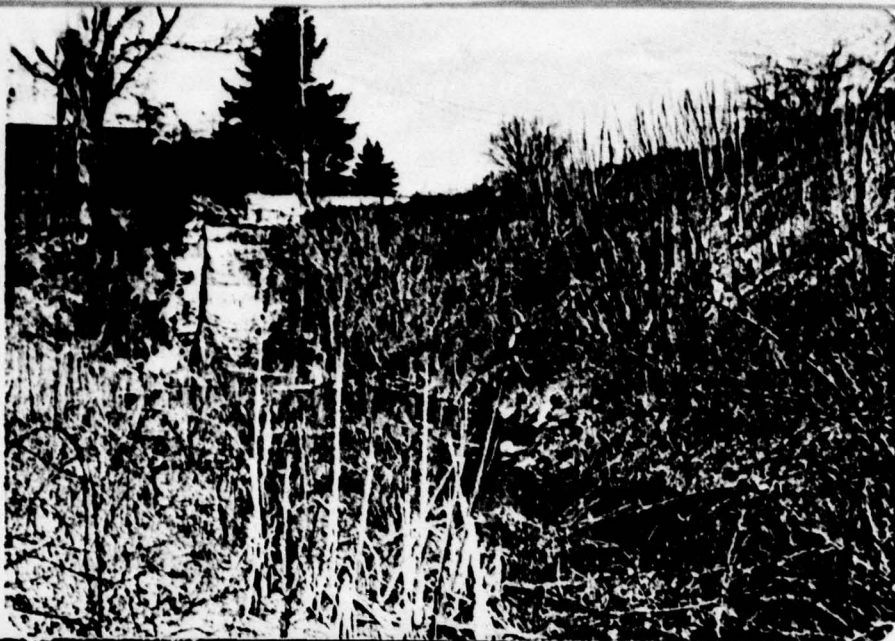
Spillway and
Downstream Channel

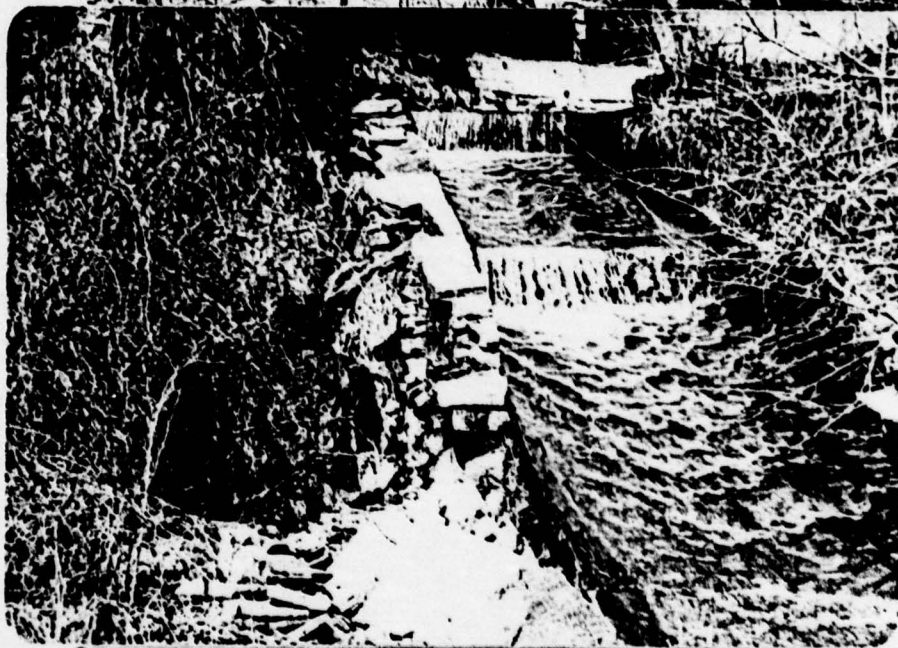
Deteriorated Right
Spillway Wall
