**PHASE I REPORT
NATIONAL DAM INSPECTION PROGRAM**

**Mathay Dam, Mercer County, Pennsylvania
NDI No. PA 00247, PennDER No. 43-46, SCS No. PA 459
Mathay Run
Inspected 26 April 1979**

PHASE I INSPECTION REPORT
NATIONAL DAM INSPECTION PROGRAM
MATHAY DAM

NDI No. PA 00247, PennDER No. 43-46, SCS No. PA 459

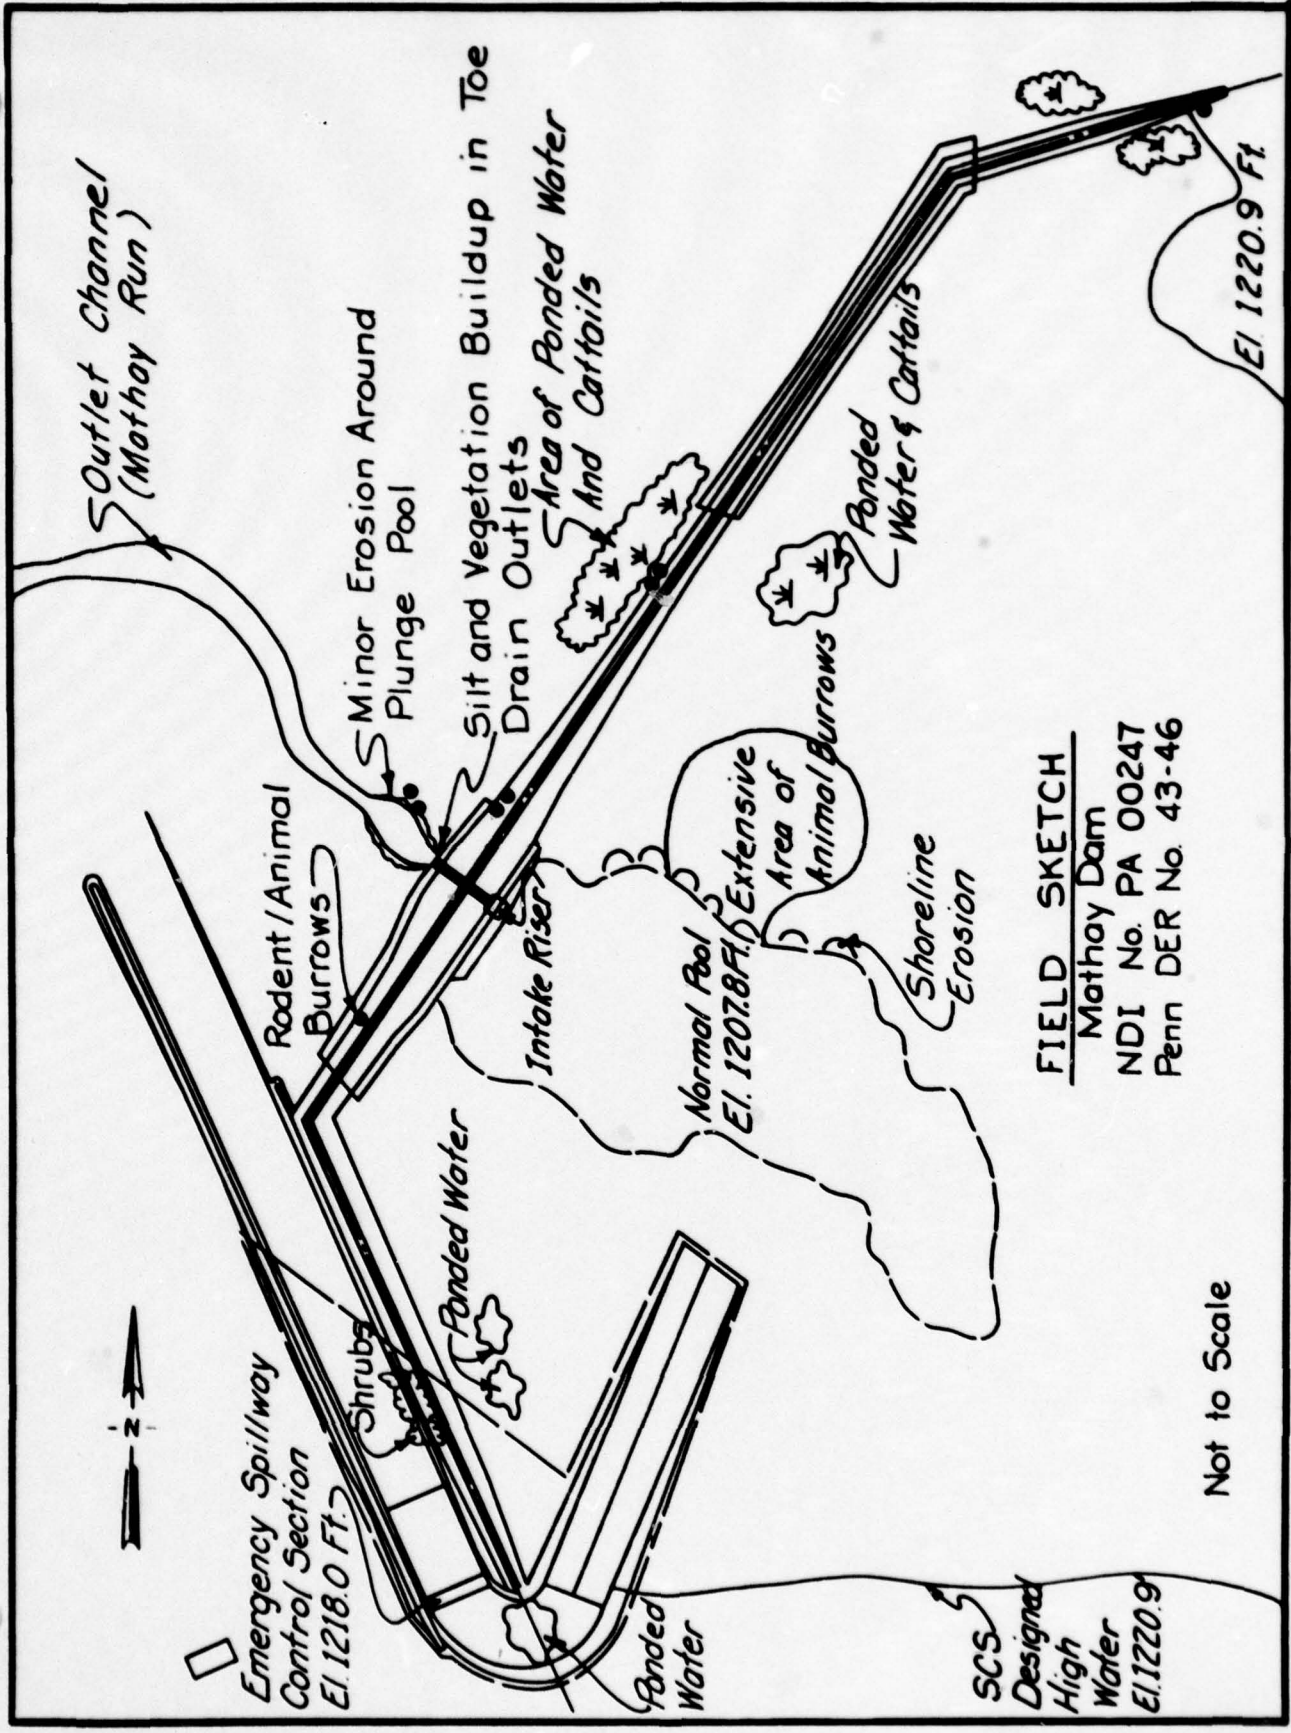
- c. Appurtenant Structures - Overall, the concrete in the intake and outlet structures of the principal spillway is in good condition. A minor amount of debris was on the trash rack of the riser orifice at the time of inspection. Minor erosion is occurring around the outlet plunge pool.

Outlet Channel
(Mathoy Run)

Minor Erosion Around
Plunge Pool

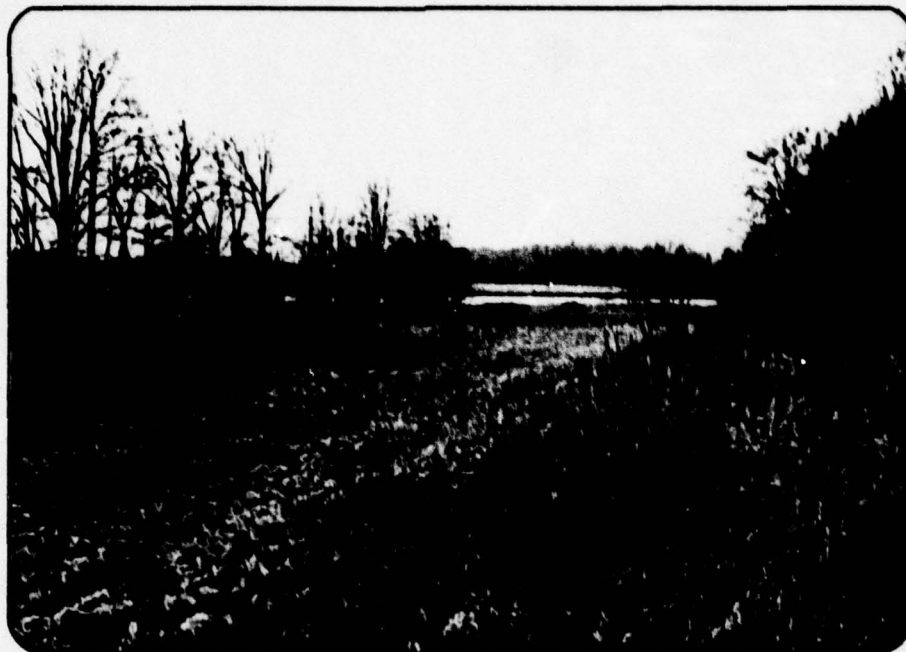
**PHOTO 3. View Looking Toward Pond in Upstream
Portion of Emergency Spillway Channel**
