LAKE WILHELM DAM

NDI No. PA 00900  
PennDER No. 43-53  
SCS No. PA 475

**PHASE I INSPECTION REPORT**  
**NATIONAL DAM INSPECTION PROGRAM**

Lake Wilhelm Dam, Mercer County, Pennsylvania  
NDI No. PA 00900, PennDER No. 43-53, SCS No. PA 475  
Sandy Creek  
Inspected 19 April 1979 and 4 June 1979

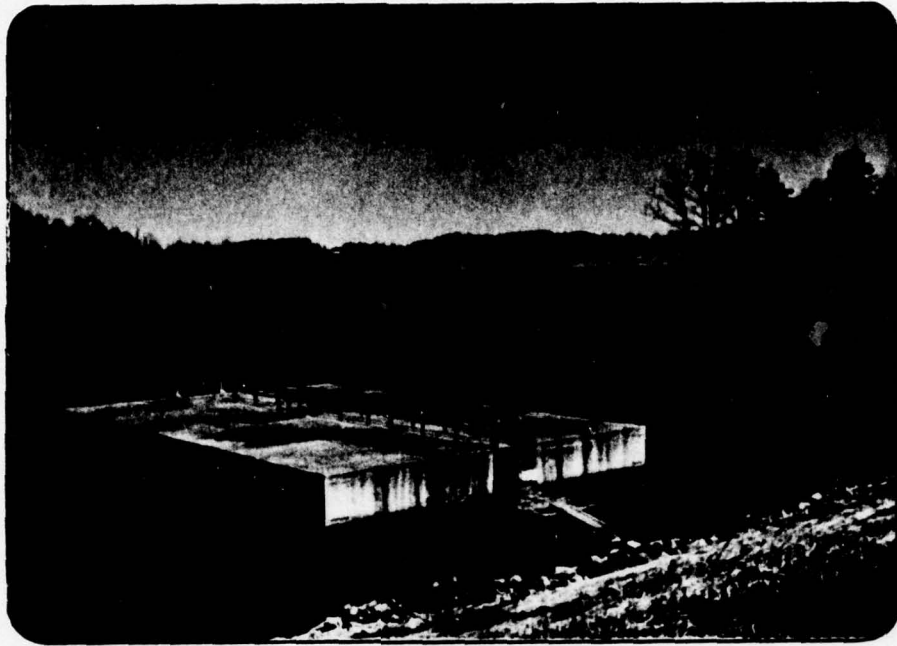
- c. Appurtenant Structures - The concrete in the intake riser assembly and outlet structure appeared to be in good condition. The cursory survey made at the time of the visual inspection indicates the riser structure has undergone a differential movement of approximately 2.5 inches. Erosion was noted around the outlet head wall and wing walls. On 4 June 1979 during a site visit, a horizontal crack was observed immediately above the outlet conduits.

**PHOTO 1. Intake Riser Assembly  
(Orange Marks Above Existing Pool Indicate Previous Highest Water Level)**

dam. It is therefore recommended that the owner initiate a program whereby the movement of the riser could be monitored more closely in order to avert any major problems.

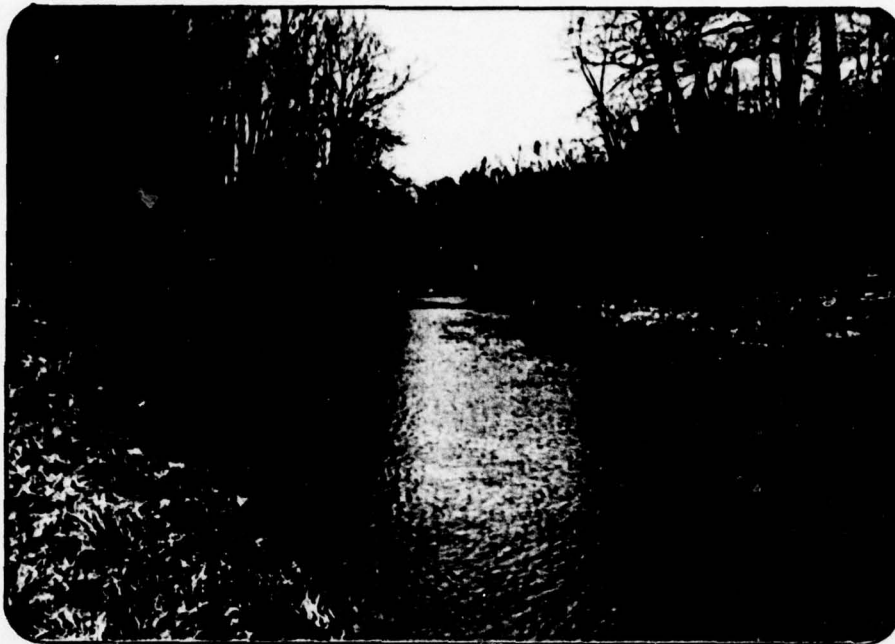
**PHOTO 5. Downstream Channel as seen from Emergency Spillway Exit**

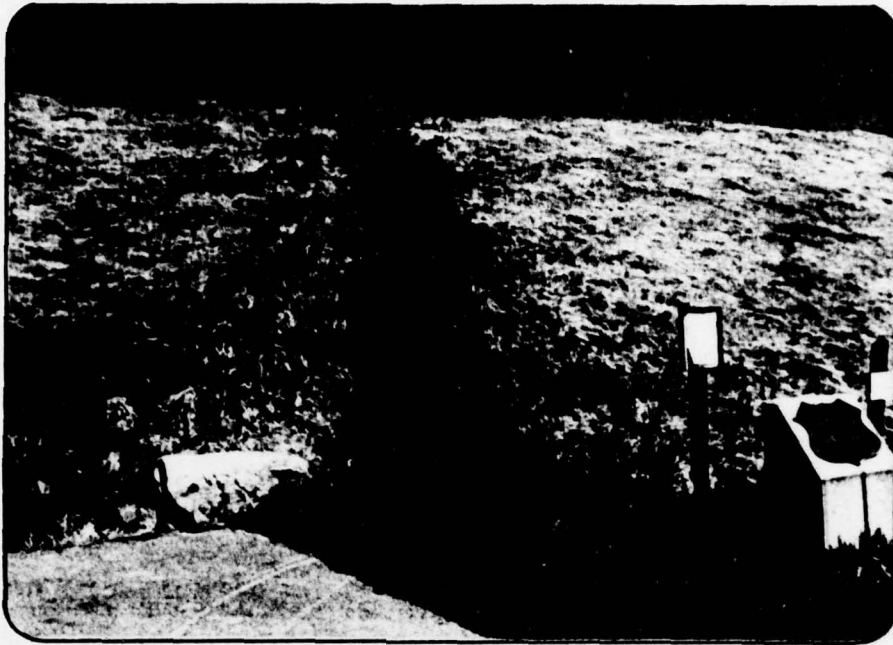
**PHOTO 7. Eroded Pedestrian Path on Downstream Face Leading from Parking Lot to Crest of Dam (Green grass on both sides of path indicates that attempts were made to control erosion. Recommend permanent steps be installed in this area.)**

1. Recommend installation of permanent walkway to prevent further reoccurrence.

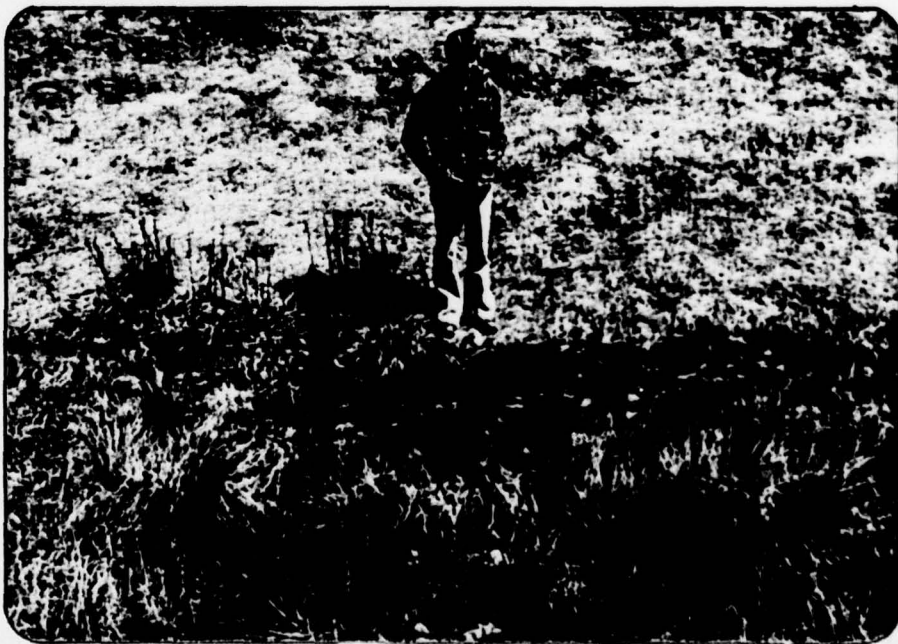
- c. Urgency - The owner should initiate without delay the recommendations discussed in paragraph 7.1.d.
- d. Necessity for Additional Data/Evaluation - The visual inspection indicated the existence of two marshy areas in the emergency spillway channel. The area in the approach channel is believed to be the result of natural springs; however, the cause of the marshy area in the exit channel could not be determined. It is therefore recommended that a monitoring program for the marshy areas be established to determine if quantity or quality changes take place and to institute appropriate action, if necessary.

**PHOTO 8. Marshy Area Located in Entrance Channel at Emergency Spillway**

- 1) The owner should initiate a monitoring program for the marshy areas to determine if quantity or quality changes take place and to institute appropriate action, if necessary. If the cause of both areas is the result of natural springs, the installation of spring drains is recommended.
- 2) The owner should initiate a program whereby the movement of the riser could be monitored and appropriate remedial measures taken, if required.
