PINE CREEK DAM
(North Park Lake)

NDI I.D. NO: PA-467

PHASE I INSPECTION REPORT
NATIONAL DAM INSPECTION PROGRAM

MAY 1979

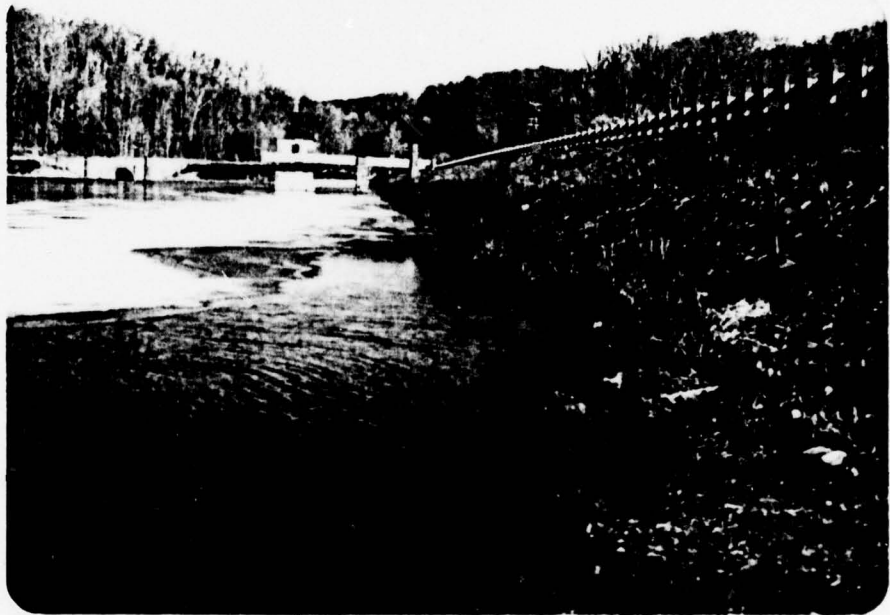
Upstream Face

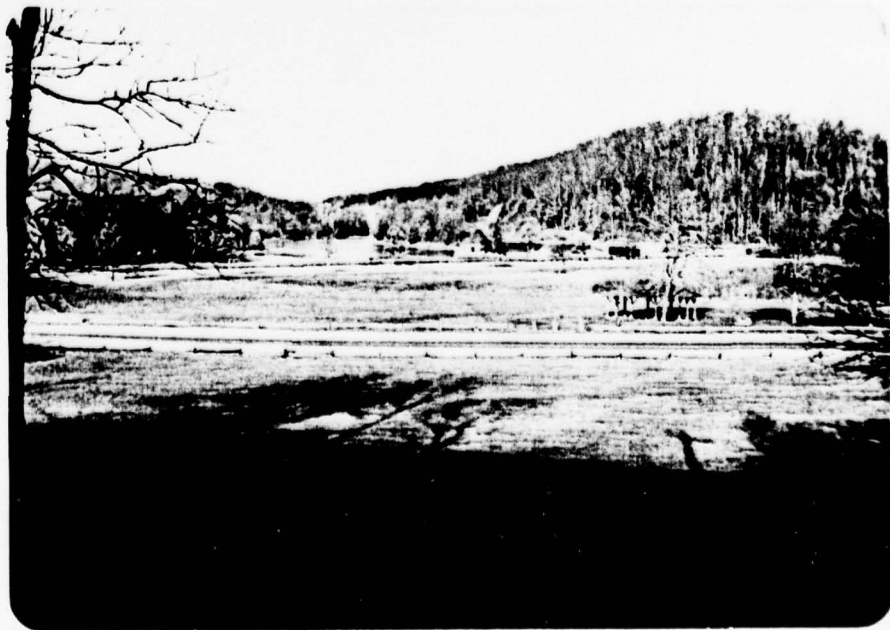
Downstream Face

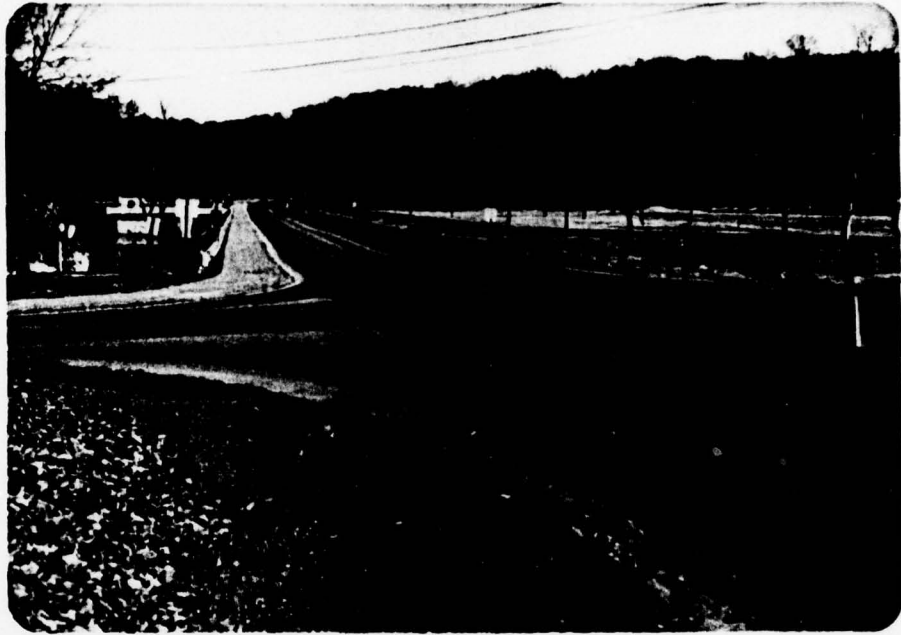
Photograph No. 1
Crest (looking north).

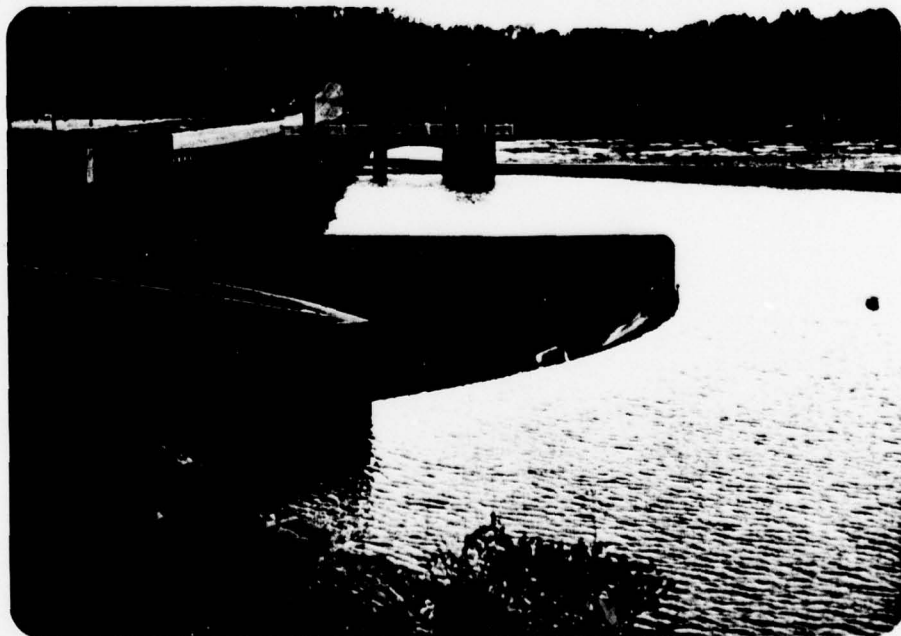
Photograph No. 2
Spillway crest (looking south).

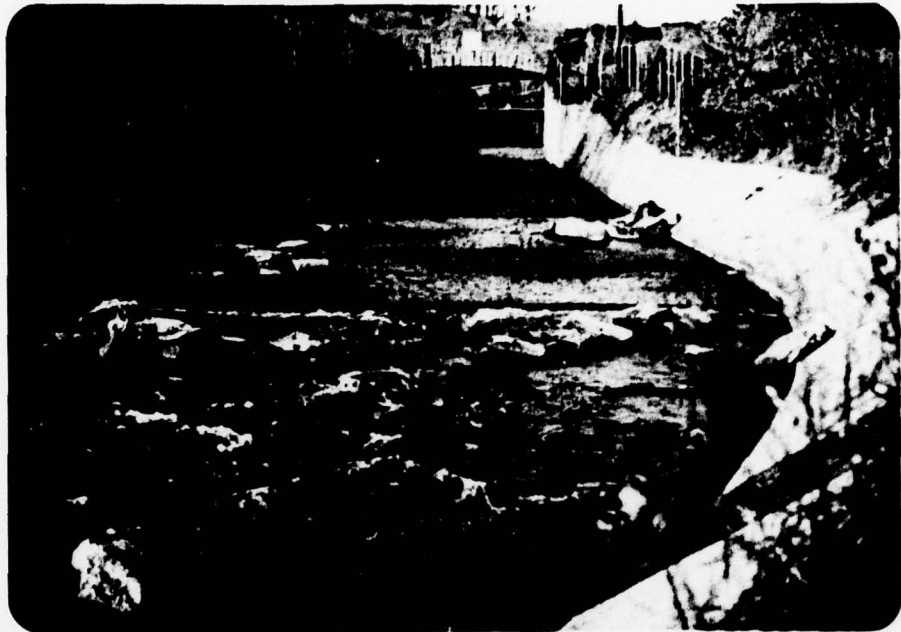
Photograph No. 3
Spillway discharge channel.

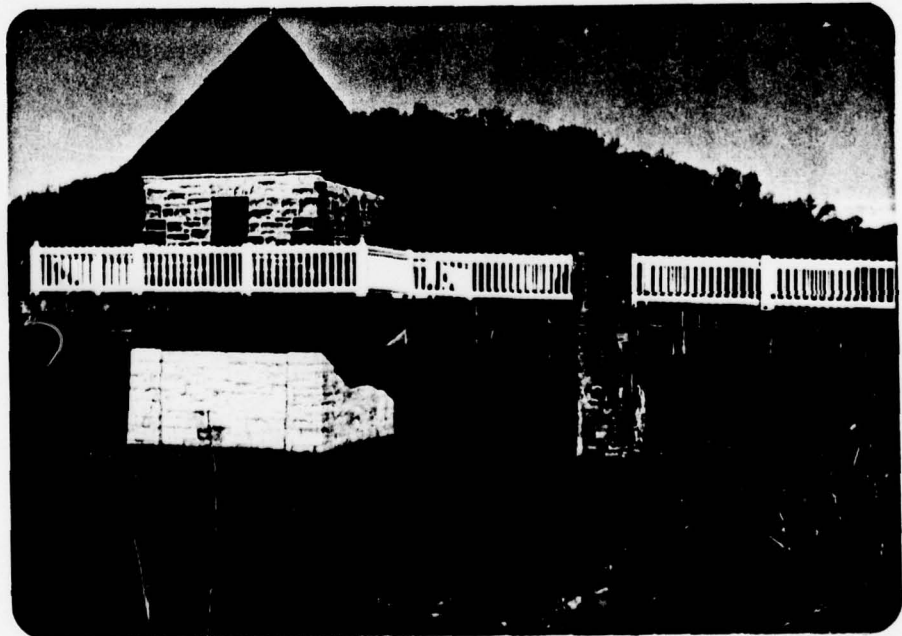
Photograph No. 4
Outlet works control tower.

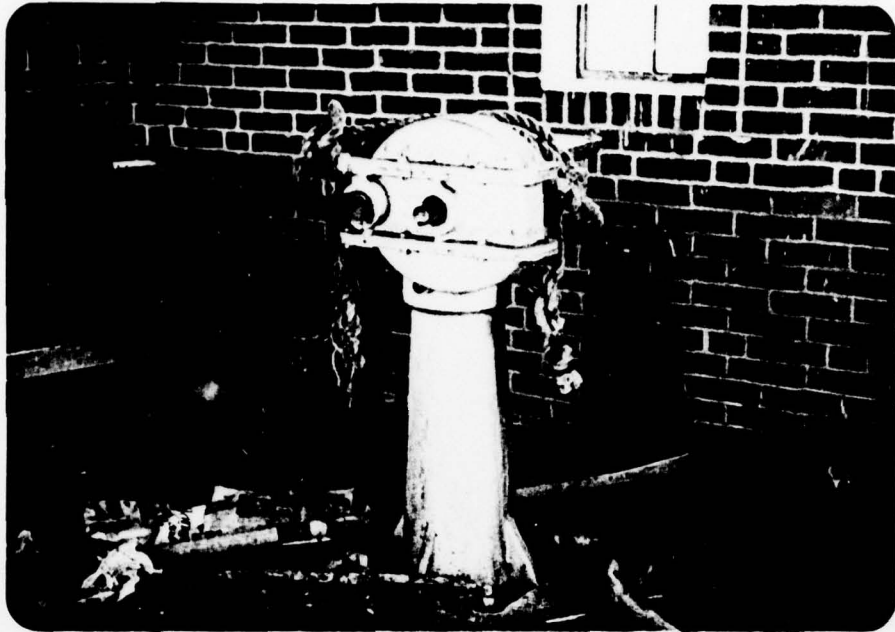
It is reported that the outlet conduit sluice gate has not been operated in the recent past. Due to the siltation problem in the reservoir, the operational condition of the sluice gate was questionable; therefore, the operation of the sluice gate was not observed.

4.3 Maintenance of Operating Facilities. The maintenance of the operating facilities is considered to be poor. It is reported that the outlet conduit sluice gate has not been operated in the recent past. Due to the siltation problems in the reservoir, the operational condition of the sluice gate was questionable; therefore, operation of the gate was not observed.

Photograph No. 5
Outlet conduit sluice gate hoist.

1. Immediate further detailed hydrologic and hydraulic studies should be performed to more accurately ascertain the spillway capacity and the nature and extent of improvements required to provide adequate spillway capacity.
2. The operational condition of the outlet pipe gate should be evaluated and necessary maintenance performed.

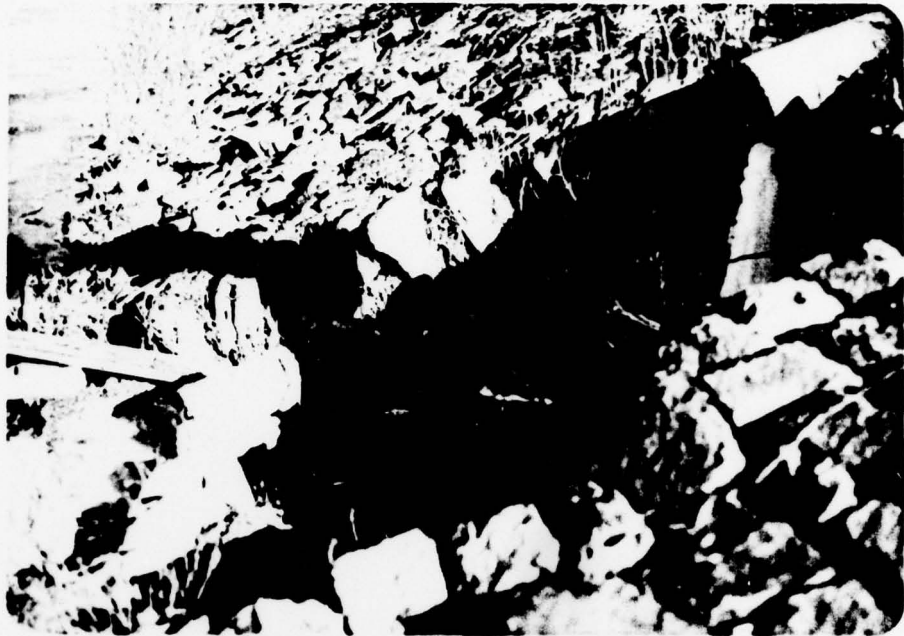
4.2 Maintenance of the Dam. The maintenance of the dam is considered to be fair. The crest of the dam is covered with grass and appears to be periodically mowed. At several locations on the upstream face, the riprap was found to be missing. This riprap should be replaced to avoid erosion problems on the upstream face.

Photograph No. 7
Erosion on upstream face riprap.

3. Missing riprap on the upstream slope should be replaced.
4. Brush should be removed from the upstream slope.
5. Spalling concrete in the spillway discharge channel should be repaired.
6. Around-the-clock surveillance should be provided during unusually heavy runoff and a formal warning system should be developed to alert downstream residents in the event of emergencies.
