FAWN LAKE DAM

PHASE I INSPECTION REPORT
NATIONAL DAM INSPECTION PROGRAM

NDI PA 00309
PA DER 52-168

Name of Dam: Fawn Lake Dam ID # PA 00309
State Located: Pennsylvania
County Located: Pike
Stream: Tributary to West Falls Creek
Coordinates: Latitude 41° 30.2' Longitude 75° 04.0'
Date of Inspection: November 20, 1978

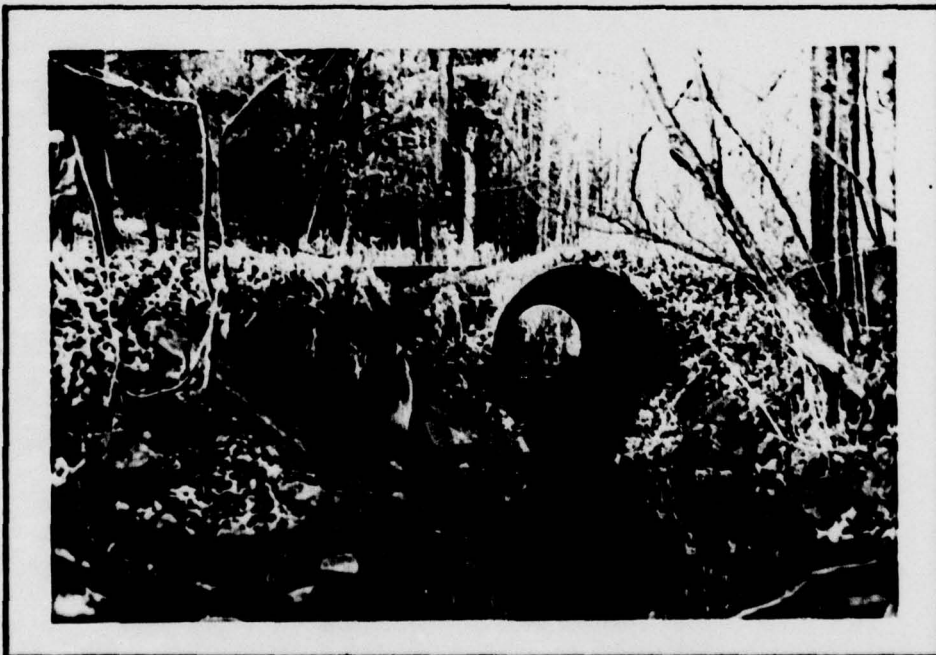
ROADWAY 1500 FEET DOWNSTREAM OF DAM

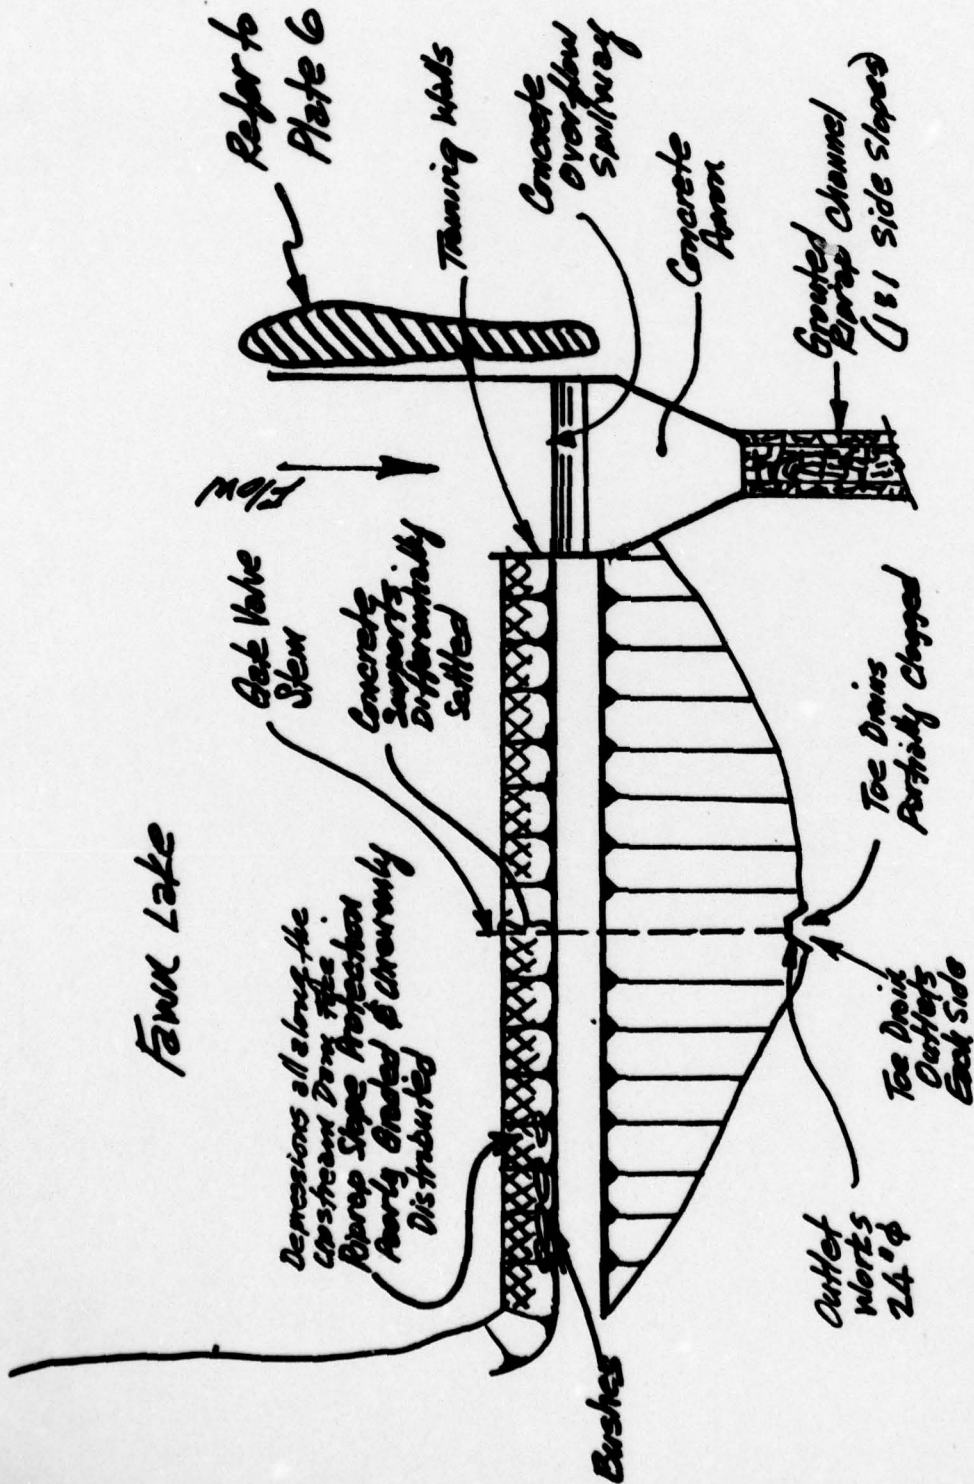
PLATE 2

FAWN LAKE DAM
General Plan of Features
with Inspection Notes
