# SCOTT'S RUN LAKE DAM

NDI - PA 00725  
PA DER 6-435

## PHASE I INSPECTION REPORT NATIONAL DAM INSPECTION PROGRAM

JULY 1979

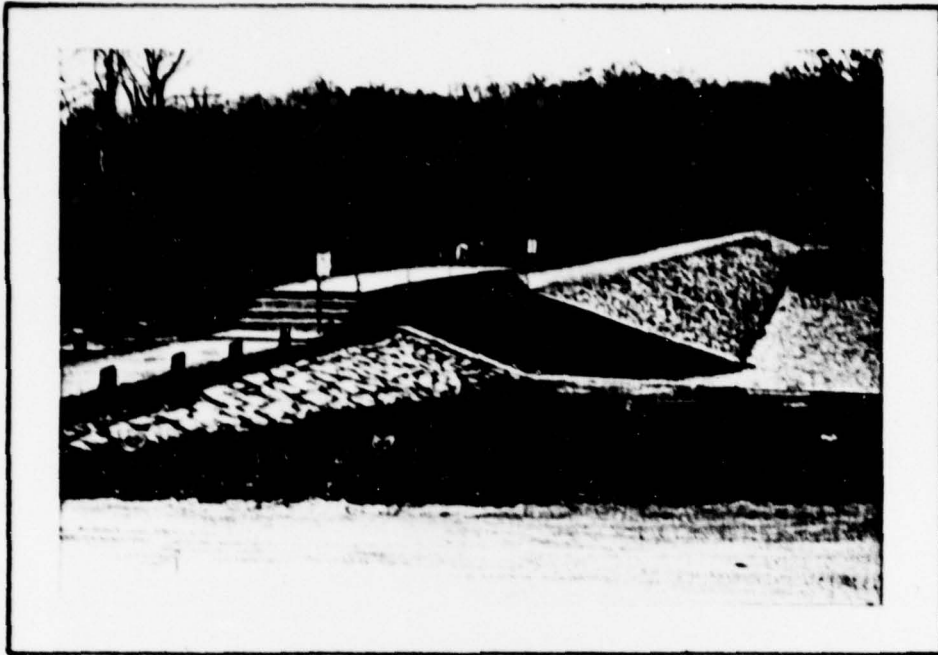
*UPSTREAM FACE OF THE DAM AS  
VIEWED FROM THE LEFT ABUTMENT*

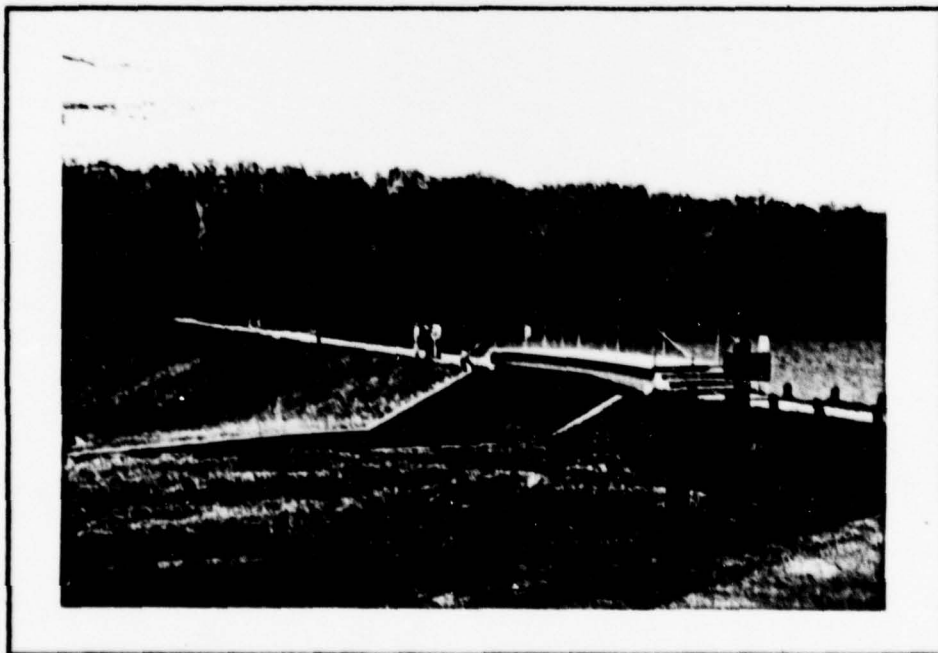
*DOWNSTREAM FACE OF THE DAM AS  
VIEWED FROM THE LEFT ABUTMENT*

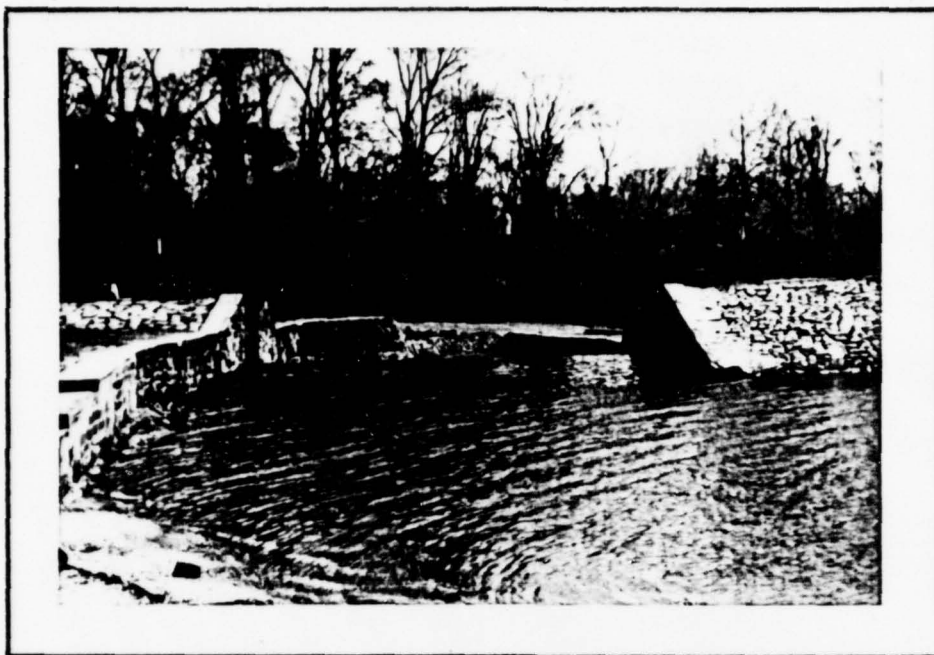
*SPILLWAY SECTION AND FOOT BRIDGE  
LOOKING DOWNSTREAM*

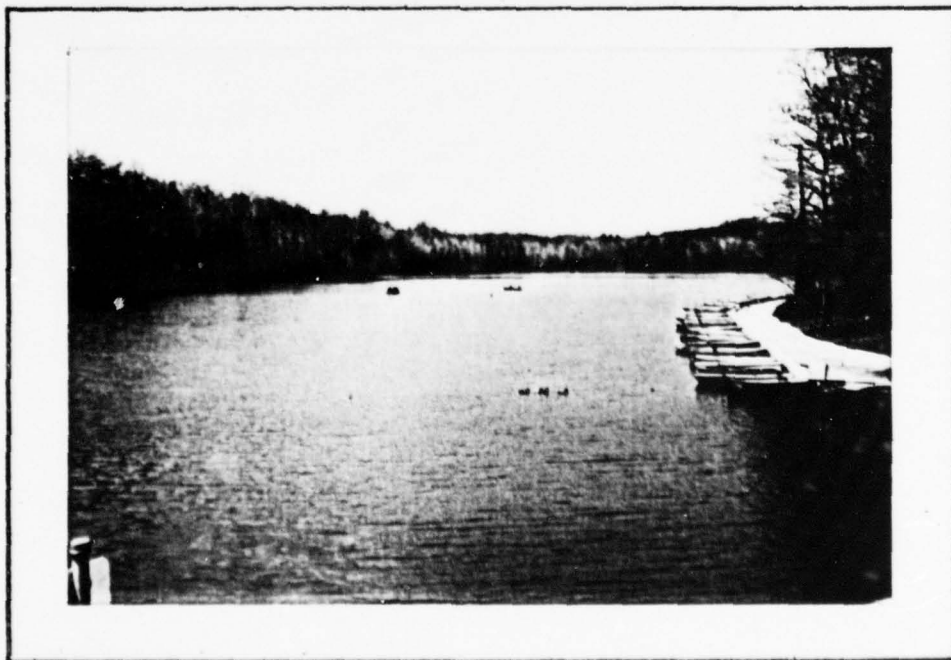
*VIEW OF THE RESERVOIR FROM THE DAM*

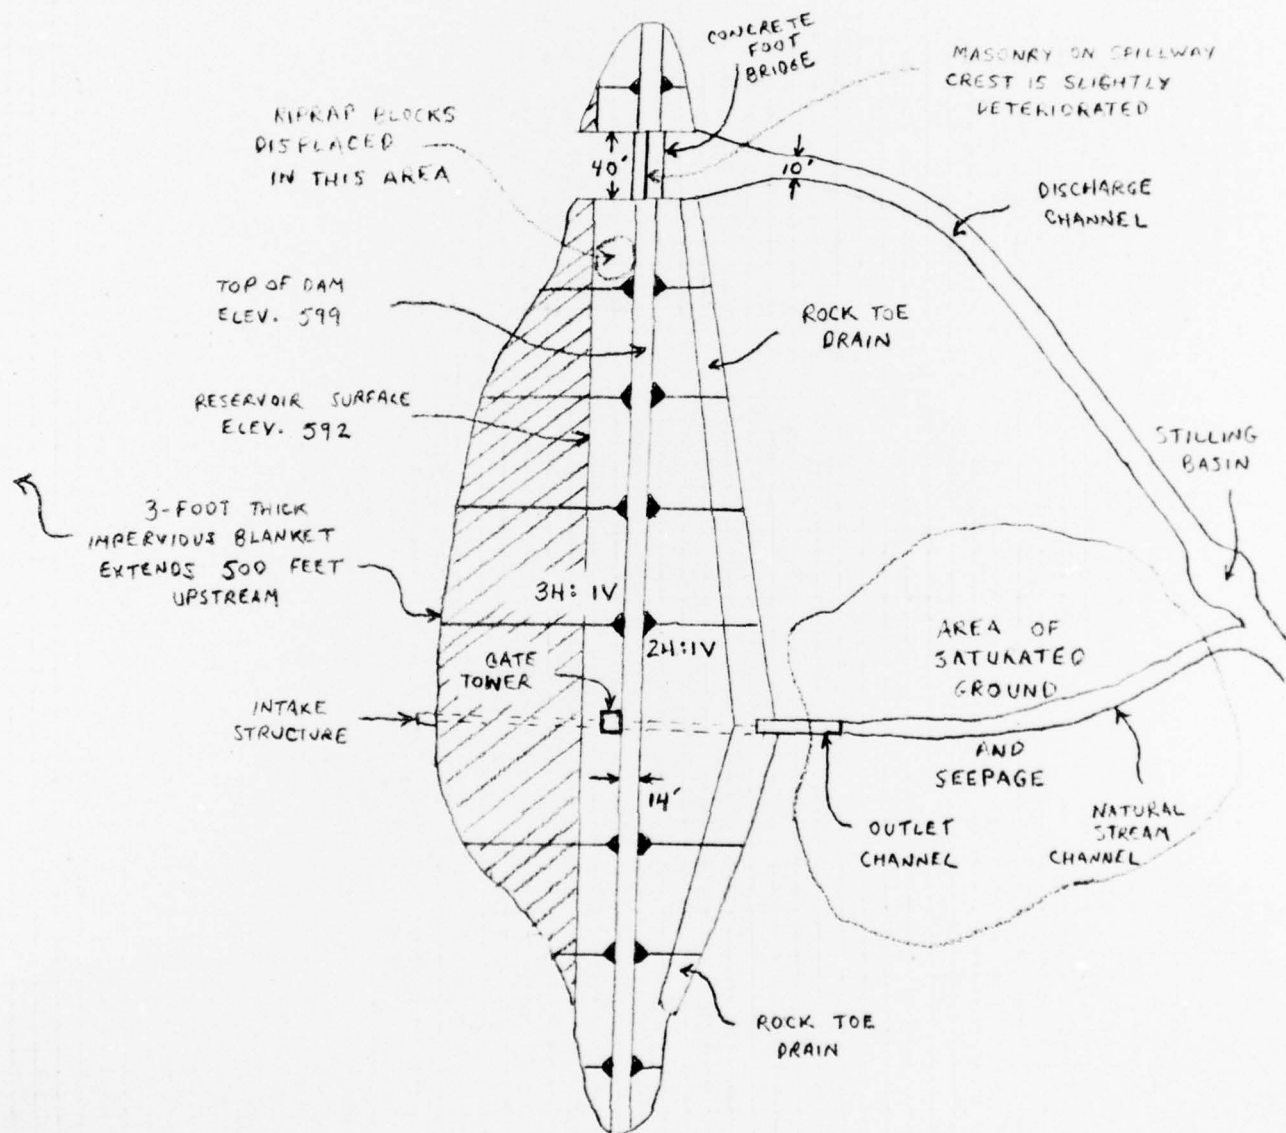
PLATE 6  
PLAN VIEW  
SHOWING PROBLEM AREAS

a. Safety. Based on the visual observations and review of the available information, Scott's Run Dam is considered to be in good condition. However, several deficiencies were noted during the inspection. Outlets are not provided for the embankment toe drain and as a consequence there are extensive soft, saturated areas in the region immediately downstream of the dam. The masonry on the spillway crest is in need of repair in several locations. Several blocks of riprap require replacement in the upstream face of the embankment.

1. The design drawings indicate that two drainage ditches were to have been provided parallel to the outlet channel (one on either side) to direct toe drain discharge downstream. These ditches were not apparent on the date of the inspection. A drainage system should be installed which would direct the toe drain discharge downstream.
2. The crest of the masonry spillway should be repaired and restored to design elevation where necessary.
3. Blocks of riprap that have been removed from the upstream face should be replaced in their original location.
