CORNWALL TAILINGS DAM

NDI NO. PA-00597
DER NO. 38-87

PHASE I INSPECTION REPORT
NATIONAL DAM INSPECTION PROGRAM

JULY 1979

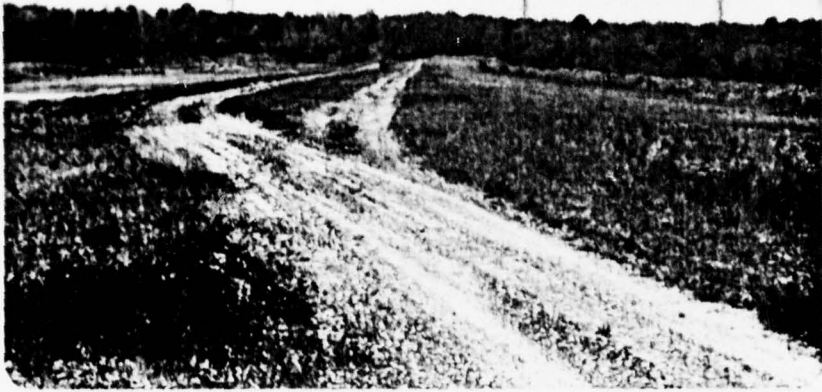
Top of Dam
Looking to
Left Abutment

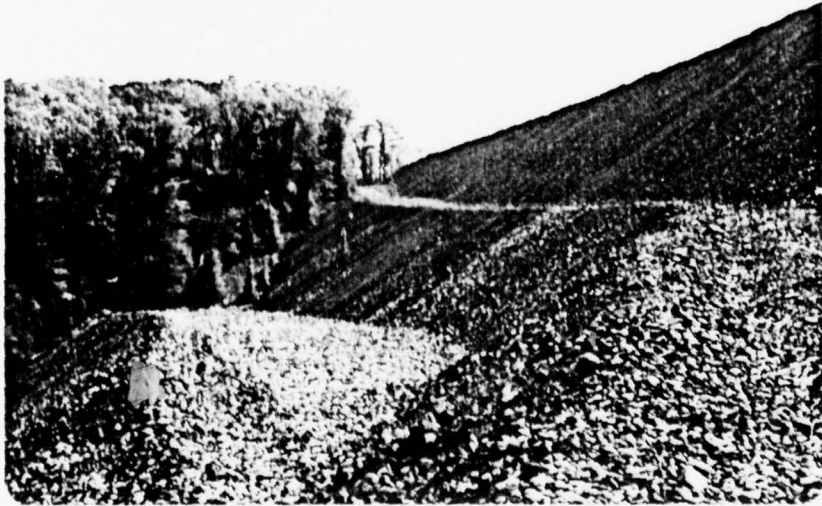
The visual inspection of the downstream slope did not reveal any evidence of instability. The rock slope surfaces appear to have stabilized with varying slope angles between the 1:1H to 1V and 1:7H to 1V range dependent upon the size of the rock and the amounts of fine stone in a particular area. When considering the dimensions of the entire downstream portion of the embankment, 395±H to 203±V, the benches do not appear to be significant in the evaluation of the slope stability. The overall top to toe slope is flatter than the recommended 1.75H to 1V. This fact, together with the observed conditions indicates that the embankment slopes are stable.

Downstream Slope

Formal maintenance procedures do not exist and are not required at the present time. Brush and tree growth should be prevented on the downstream slope, the crest and the upstream slope near the crest. It is recommended that a formal surveillance and downstream warning system be developed for implementation during periods of high or prolonged precipitation.

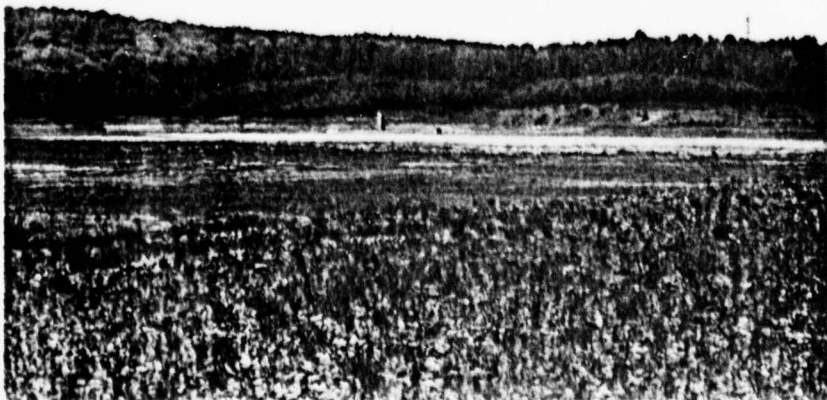
View from top of
dam towards
decant towers

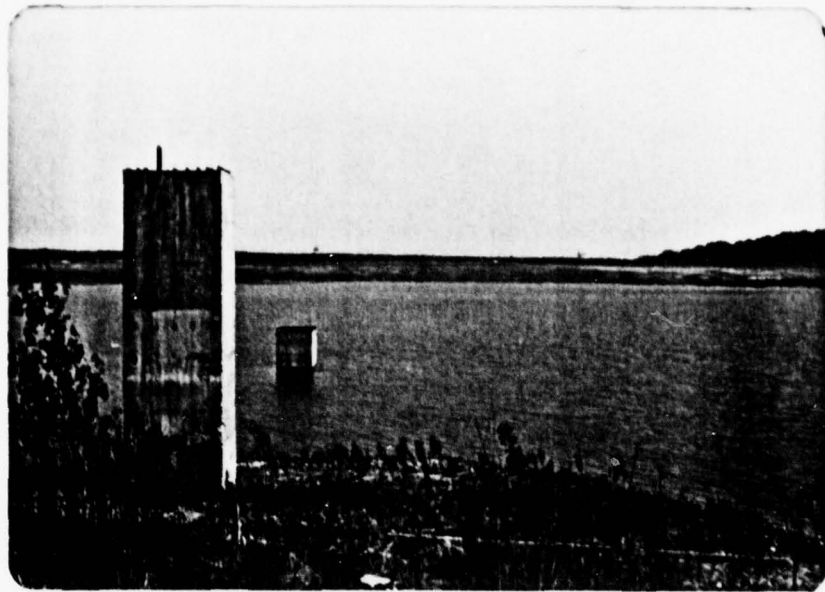
Reservoir with decant towers.
Dam in background

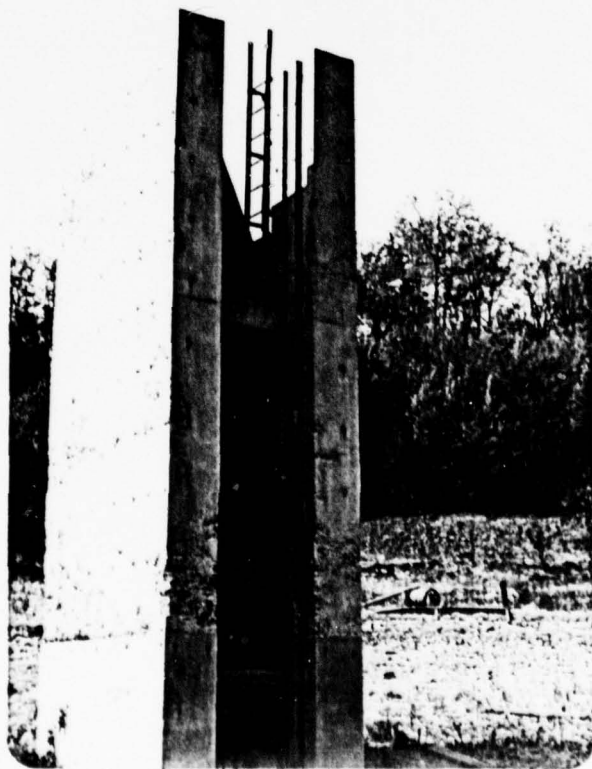
the drain pipe. All structures appeared to be in good condition. A boat would be required to inspect the tower located in the reservoir. The owner's representative stated that a standpipe was located in this tower on the decant line. The inflow elevation is unknown.

Detail of Decant Tower

1. That a staff gauge be installed on the decant tower located in the pool and that at least monthly readings be taken to establish records of changes in the pool level.
2. That the 6-inch blowoff valve on the decant pipe be located and made operable for use in the event of an emergency.

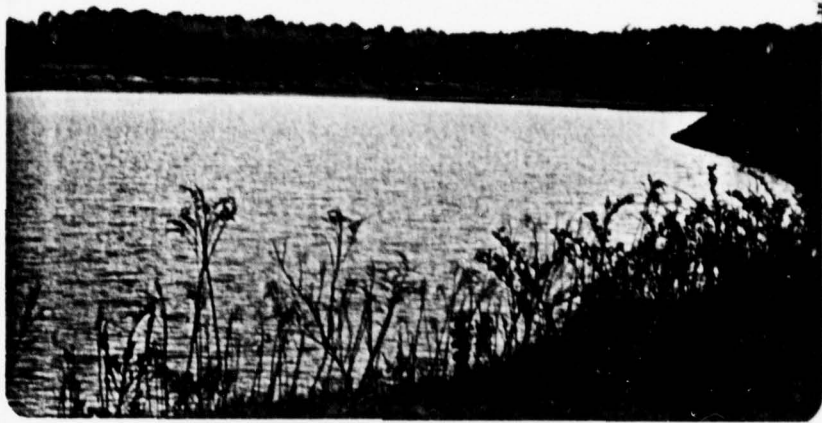
Reservoir - Dam in background

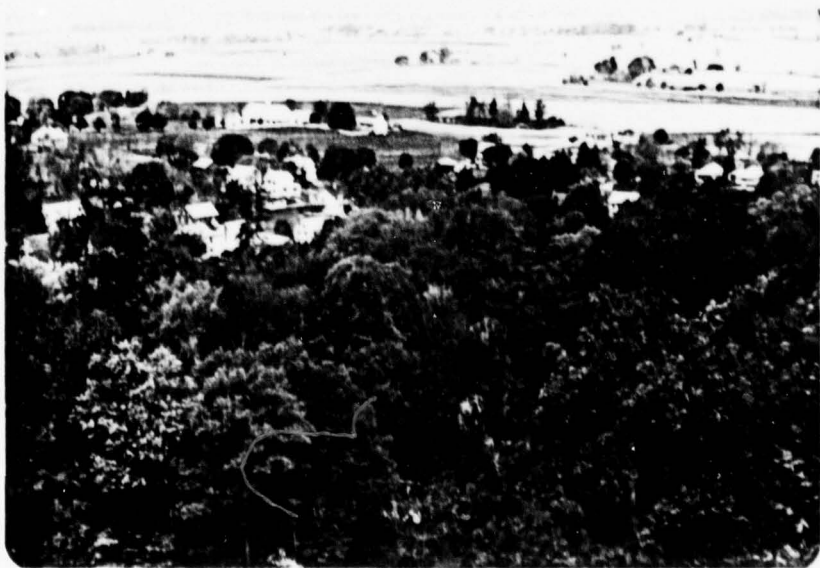
The downstream channel is the natural stream (Bernhard Creek) with several houses close to the stream and close to the embankment fill. About 2,000 feet downstream from the dam, the stream runs through the town of Rexmont with several homes located close to the stream. If the dam would fail due to overtopping, it is expected that the hazard to loss of life would increase. The hazard category for this dam is considered to be "High".

Looking downstream from top of dam

3. That a formal surveillance and downstream warning system be developed for implementation during periods of heavy or prolonged precipitation.
