**R. G. STRUBLE DAM**

NDI - PA 00621  
PA DER 15-298  
SCS PA - 431

PHASE I INSPECTION REPORT  
NATIONAL DAM INSPECTION PROGRAM

Name of Dam: Robert G. Struble Dam ID # PA 00621  
State Located: Pennsylvania  
County Located: Chester County  
Stream: East Branch Brandywine Creek  
Coordinates: Latitude 40° 6.7' Longitude 75° 51.9'  
Date of Inspection: May 2, 1979

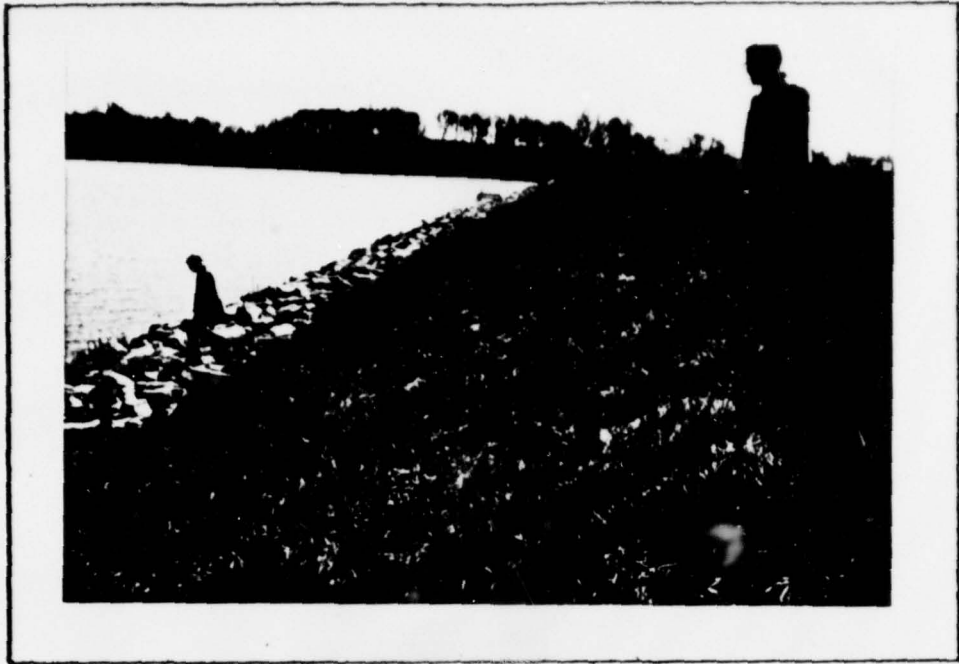
*UPSTREAM FACE OF THE DAM  
LOOKING TOWARDS THE LEFT ABUTMENT*

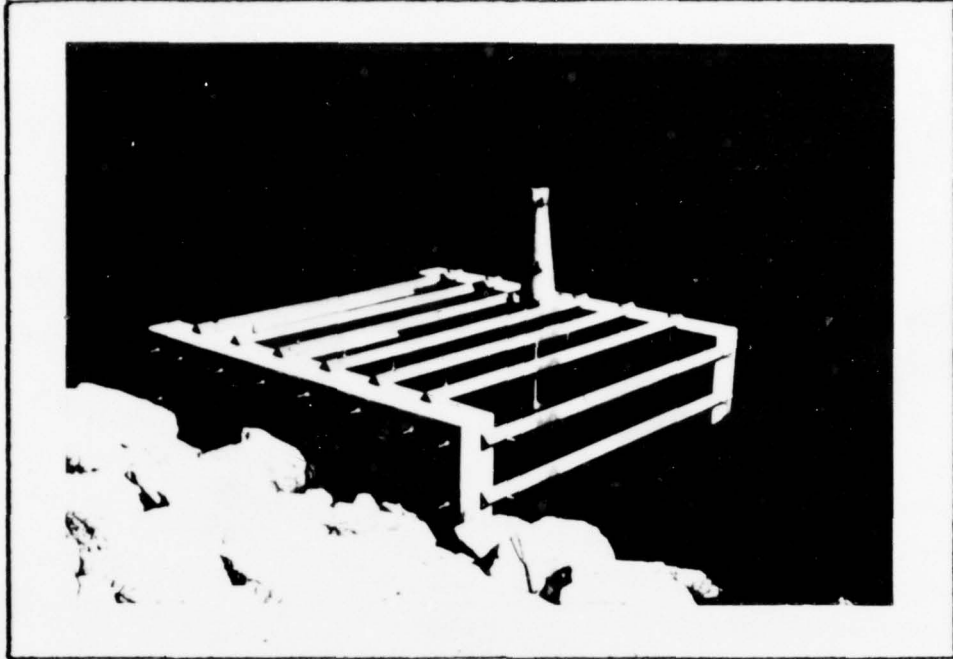
*PRINCIPAL SPILLWAY RISER INLET STRUCTURE  
ADJACENT TO THE ROCK BERM ON THE  
UPSTREAM FACE OF THE DAM*

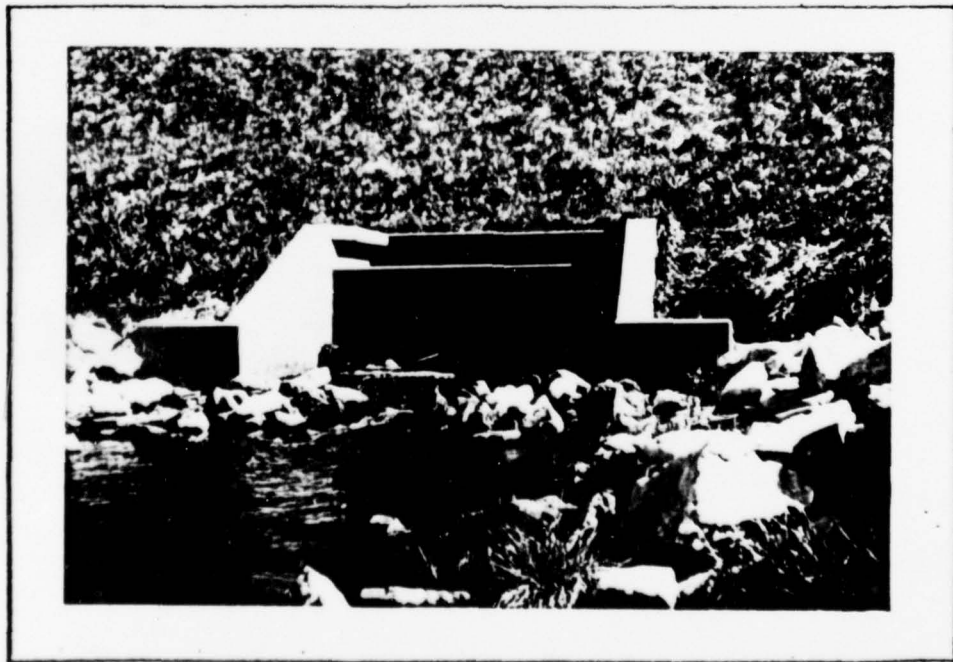
*PRINCIPAL SPILLWAY IMPACT BASIN OUTLET  
STRUCTURE AT THE DOWNSTREAM TOE OF THE DAM*

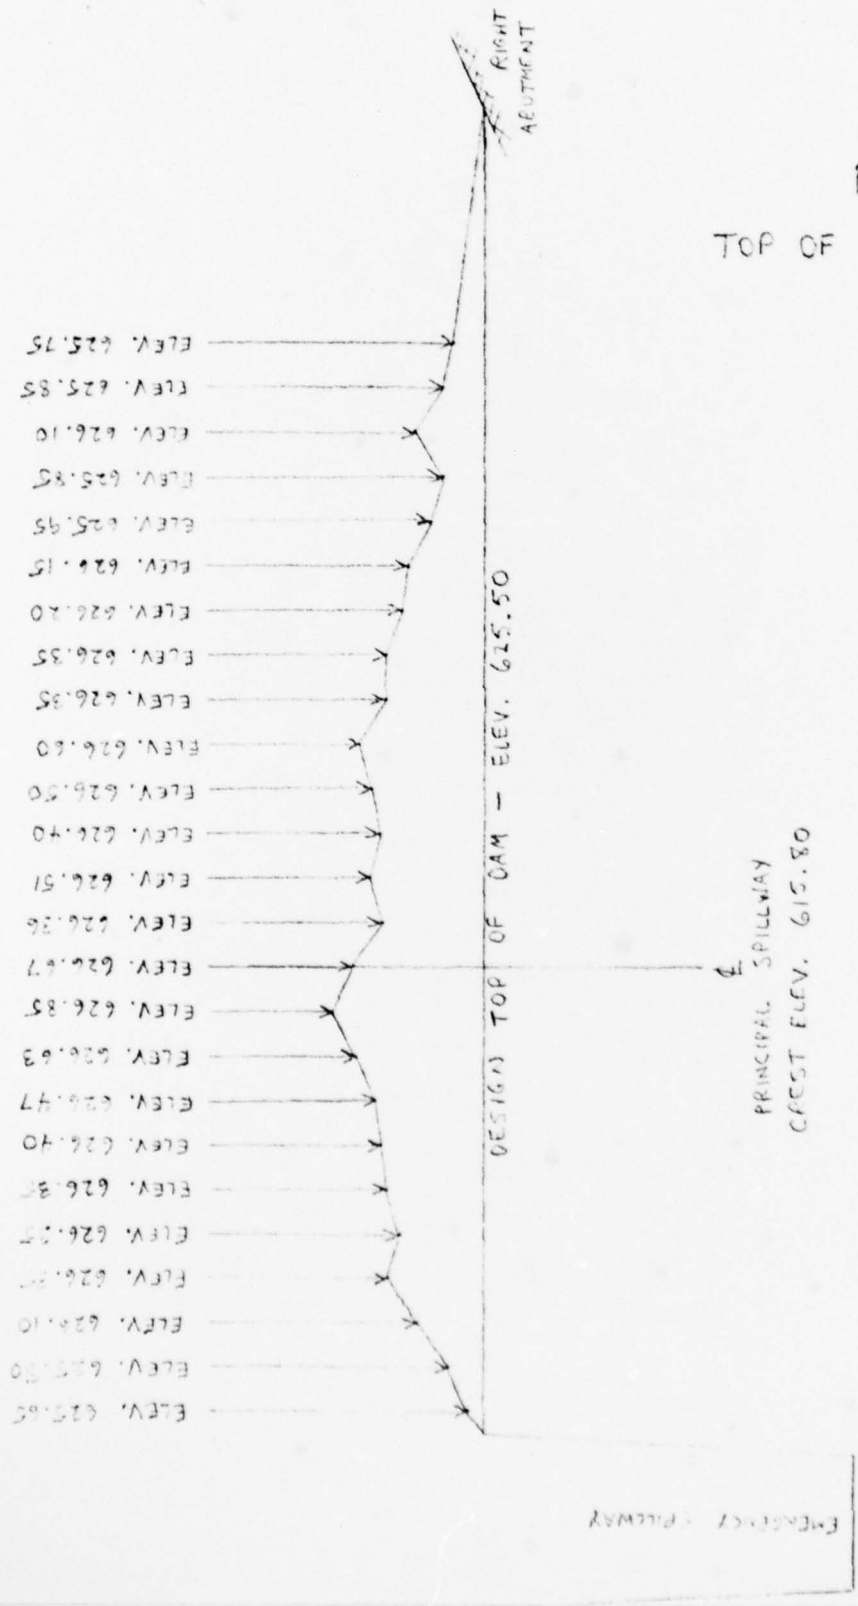
PLATE 5  
TOP OF DAM PROFILE

- a. Visual Observations. The downstream face of the embankment and the visible portion of the upstream face appear to be in good condition. There are no visible signs of instability of the dam. The survey of the top of dam revealed that little settlement has occurred since construction. The entire length of the top of dam is well above design elevation which is evidence of the overfill built into the top of the dam for possible future settlement of the embankment and to maintain a level appearance.
