4 GREENE DREHER DAM
WAYNE COUNTY, PENNSYLVANIA

NDS I.D. NO. PA 00174
DER I.D. NO. 64-174

5
6 PHASE I INSPECTION REPORT
NATIONAL DAM INSPECTION PROGRAM,
NDS I.D. Number PA-00174.
DER I.D. Number 64-174.
Delaware River Basin, Greene Dreher
Dam, Wayne County, Pennsylvania.
Phase I Inspection Report.

WOODWARD-CLYDE CONSULTANTS
5120 Butler Pike
Plymouth Meeting, Pennsylvania 19462

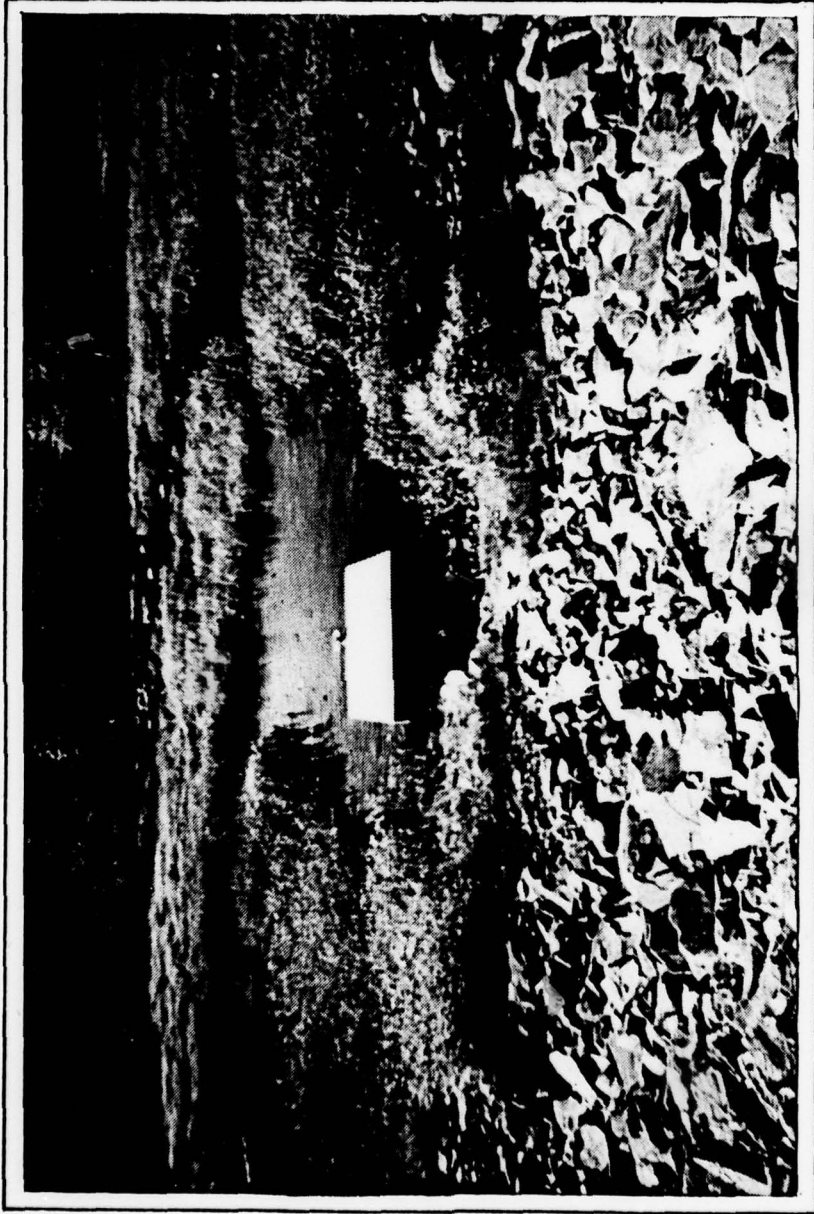
PHOTOGRAPH NO. 1

INTAKE RISER AND PRINCIPAL SPILLWAY.

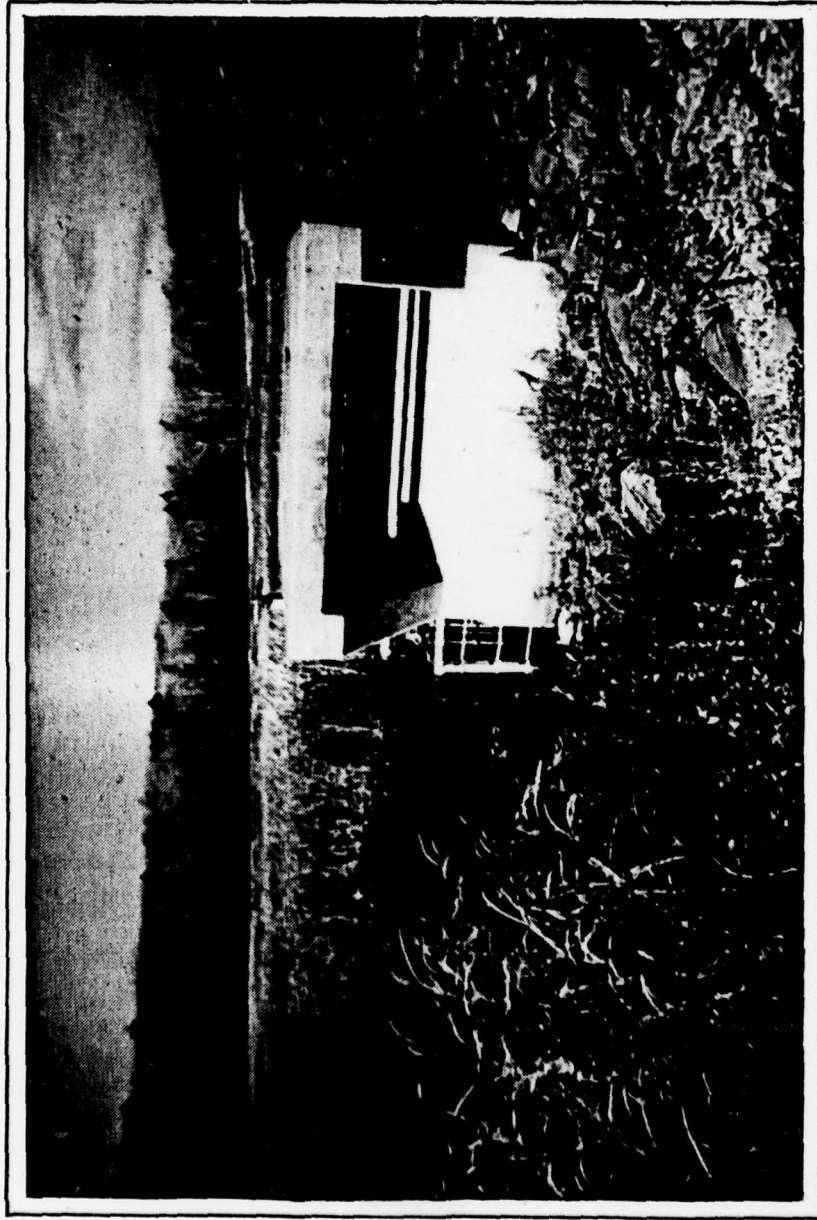
PHOTOGRAPH NO. 2

1. Principal Spillway. There was no cracking or significant spalling observed on the intake riser. The discharge conduit could not be inspected, but the exposed portions of the riser and the conduit were carefully inspected and observed to be in good condition. One trash rack pipe was missing on the right side of the intake riser, which can be seen in Photograph No. 2. The rock-lined outlet channel, as

The exposed portions of the intake riser were inspected and found to be in good condition. However, one of the trash racks was missing and should be replaced.

SIDE VIEW OF RISER. NOTE TRASH RACKS
AND THAT ONE IS MISSING.

1. The swale at the right abutment should be filled with compacted soil to at least the same elevation as the dam.
2. The missing trash rack pipe on the intake riser should be replaced.
3. The woody vegetation on the downstream embankment slopes should be cleared during the normal maintenance program.

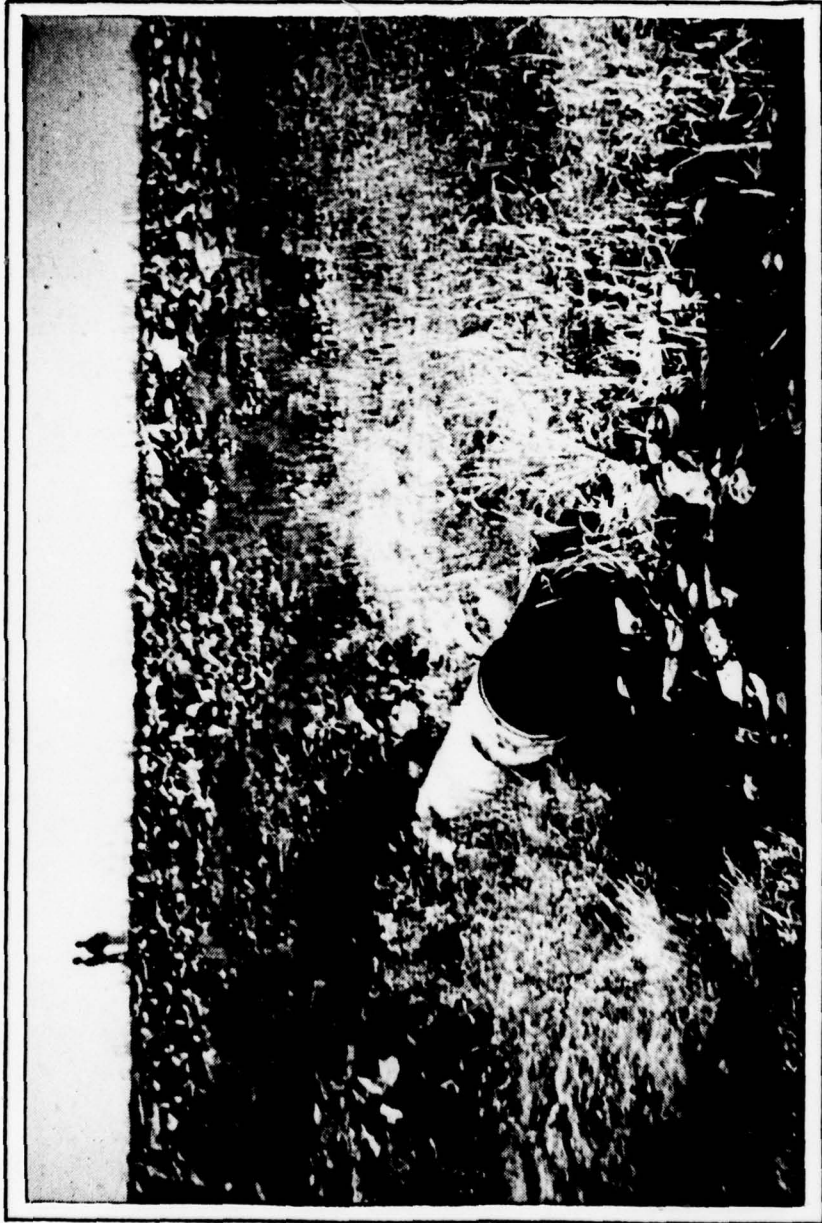
PHOTOGRAPH NO. 3

The outlet pipe was found to be in good condition.

OUTLET PIPE FOR PRINCIPAL SPILLWAY.

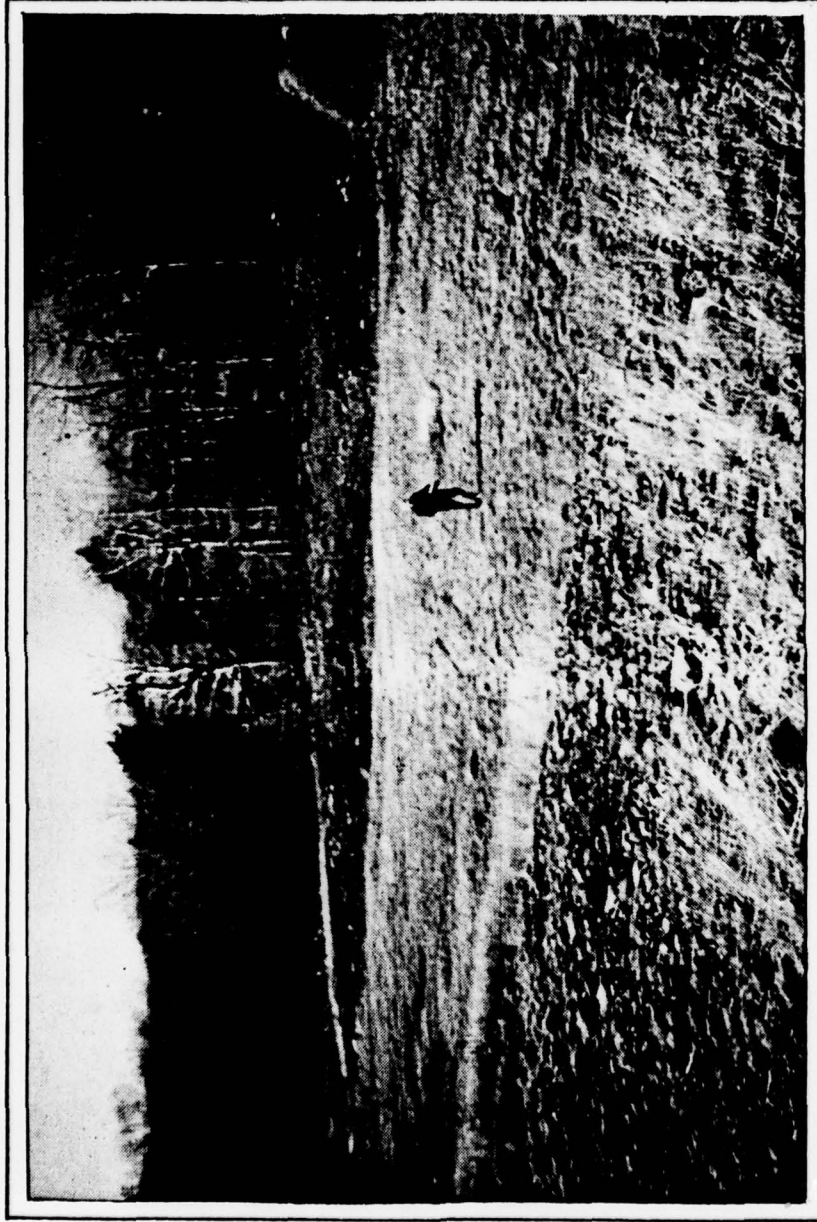
PHOTOGRAPH NO. 5

2. Emergency Spillway. The approach and discharge channels were both stable and well vegetated, being excavated into erosion-resistant materials and grass-lined. The side slopes were also well vegetated. The control section was checked with instruments and found to be of the dimensions and elevations shown on the Soil Conservation Service (SCS) drawings; see Plate 2, Appendix E. In summary, there were no signs of significant erosion, channel deterioration, or other evidence that would indicate that the spillway would not function as designed.

OVERVIEW OF EMERGENCY SPILLWAY
LOOKING UPSTREAM FROM LEFT END
OF EMBANKMENT.

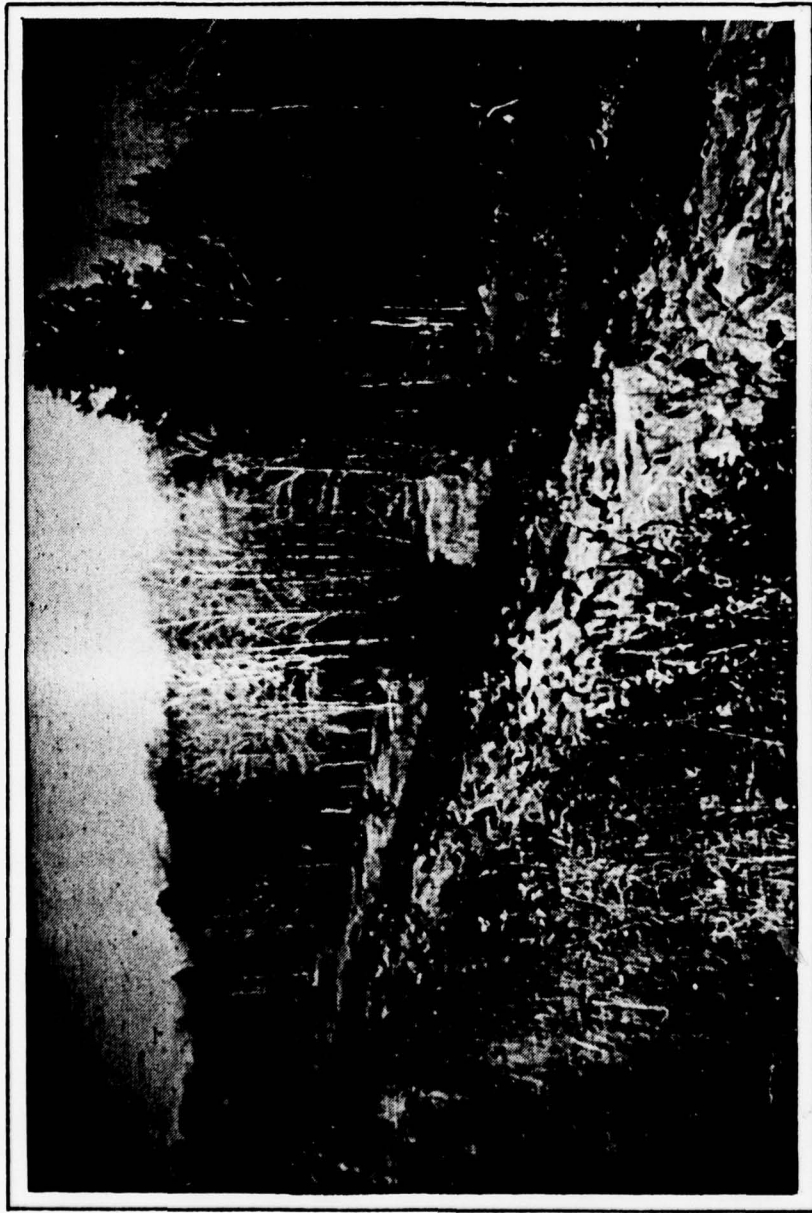
PHOTOGRAPH NO. 7

There was no spalling or concrete deterioration of the exposed portions of the principal spillway riser or conduit observed. The upstream slope of the dam was assessed to be quite stable and the woody vegetation recently removed. The downstream slope had a few small evergreen trees growing on the slope, which should be removed in the near future.

OVERVIEW OF DOWNSTREAM SLOPE.

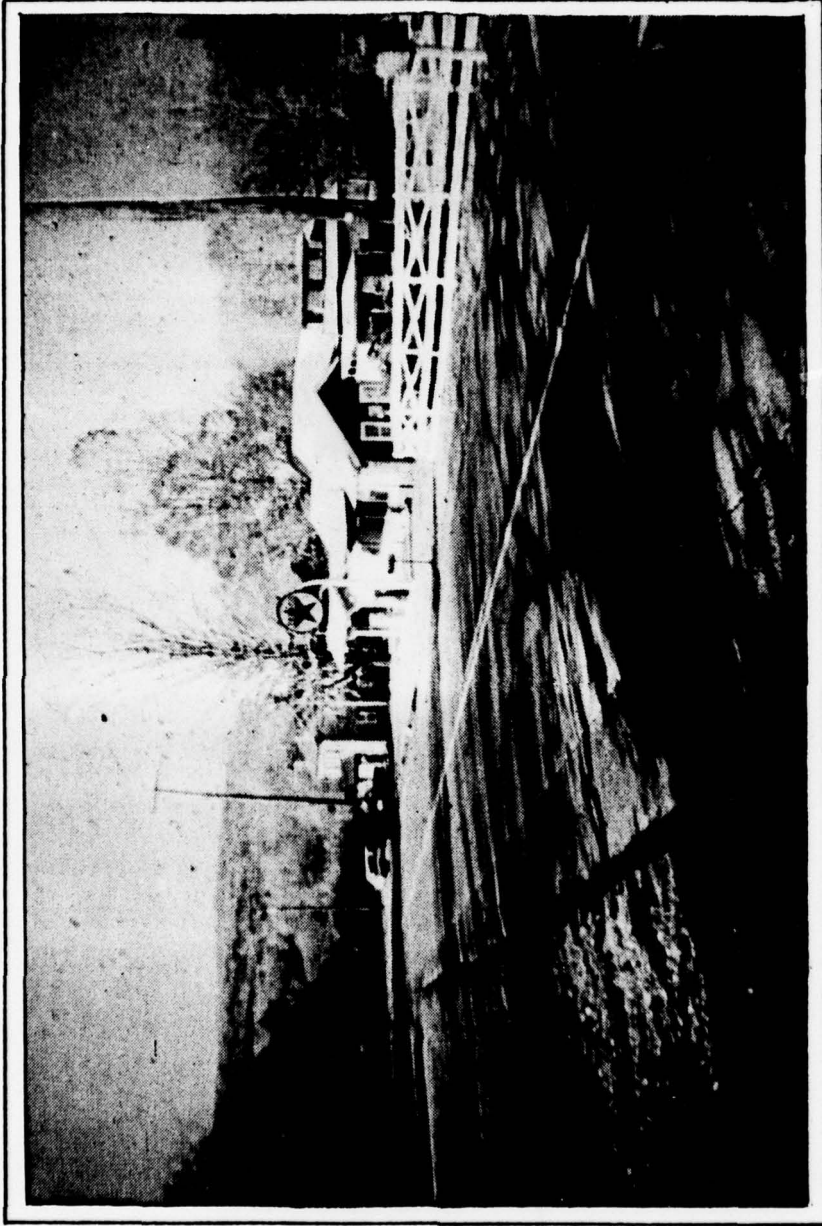
PHOTOGRAPH NO. 10

e. Downstream Channel. The downstream channel was inspected from the dam to Route 196 and found to be unobstructed and quite stable. Between Route 196 and the junction of Manny Run with Routes 423 and 191, the creek was not inspected in that it passed through a dense wooded area which was not reasonably accessible. However, the creek was inspected at the damage center (intersection of Manny Run and Route 423) and the banks were found to be stable. A view of the bridge at the damage center is shown on Photograph No. 8. The houses that would be affected by high flows are shown on Photograph No. 10.

POPULATED AREAS ALONG ROUTE 191
ADJACENT TO MANNY RUN.
