4 WARRINGTON DAM, BUCKS COUNTY
PENNSYLVANIA

2 NDS I.D. NO PA 00221
DER I.D. NO. 9-174
SCS PA 611

5
6 PHASE I INSPECTION REPORT
NATIONAL DAM INSPECTION PROGRAM.

WOODWARD-CLYDE CONSULTANTS
5120 Butler Pike
Plymouth Meeting, Pennsylvania 19462

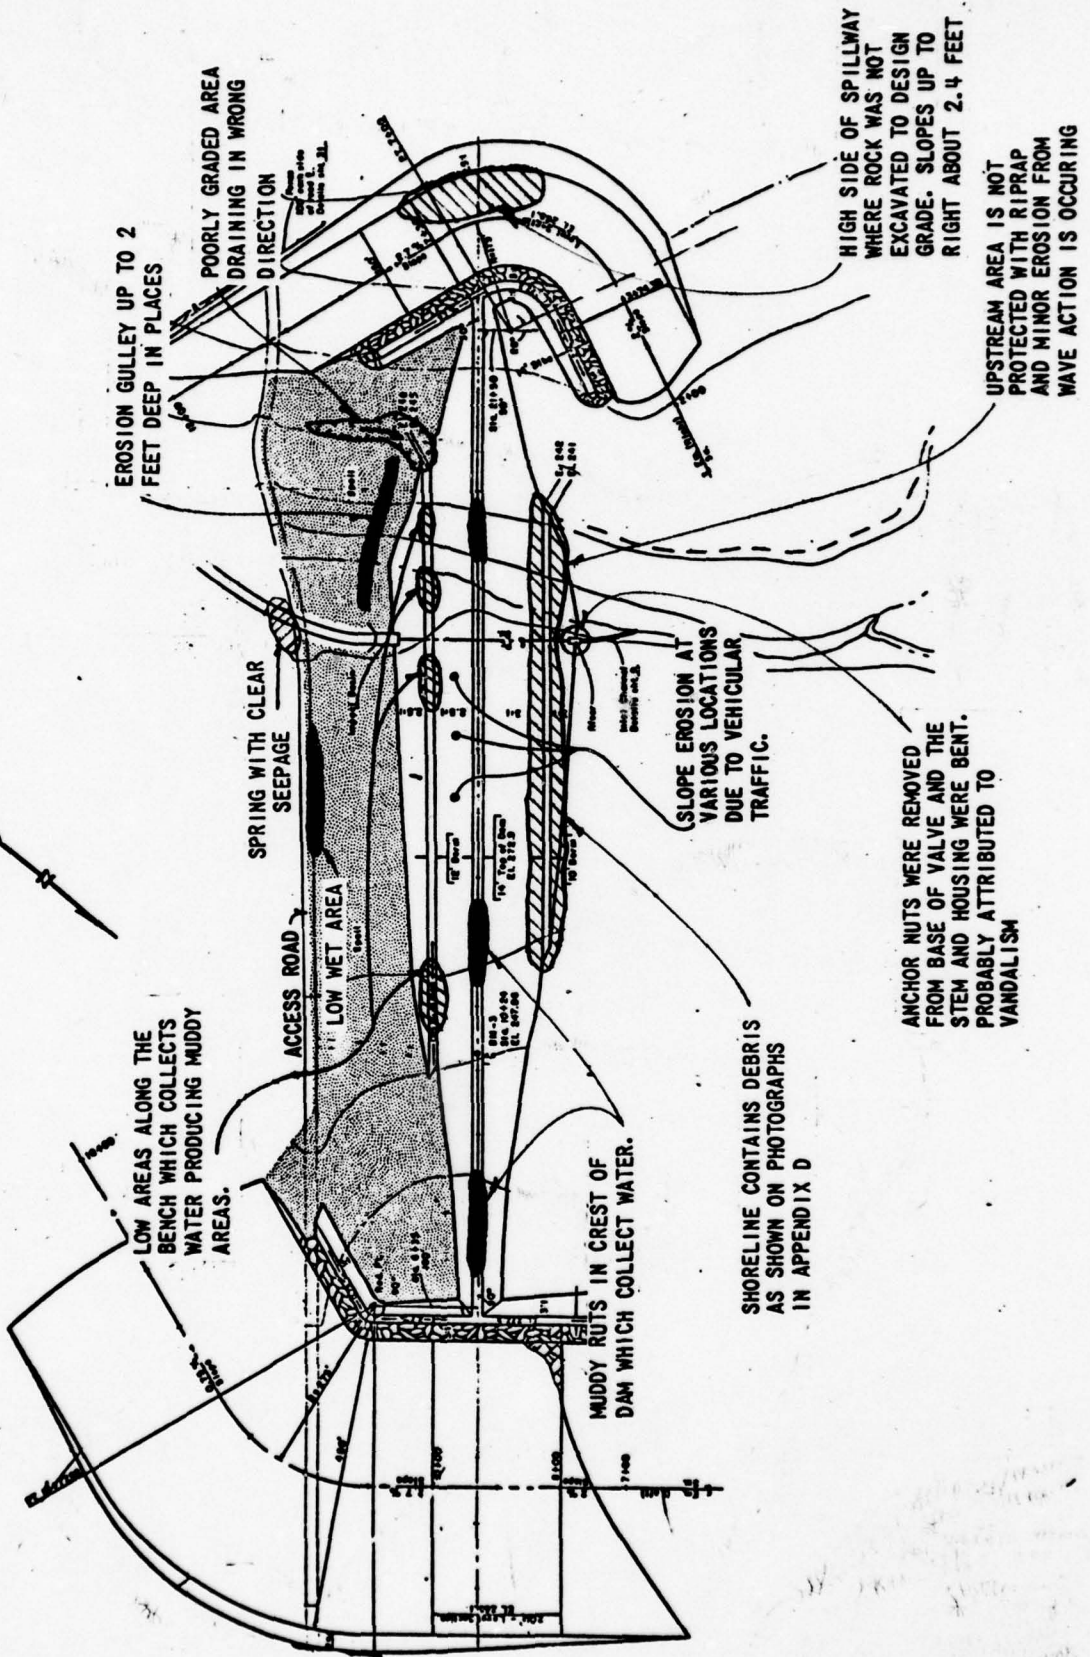
FIELD OBSERVATION PLAN
 WARRINGTON DAM
 SHEET 5A OF 11

The only seepage noted is shown on sheet 5a and is located downstream of the dam beyond the spoil area along an access road. This seepage was assessed to be associated with a localized rise of groundwater as a result of impoundment behind the dam.

No significant erosion observed on the embankment but as shown on Sheet 5a, substantial erosion was noted beyond the toe. Upstream slopes contain a lot of debris. See photographs.

4. Seepage noted beyond the downstream toe should be monitored. If there is an increase in the seepage, appropriate remedial measures should be taken.

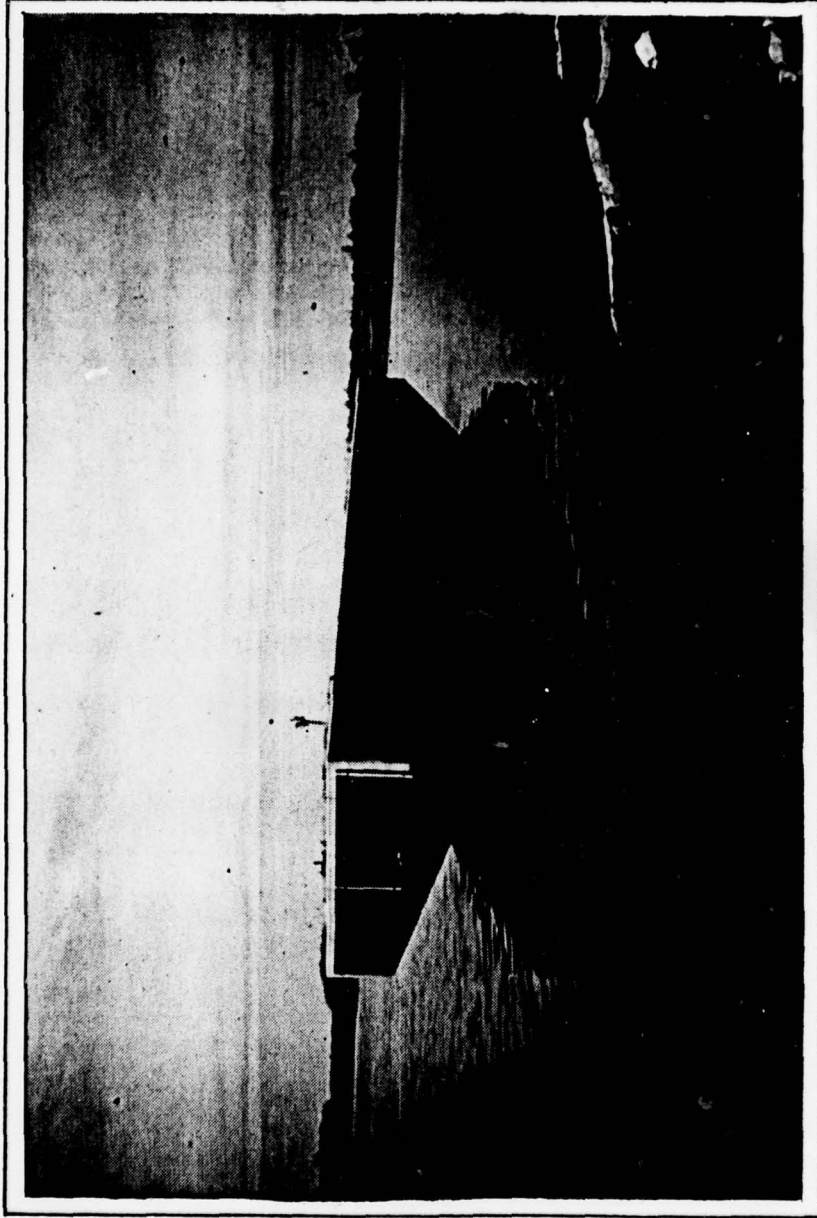
PHOTOGRAPH NO. 1

1. Intake Riser. Exposed portions of the concrete riser were noted to be in good condition with no significant cracking, spalling or undue deterioration of the concrete above the waterline. The interior of the riser could not be inspected as a result of flow over the weirs. It was noted that the pond drain gate hoist at the top of the riser was bent and that two upstream bolts are missing, possibly rendering the valve unserviceable. The Owner's representative was not aware of this condition and indicated that they would remedy the situation as soon as possible. The impact basin at the downstream toe was inspected and found to be in good condition with no significant cracking, spalling of the concrete or erosion adjacent to the structure. The downstream channel was also inspected and found to be in good condition with no unacceptable erosion or deterioration.

OVERVIEW OF PRINCIPAL SPILLWAY RISER.

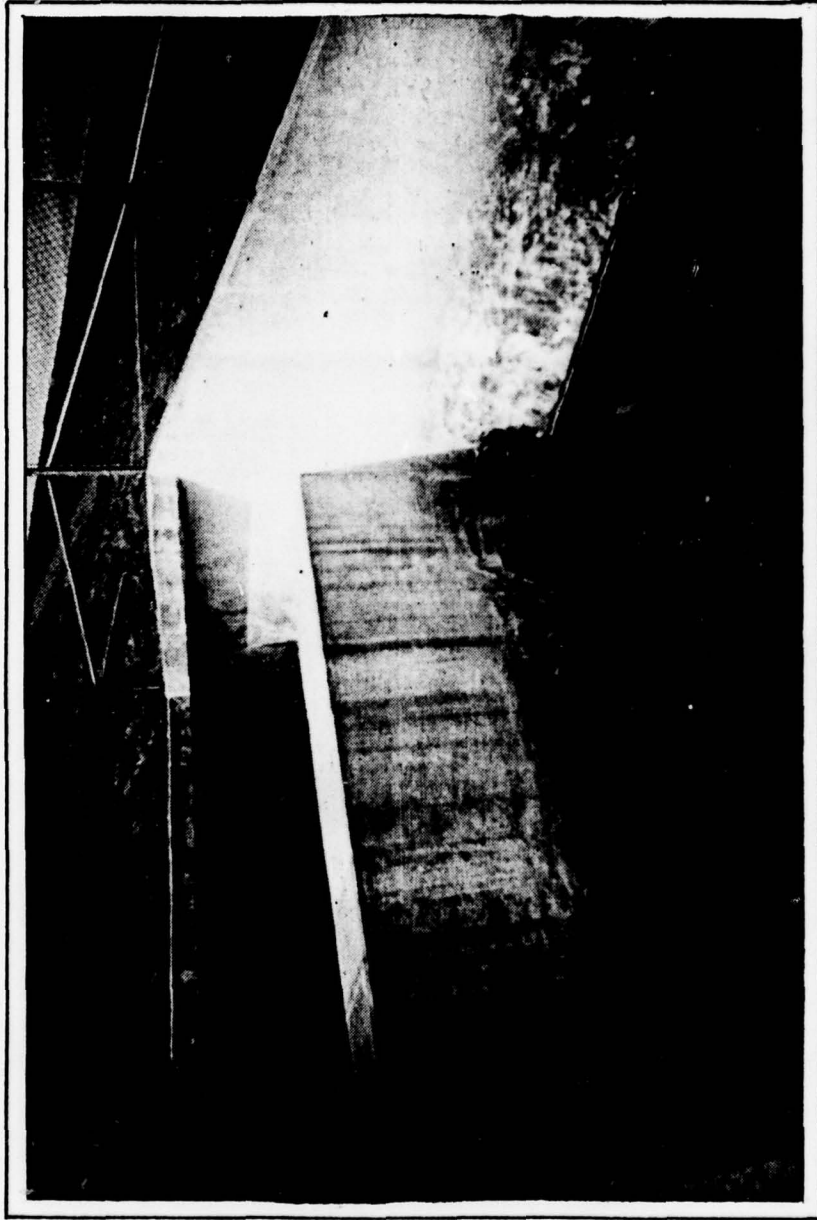
PHOTOGRAPH NO. 2

PRINCIPAL SPILLWAY IMPACT BASIN.

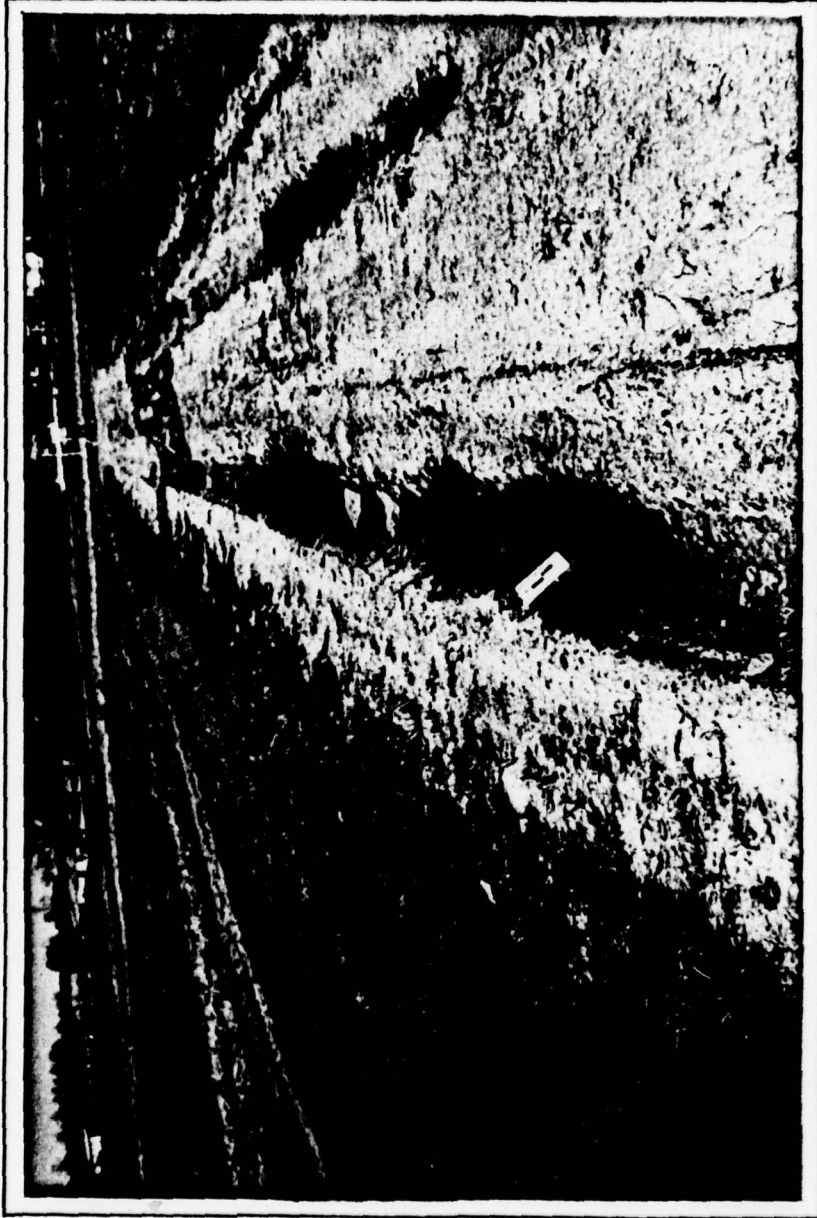
PHOTOGRAPH NO. 9

None observed. The crest is rutted and muddy in areas as a result of unauthorized vehicles.

VIEW OF CREST CONTAINING RUTS AND
STANDING WATER.

1. The pond drain gate hoist should be rehabilitated and suitably protected to minimize the possibility of future vandalism to this system.
2. Erosion on the upstream and downstream slopes should be corrected and vegetation established in a satisfactory manner on the entire embankment.
3. The crest of the dam should be cleaned of mud and ruts and the top stabilized with stone or as recommended by the SCS.

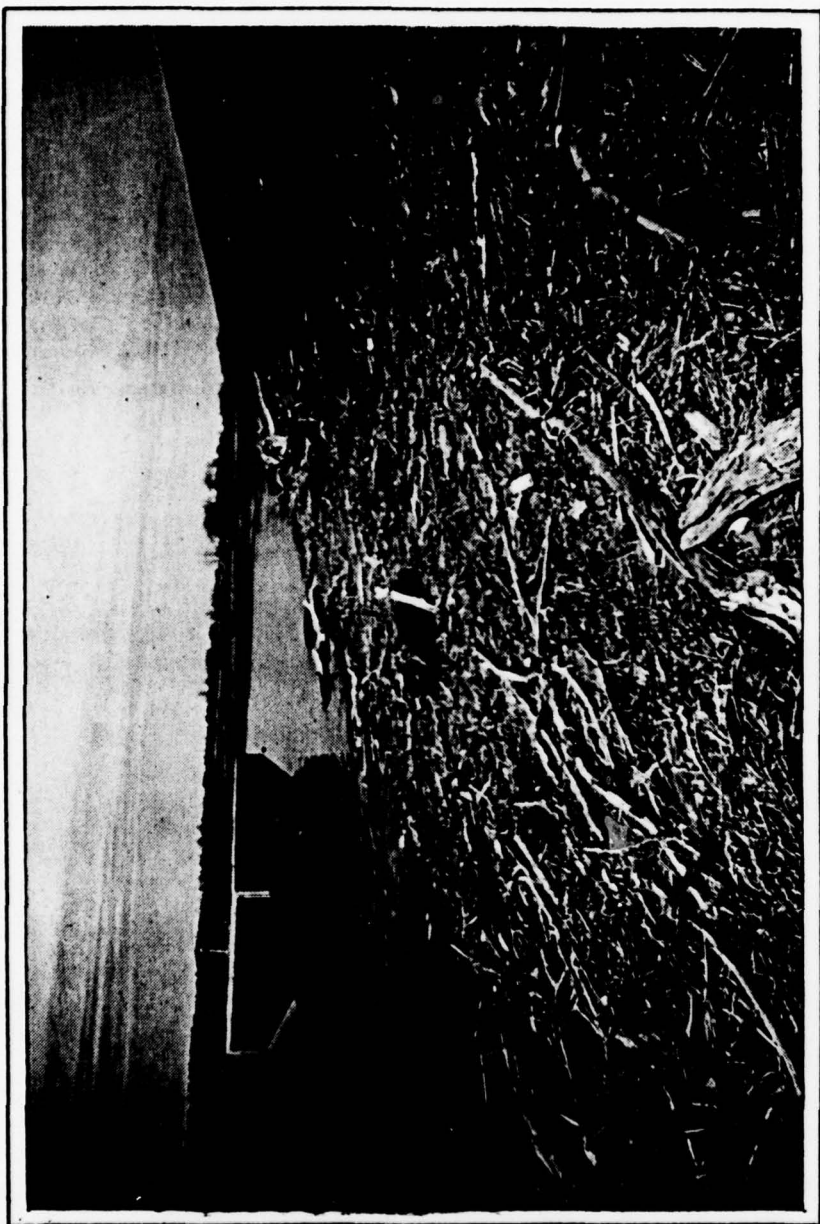
PHOTOGRAPH NO. 12

Debris was noted along the upstream slope of the dam, which is considered undesirable and could partially clog the principal spillway. Muddy areas, ruts, erosion, and general deterioration of both the upstream and downstream slopes and the benches were noted, predominantly as a result of unauthorized vehicular traffic across the dam and slopes.

DEBRIS ALONG UPSTREAM SLOPE.

1. Debris along the upstream slope and along the sides of the reservoir should be removed to minimize the potential for clogging the spillway intake system.
2. Erosion along the shoreline, if it continues to worsen, should be stabilized with designed riprap. Recommendations for this stabilization should be obtained from the Soil Conservation Service (SCS).
3. If at all possible, devices should be installed to discourage vehicular traffic along the crest and slopes of the embankment. Without this unauthorized traffic, the erosion, ruts and general deterioration of the slopes would have been minimal.
4. Erosion along the walls of the impact basin should be repaired.

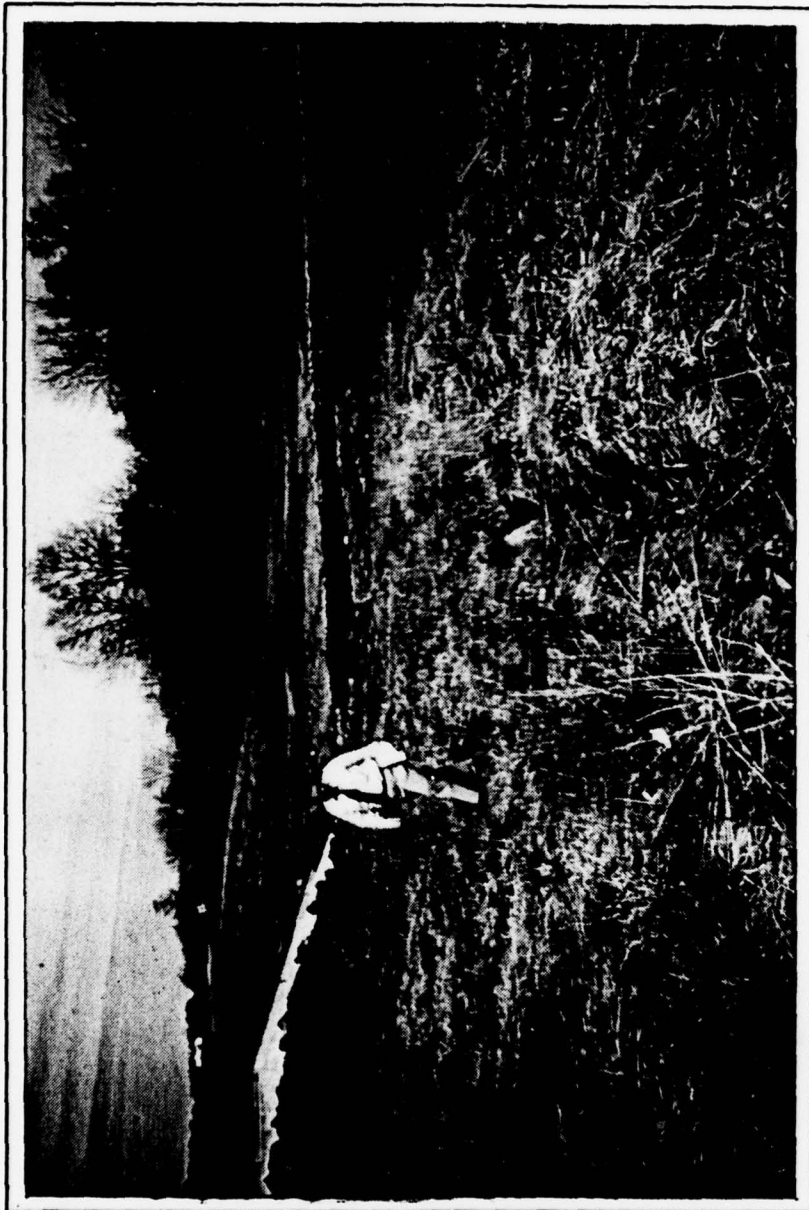
PHOTOGRAPH NO. 13

Beyond the toe in the spoil area, erosion gullies up to two feet deep were noted. These gullies drain towards the dam into a poorly drained area which produces a marshy condition.

EROSION GULLY ALONG DOWNSTREAM TOE
ON THE RIGHT SIDE OF THE IMPACT
BASIN.
