DELAWARE RIVER BASIN  
LEAVITT BRANCH, BRODHEAD CREEK  
MONROE COUNTY, PENNSYLVANIA

NDS ID PA. 00634  
DER ID 45-71

# SKYTOP DAM (MOUNTAIN LAKE)

PHASE I INSPECTION REPORT  
NATIONAL DAM INSPECTION PROGRAM

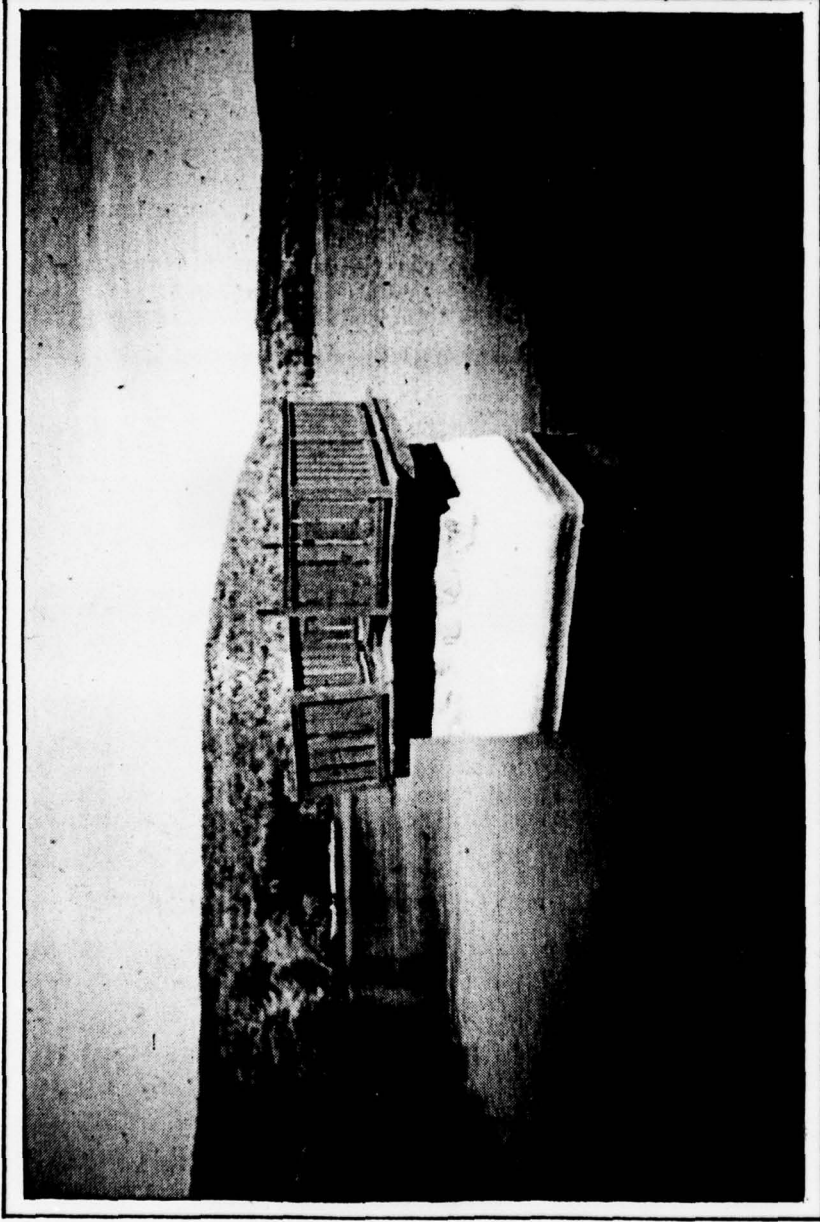
PHOTOGRAPH NO. 1

INTAKE TOWER

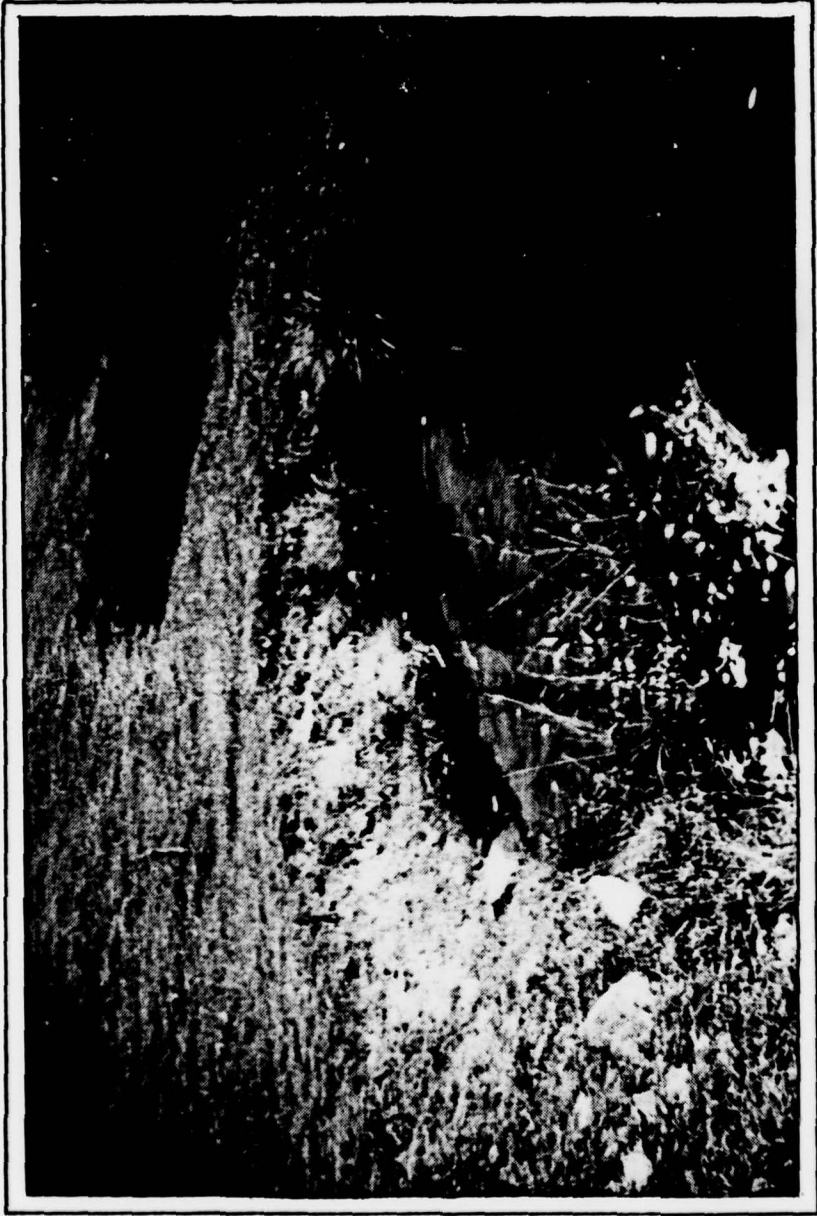
VIEW OF OUTLET SYSTEM AT DOWNSTREAM  
TOE. THE OUTLET PIPE DISCHARGES BELOW  
THE WATER LEVEL OF THE LOWER RESERVOIR  
(DOCTOR MAINE POND).

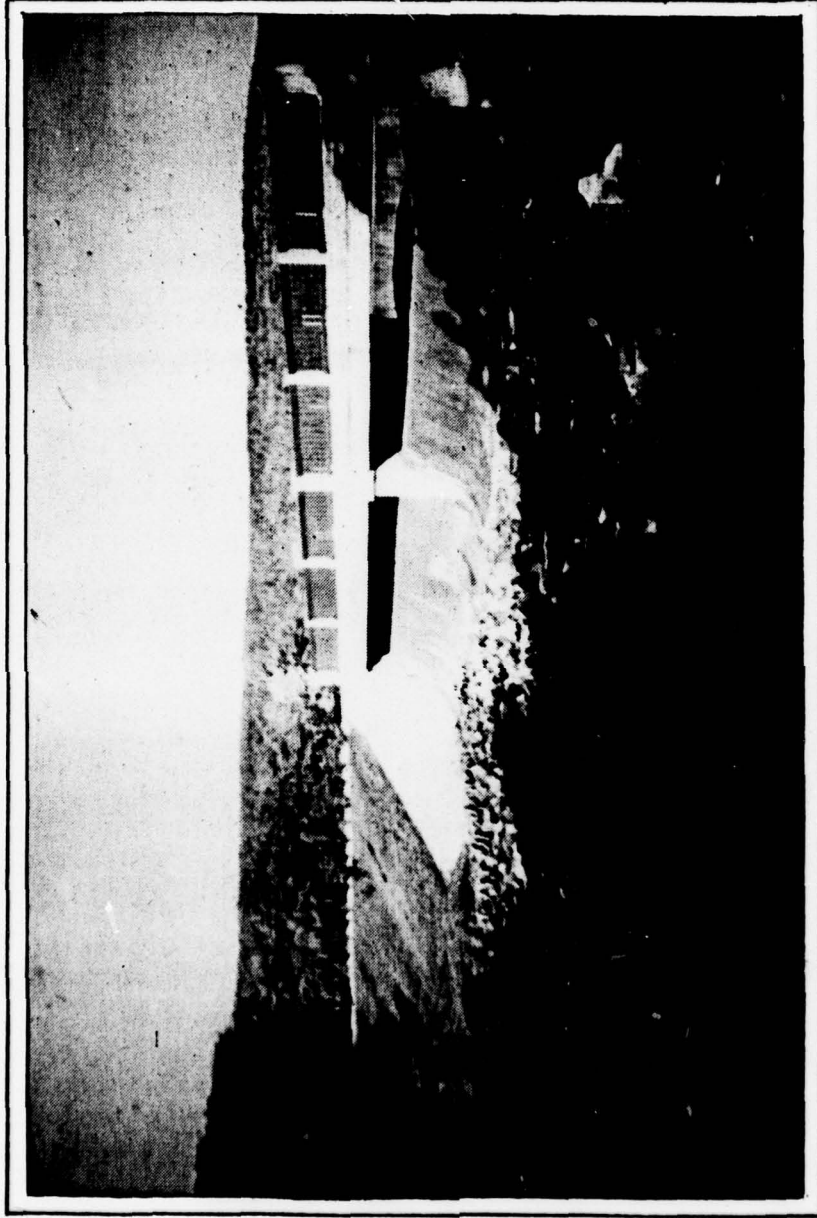
PHOTOGRAPH NO. 3

OVERVIEW OF SPILLWAY AND DISCHARGE  
CHANNEL.

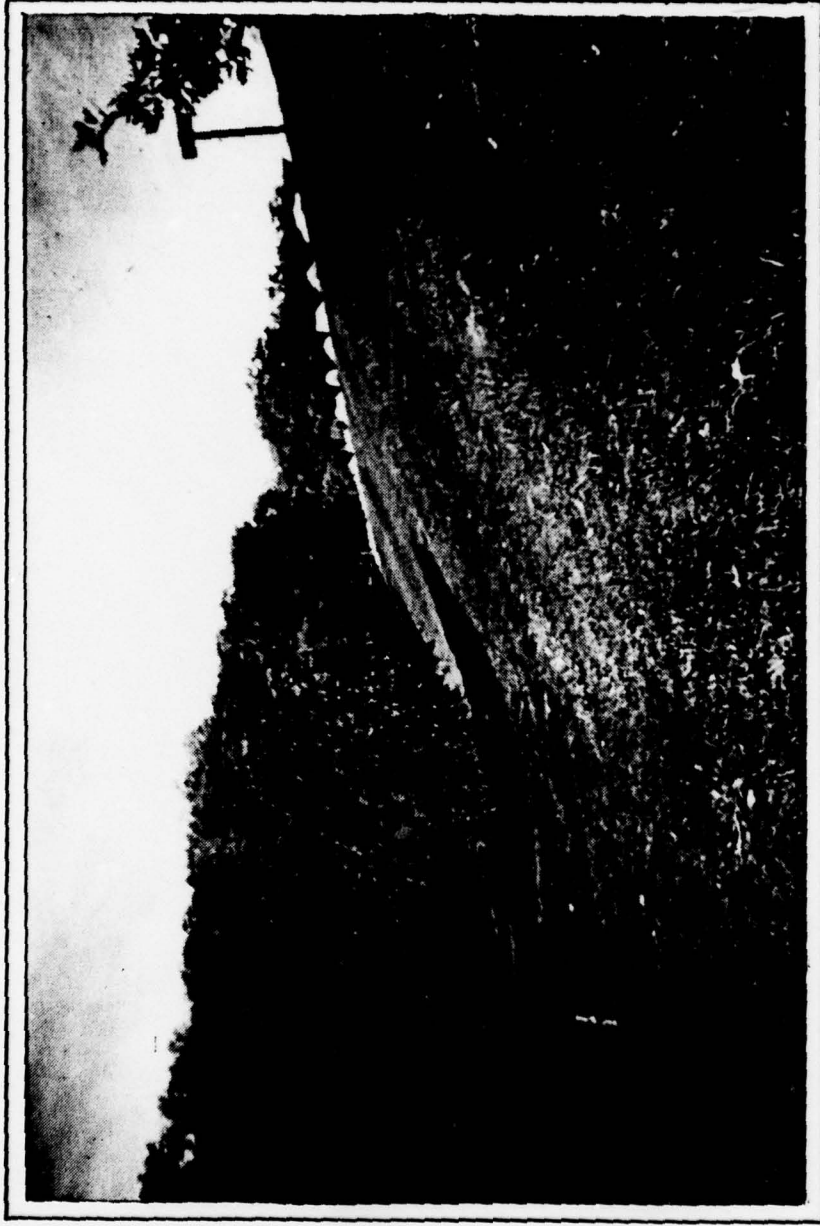
PHOTOGRAPH NO. 7

VIEW OF DOWNSTREAM SLOPE LOOKING  
TOWARDS RIGHT ABUTMENT.

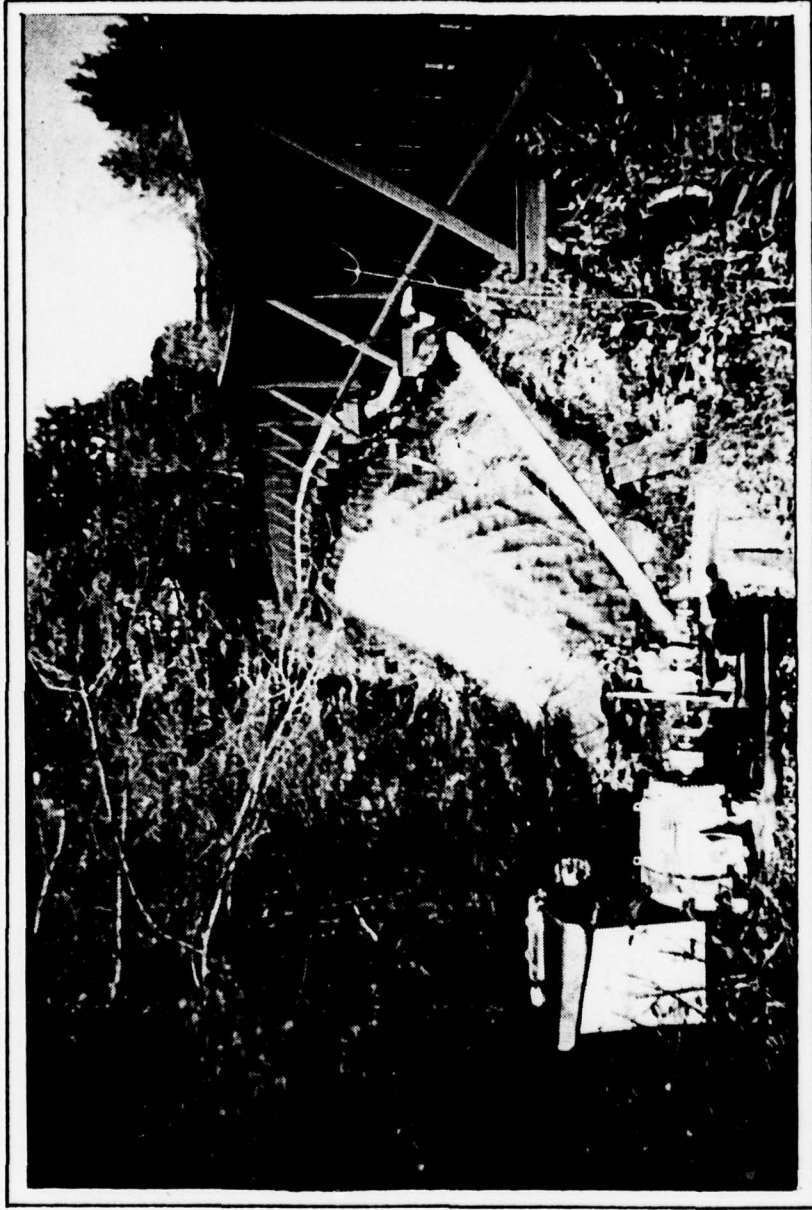
PHOTOGRAPH NO. 9

VIEW OF DOWNSTREAM SIDE OF NO. 10  
DAM.

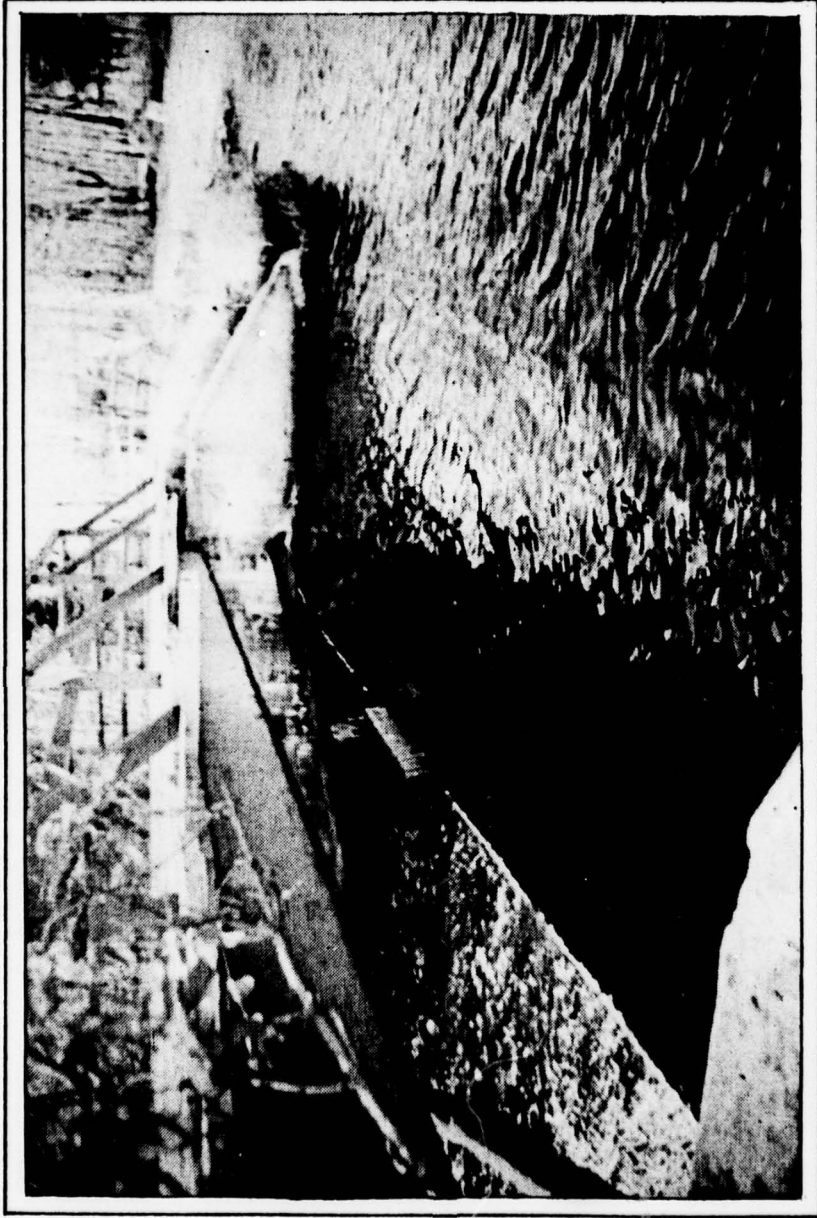
SPELLWAY OF LAKE IN THE CLOUDS.  
THE DAM AND RESERVOIR ARE  
LOCATED APPROXIMATELY 2.5 MILES  
UPSTREAM OF SKYTOP RESERVOIR.
