# BRUSH VALLEY DAM

NDI-PA 00652  
PA DER 19-3

## PHASE I INSPECTION REPORT NATIONAL DAM INSPECTION PROGRAM

6  
PHASE I INSPECTION REPORT  
NATIONAL DAM SAFETY PROGRAM,  
Brush Valley Dam. NDI-PA-00652.  
PA DER-19-3. Susquehanna River Basin.  
South Branch Roaring Creek, Columbia  
County, Pennsylvania. Phase I Inspection  
Report.

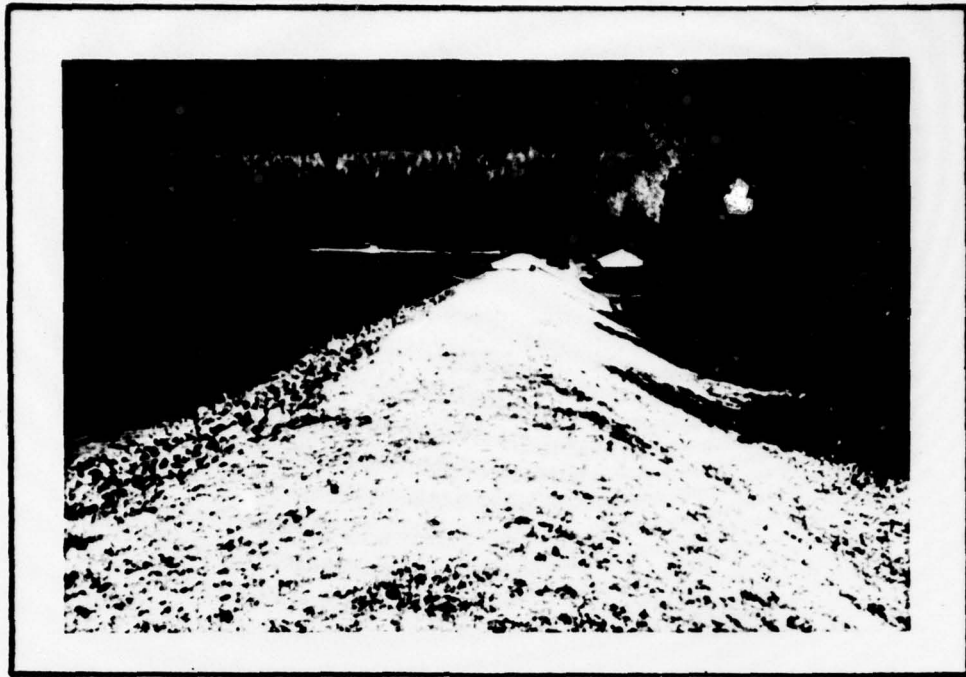
*EMBANKMENT AND PUMPHOUSE  
LOOKING SOUTH FROM THE RIGHT ABUTMENT*

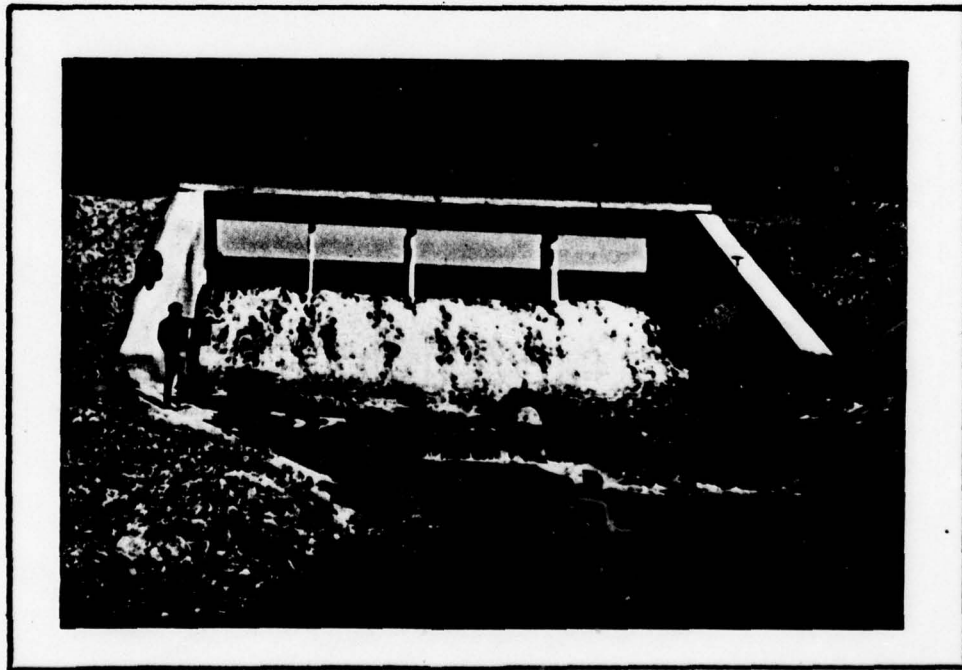
The single control valve on the diversion pipe located in the center of the spillway discharge channel, is considered inadequate. The valve control wheel would not be accessible under all flow conditions. An additional valve should be located upstream of the existing valve and should be readily accessible to operating personnel during all weather conditions.

The operational control of the diversion pipe is considered to be inadequate. The control valve would not be accessible under all flow conditions.

*DOWNSTREAM VIEW OF THE SPILLWAY WITH  
THE DIVERSION PIPE CONTROL VALVE IN THE FOREGROUND*

3. Provisions for placing an additional positive control valve on the 16-inch diversion pipe upstream of the embankment should be made. The valve operating mechanism should be fully accessible for all flow conditions.
  4. A ditch should be constructed to drain water away from the toe of the embankment.
- b. Operation and Maintenance
1. The Owner should develop and implement a formal maintenance and inspection program to insure that all items are maintained on a regular basis. Maintenance activities performed should be recorded to provide a history of corrected deficiencies.
  2. A downstream warning system should be developed by the Owner. During periods of heavy rainfall, the dam should be monitored and appropriate agencies should be alerted in the event of an impending failure.

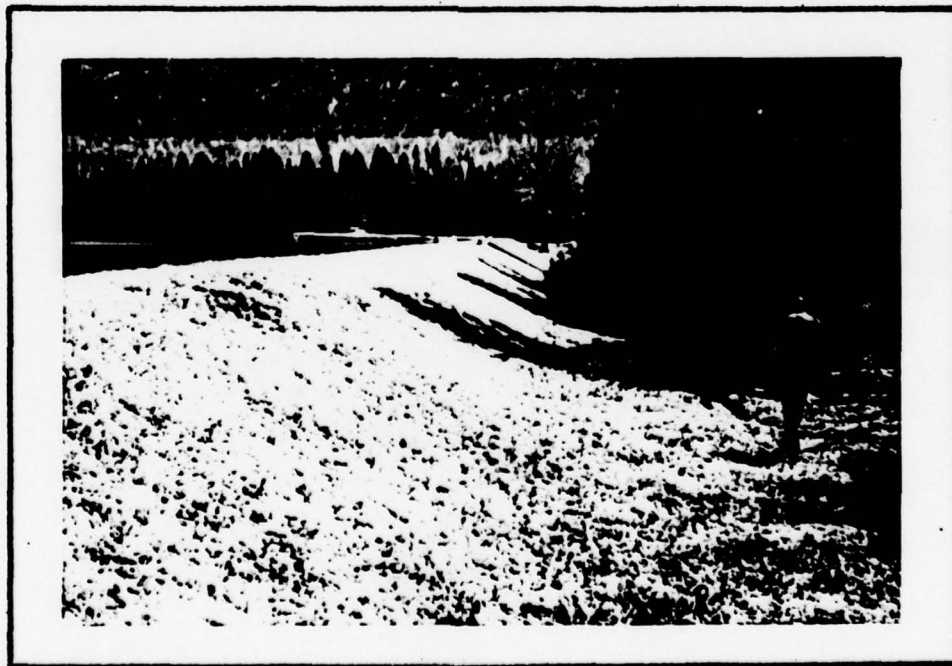
The downstream slope has a number of bulges between the spillway and the pumphouse. The downstream portion of the embankment is noticeably non-uniform in slope along this portion of the dam. The bulges may be due to poor construction control or methods; no indications of recent movement or cracks are evident. Some minor sloughing and erosion of the embankment toe was noted to the left of the pumphouse.

Areas of saturated soil and small puddles of water were located along the toe of the embankment between the pumphouse and the spillway below the general area of the embankment bulging. The wet soil condition extends about one third up the length of the slope. No movement could be detected in the puddles of water; the water appeared to be clear. The downstream slope is covered in dense grass that appears to be well maintained. Two small pine seedling were located along the embankment slope. A number of large pine trees, 16-18 inches in diameter, are located about 10 feet downstream of the embankment toe on the right side of the spillway section.

*DOWNSTREAM SLOPE OF THE EMBANKMENT*

Further investigation should be initiated to determine the cause and severity of the moisture condition.

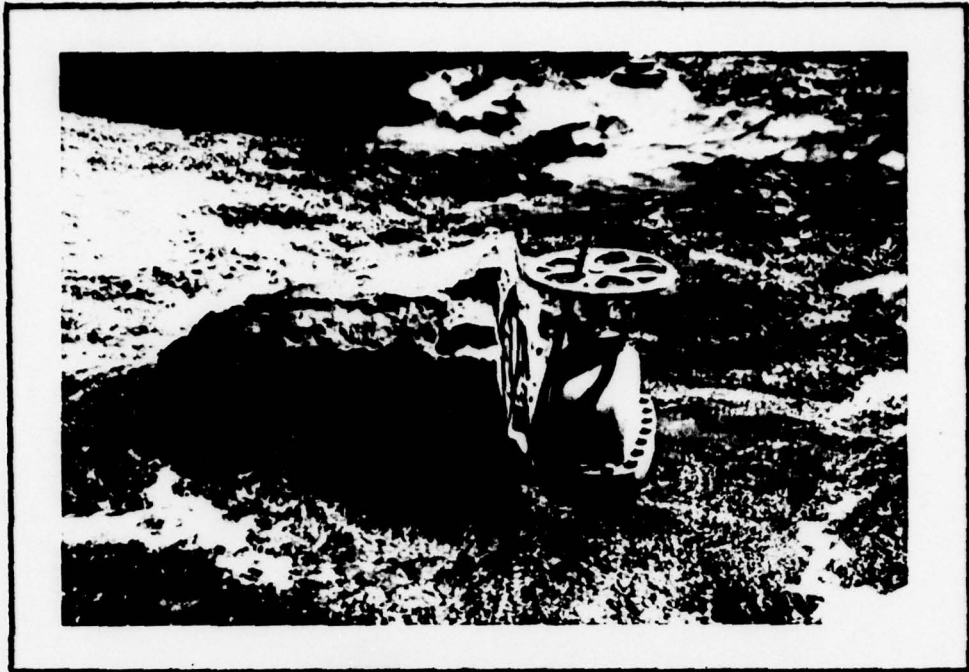
*DIVERSION PIPE CONTROL VALVE IN THE OUTLET CHANNEL  
IMMEDIATELY DOWNSTREAM OF THE SPILLWAY*
