HOSENSOCK DAM

NDI NO. PA-00672

⑥ PHASE I INSPECTION REPORT
NATIONAL DAM INSPECTION PROGRAM

Name of Dam: HOSENSOCK DAM
State & State No: PENNSYLVANIA, 54-168
County: SCHUYLKILL
Stream: HOSENSOCK CREEK
Date of Inspection: May 8, 1979

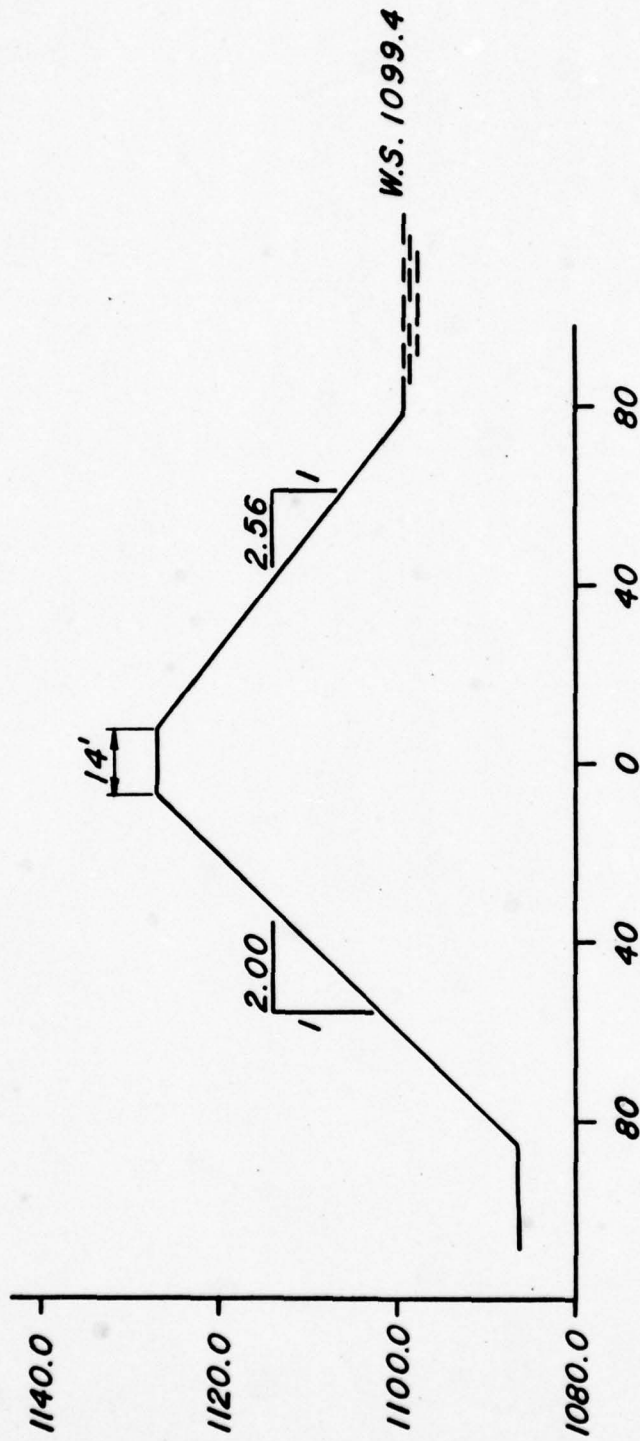
PLATE A-III

The visual inspection did not observe or detect any signs of embankment instability. The original design report indicates a minimum factor of safety of 1.52 for full drawdown condition. The slopes were surveyed to be virtually the same as designed. Refer to Appendix A, Plate A-III.

EMBANKMENT SECTION

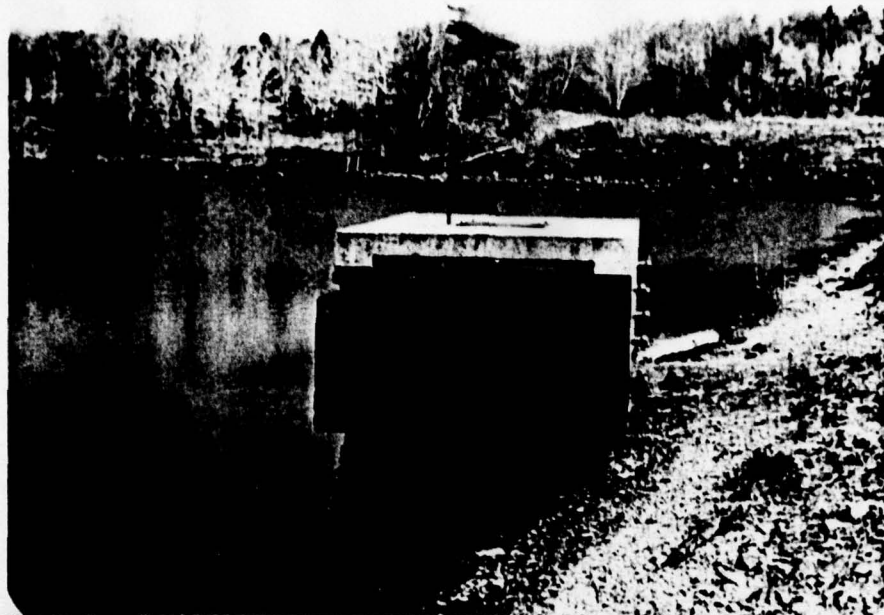
Control Structure
"Riser"

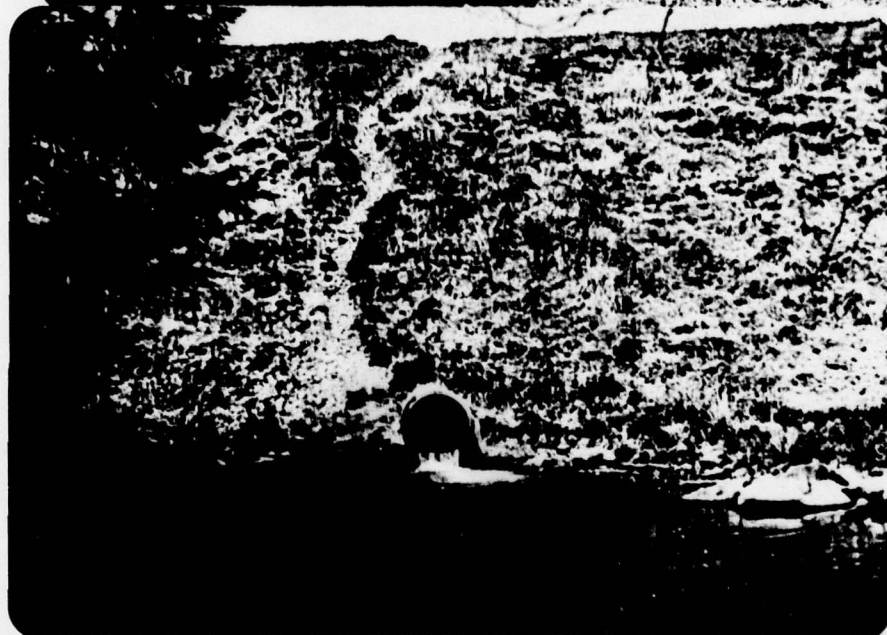
B. OUTLET STRUCTURE	30-inch diameter concrete pipe discharges directly into the natural stream channel. This discharge is from the principal spillway structure - good condition.

Outlet Pipe

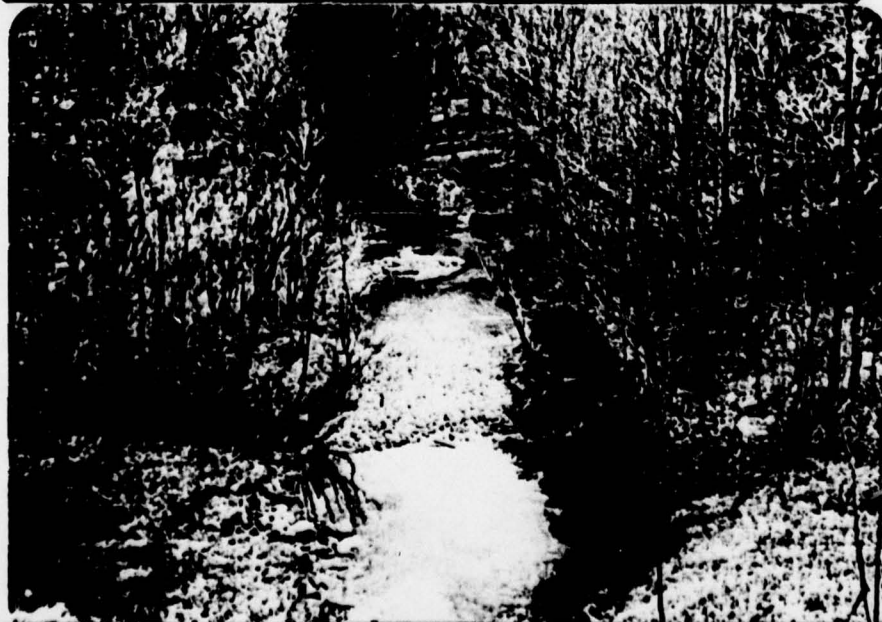
PLATE E-II

Downstream Channel
Outlet Pipe

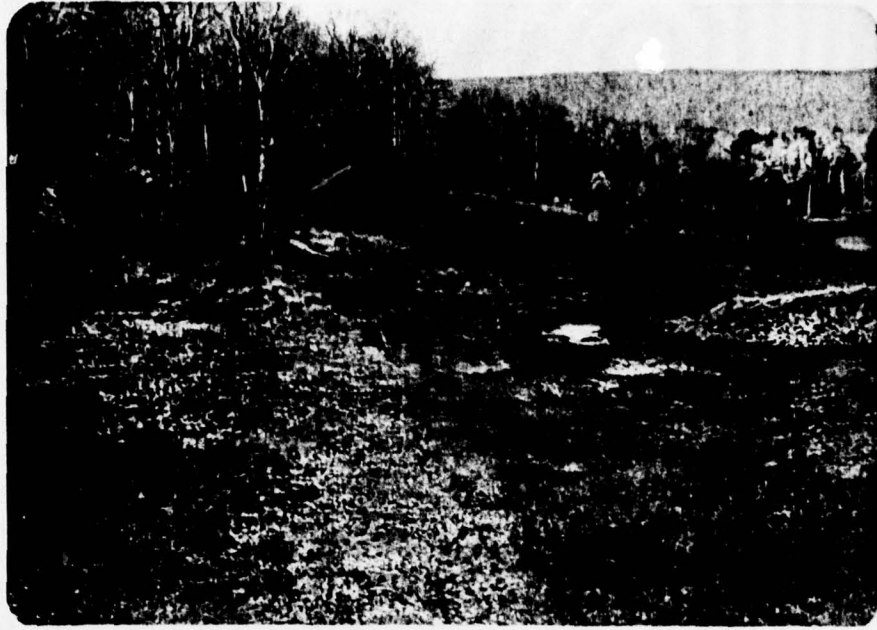
The emergency spillway is covered with a firm stand of grass. It is in very good condition and it appears that erosion will not be a problem in the event of flood flow through this area.

Forebay & Emergency Spillway
