Wolf Creek Dam (Lake Rene).
NDI I.D. Number PA-748. DER I.D.
Number 17-108. Ohio River Basin,
Wolf Creek, Clearfield County,
Pennsylvania. Phase I Inspection Report.

PHASE I REPORT
NATIONAL DAM INSPECTION PROGRAM

NAME OF DAM: Wolf Creek Dam
STATE LOCATED: Pennsylvania
COUNTY LOCATED: Clearfield
STREAM: Wolf Run, a secondary tributary of Sandy Lick Creek
DATE OF INSPECTION: April 4 and May 4, 1979

WOLF CREEK DAM
NDI I.D. NO. PA-748
APRIL 4, 1979

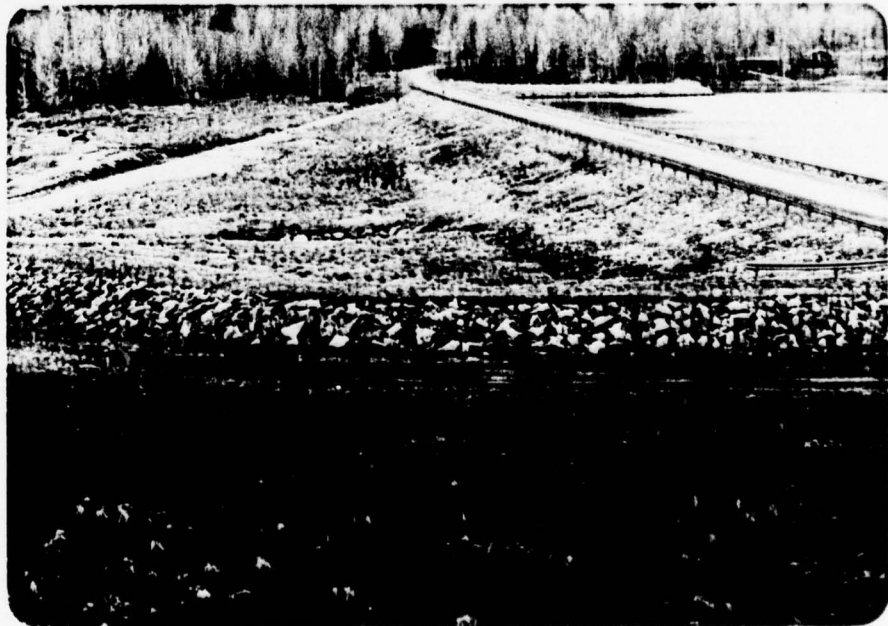
Several wet areas were observed on the downstream slope and along the toe of the embankment. These areas should be periodically observed and remedial work performed if conditions worsen.

Downstream Face

1. The wet areas located along the downstream face and the toe of the embankment should be periodically observed. Necessary remedial work should be performed if the extent of the wet areas increases or seepage and sloughing conditions develop.
2. Around-the-clock surveillance should be provided during unusually heavy runoff and a formal warning system should be developed to alert the downstream residents in the event of emergencies.
3. Small trees on the upstream face of the dam should be removed.

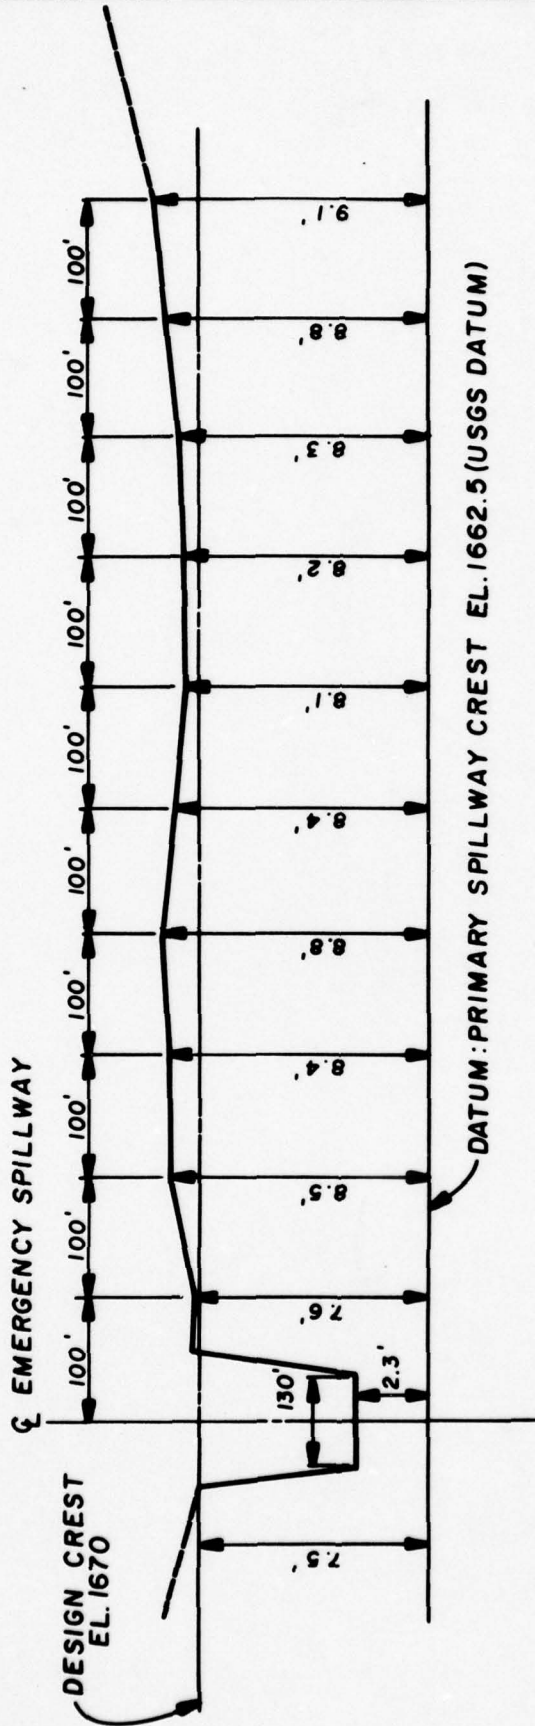
DAM CREST PROFILE
(LOOKING DOWNSTREAM)

The top of the embankment was surveyed relative to the pool level on the date of inspection, which was estimated to be at Elevation 1662.6, the spillway crest level (Elevation 1664.5), and the crest of the embankment was found to be approximately 0.7 to 1.0 foot above the design elevation of 1670. The dam crest profile is illustrated on Plate 8.

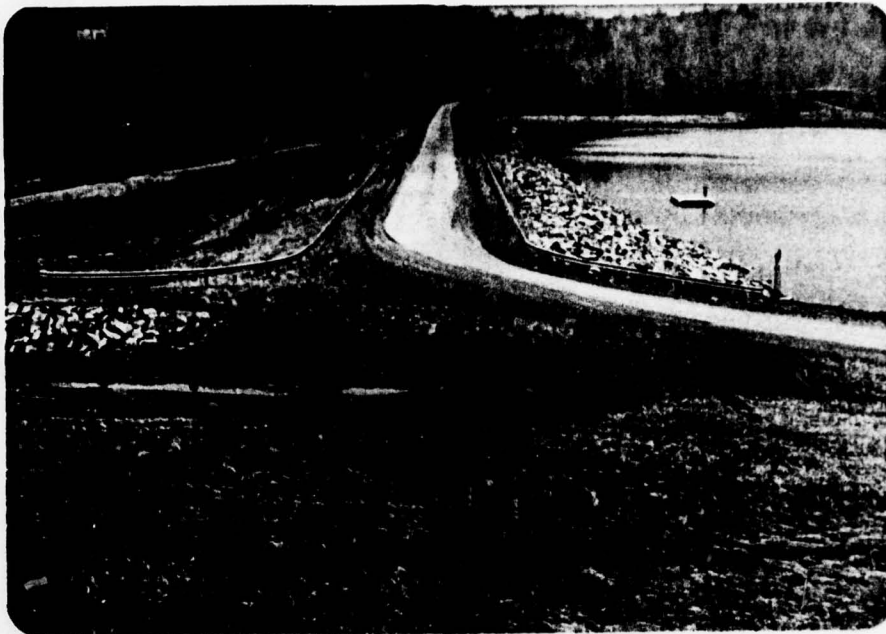
Photograph No. 1

Crest (looking north). Emergency spillway in foreground.

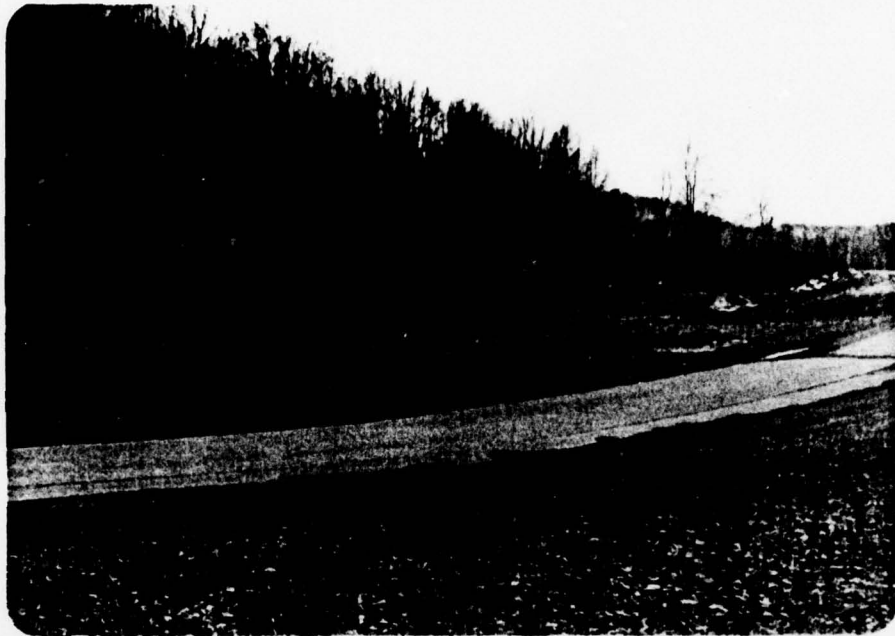
Photograph No. 3
Emergency spillway discharge channel.

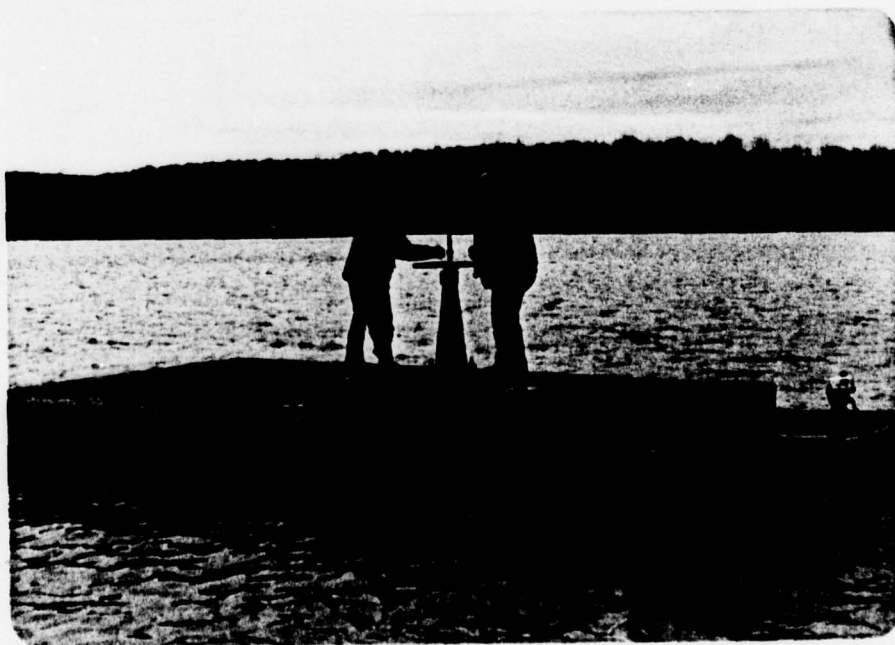
Photograph No. 4
Primary spillway intake structure and outlet pipe
sluice gate control.

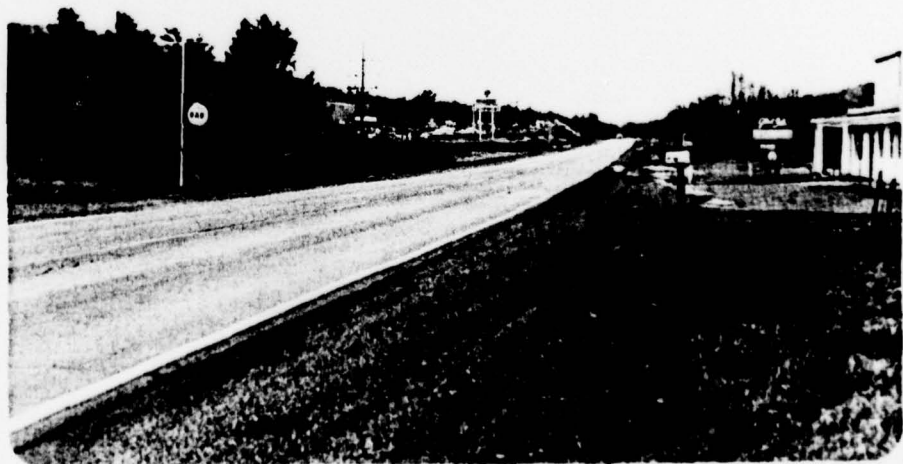
Photograph No. 6
Wolf Run, approximately two miles downstream
(stream behind pine trees).
