National Dam Inspection Program. Lake
Rene Dam (Lake Rene) (NDI PA-426, DER
17-102), Ohio River Basin, Tributary of
Narrows Creek, Clearfield County,
Pennsylvania. Phase I Inspection Report.

PHASE I REPORT
NATIONAL DAM INSPECTION PROGRAM

NAME OF DAM: Lake Rene Dam
STATE LOCATED: Pennsylvania
COUNTY LOCATED: Clearfield County
STREAM: Narrows Creek, a tributary of Sandy Lick Creek
DATE OF INSPECTION: April 2, 1979 and May 4, 1979

LAKE RENE DAM
NDI I.D. NO. PA-426
APRIL 2, 1979

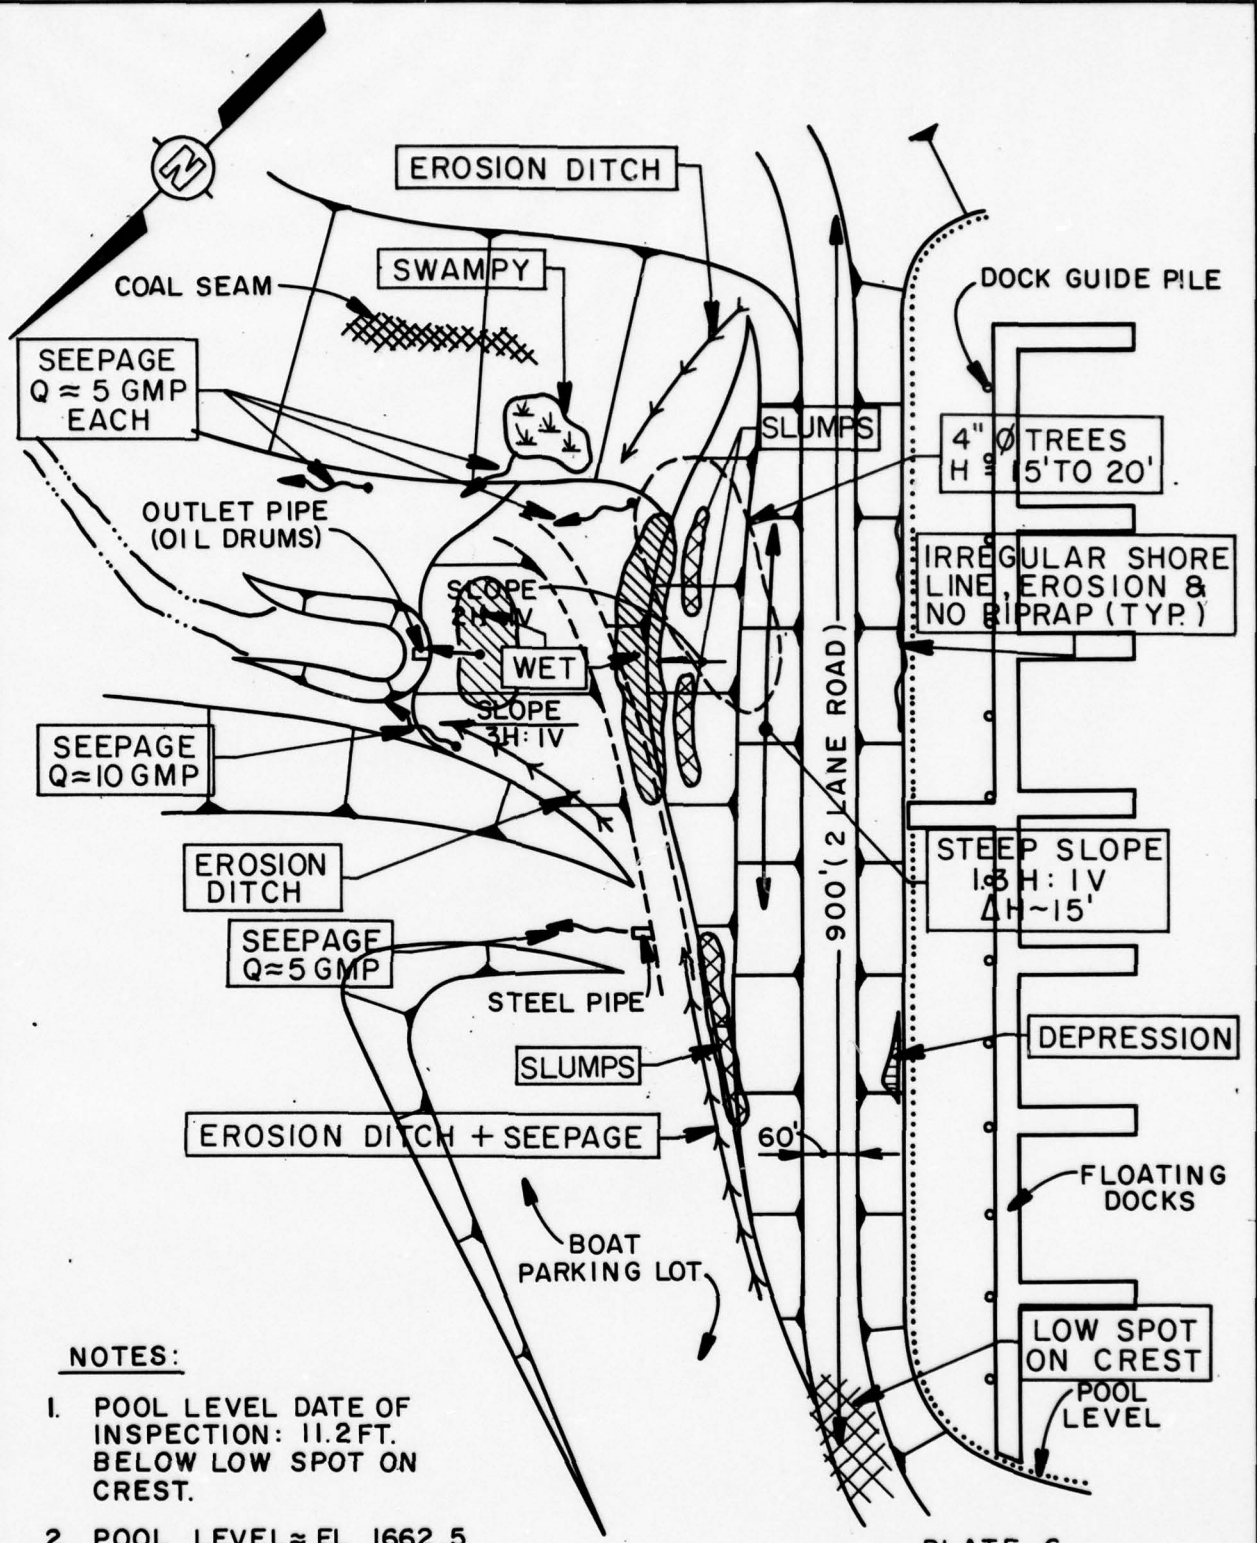
PLATE 6
 LAKE RENE DAM
 GENERAL PLAN
 FIELD INSPECTION NOTES
 FIELD INSPECTION DATE: APR. 2, 79

- NOTES:**
1. POOL LEVEL DATE OF INSPECTION: 11.2 FT. BELOW LOW SPOT ON CREST.
 2. POOL LEVEL ≈ EL. 1662.5 (U.S.G.S. DATUM)

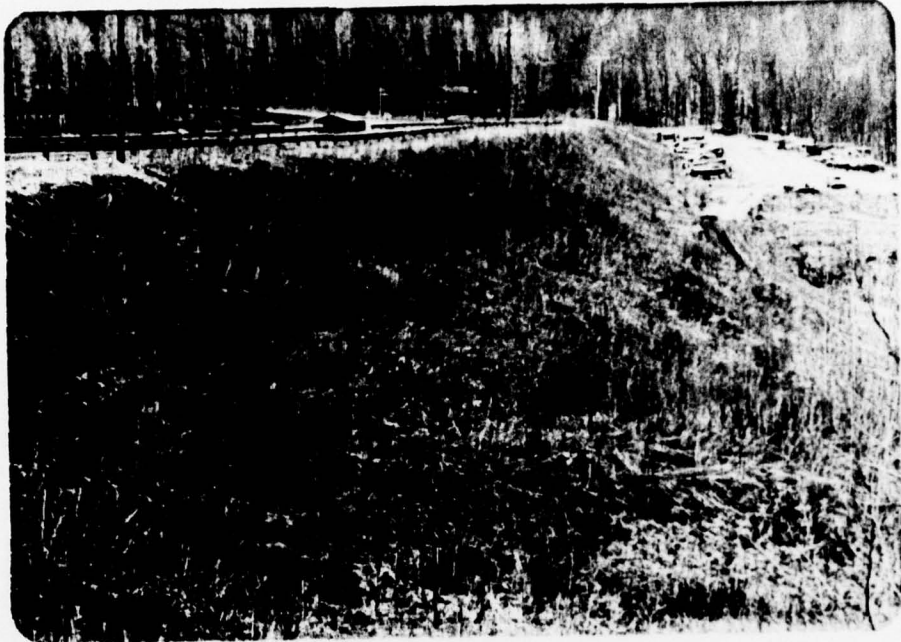
In general, the condition of the dam is considered to be poor. Numerous seeps, wet areas, and slumps were found on the downstream face of the dam extending approximately from the midheight of the embankment to the toe level. Total flow from three seepages near the right abutment at the toe level was estimated to be about 5 gallons per minute. Flow from another seepage located on the left side of the outlet pipe was estimated to be approximately 10 gallons per minute. The downstream face of the dam is very irregular with varying slopes. The top 15 feet of the downstream slope was estimated to be on 1.3 horizontal to 1 vertical slope. The remaining portions are 2 horizontal to 1 vertical or flatter. While most of the downstream slope is covered with brush, a section near the right abutment is covered with trees up to four inches in diameter and 15 to 20 feet high. The upstream slope of the dam has no erosion protection and the shoreline is irregular. It appears that most of the shoreline irregularities are caused by wave erosion.

Photograph No. 1
Downstream face (looking north).

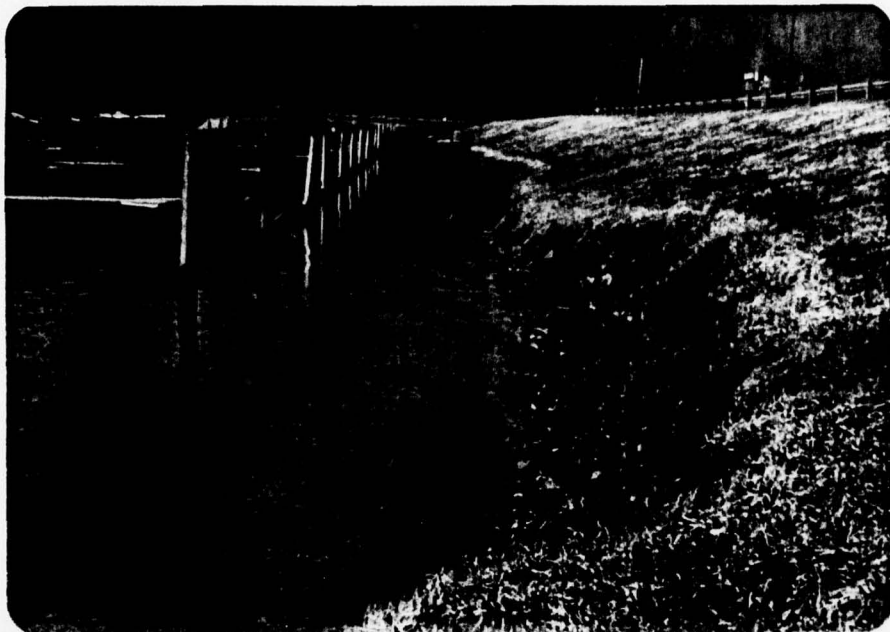
Photograph No. 3
Upstream slope shoreline erosion.

2. The upstream face of the dam should be provided with adequate erosion protection to avoid further shoreline erosion.
3. Around-the-clock surveillance should be provided during unusually heavy runoff and a formal warning system developed to alert the downstream residents in the event of emergencies.
4. The dam and appurtenant structures should be inspected regularly and necessary maintenance performed.

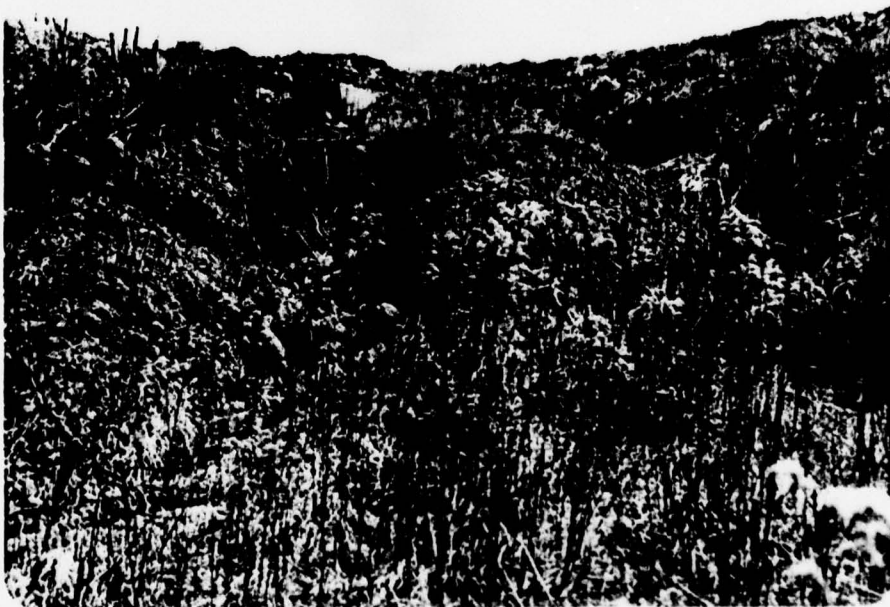
VISUAL EXAMINATION OF	OBSERVATIONS	REMARKS OR RECOMMENDATIONS
JUNCTION OF EMBANKMENT AND ABUTMENT, SPILLWAY AND DAM	A major erosion ditch at the junction of the right abutment. Erosion ditch and seepage at the junction with the left abutment.	The erosion ditches should be filled and seepage should be controlled.
ANY NOTICEABLE SEEPAGE	There are numerous seeps and wet areas on the downstream slope extending from the midheight of the embankment to toe level. See Plate 6 for location of wet areas and seepage points.	
STAFF GAGE AND RECORDER	None.	
DRAINS	None.

Photograph No. 4
Erosion ditch at right abutment-embankment
junction.

4.5 Evaluation. The overall maintenance condition of the dam is considered to be poor. The dam has no functional outlet works. It is therefore recommended that either the outlet conduit should be equipped with upstream flow control facilities or other means of drawdown should be provided. The brush and trees on the downstream face of the dam should be removed and erosion ditches should be filled.
