PENNSYLVANIA
LEVEL 4
BERNHART DAM

PHASE I INSPECTION REPORT
NATIONAL DAM INSPECTION PROGRAM

Name of Dam: Bernhart Dam

Inventory Number: PA 00717

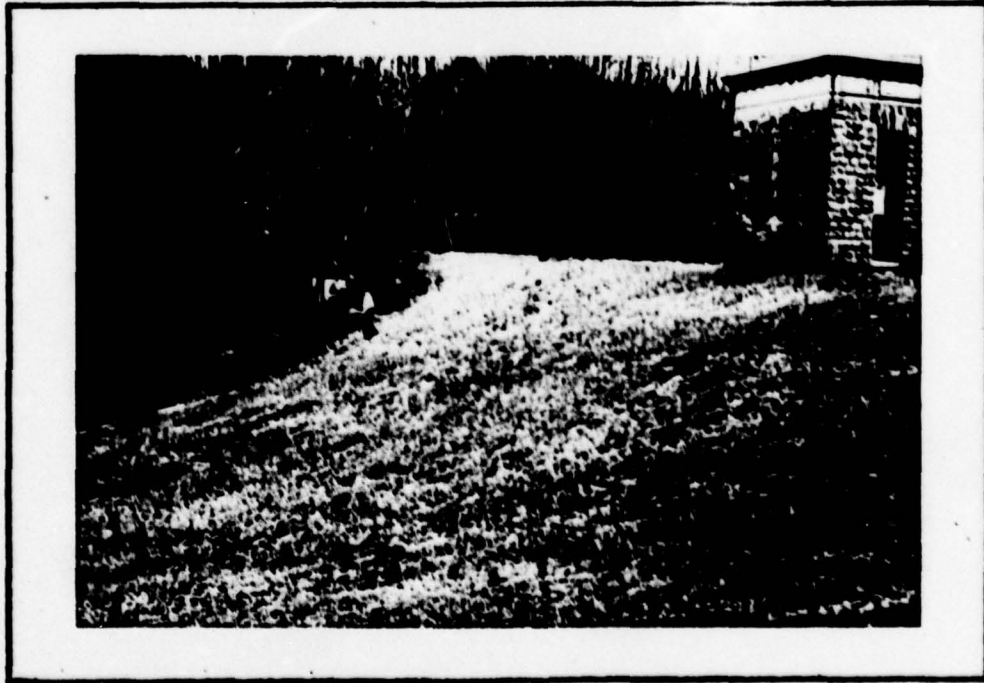
DOWNSTREAM FACE OF THE DAM

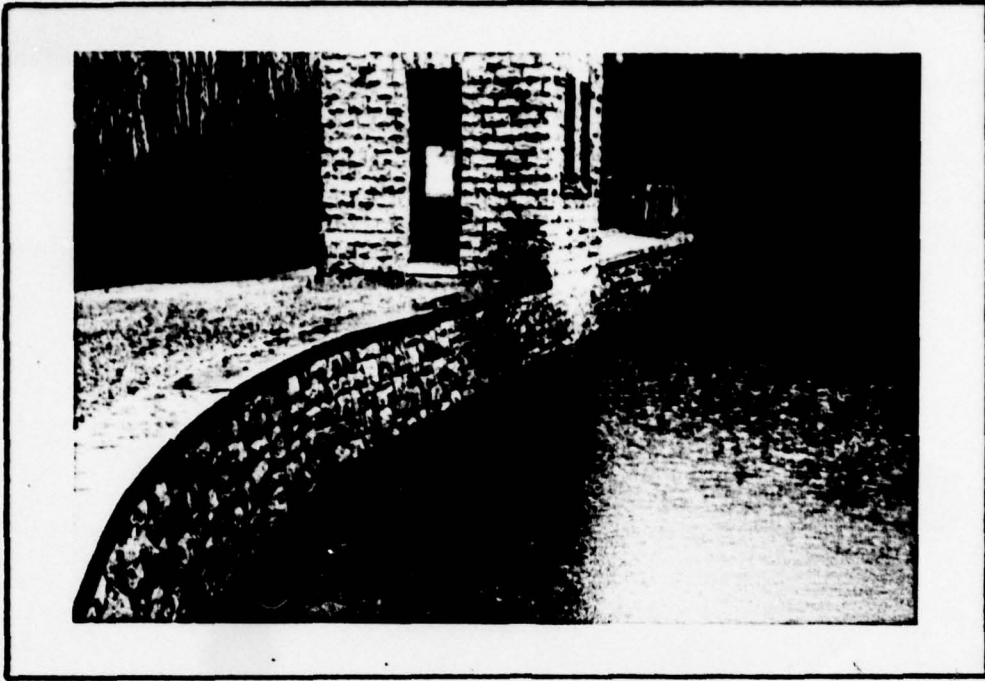
- a. Visual Observations. The small trees growing out of cracks in the upstream face of the masonry wall create potential seepage paths through the embankment. The point at which the trees protrude from the wall is about 2 feet above normal pool, so during periods of high reservoir level, water could seep through the cracks and along the root systems.

*UPSTREAM FACE OF THE DAM SHOWING THE GATE HOUSE
AND THE VEGETATION GROWING FROM THE MASONRY WALL*

5. The eroded path along the embankment and spillway junction should be filled with compacted earth and reseeded.
6. The small trees should be removed from the upstream face of the masonry wall and the cracks from which they were growing should be sealed.
7. The spillway for the upstream settling basin should be repaired so that it functions as designed.

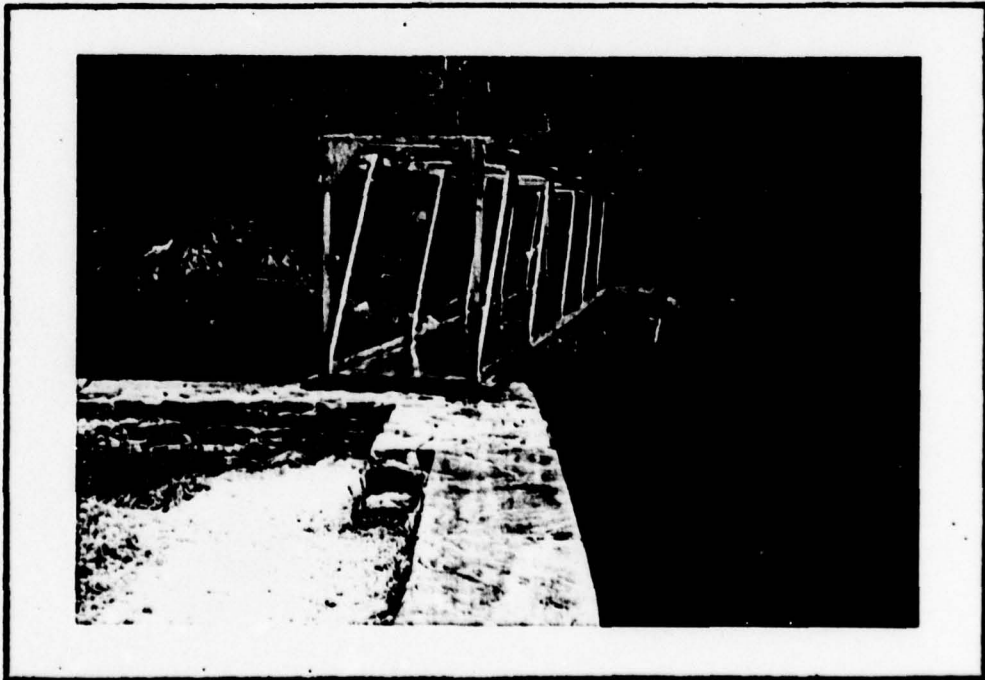
*VIEW SHOWING THE FOOT BRIDGE OVER THE SPILLWAY
AND THE LACK OF VEGETATION ON PORTIONS OF THE DAM*

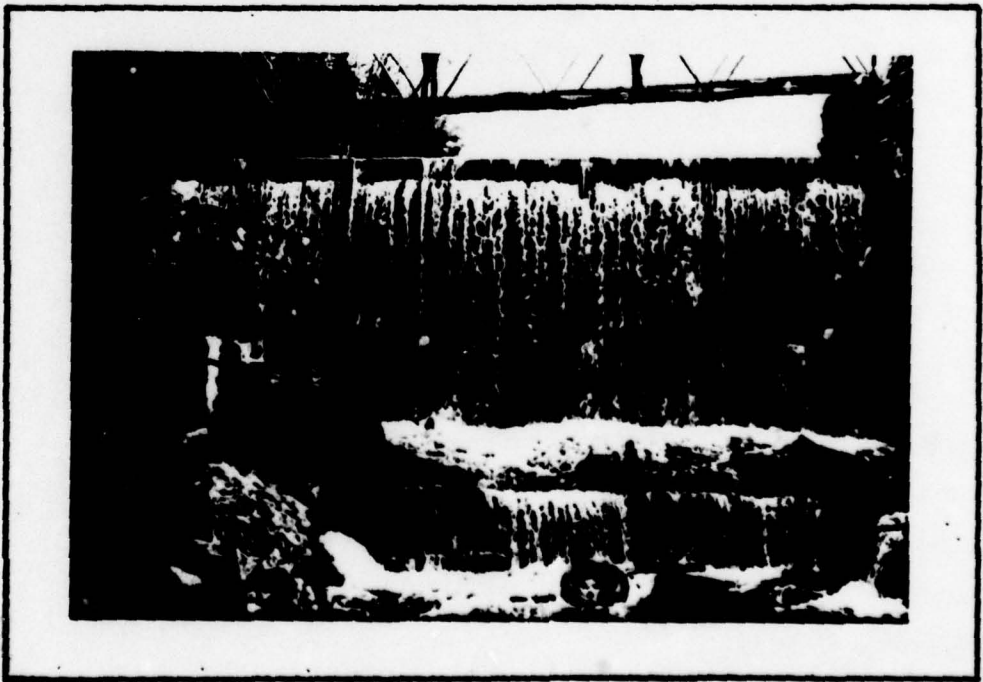
- c. Appurtenant Structures. The spillway vertical drop is approximately 15 feet and the drop section appears to be in good condition. A metal truss and wood deck bridge spans the spillway with a minimum clearance of 5 feet between the spillway crest and the bottom of the bridge.

*VIEW SHOWING THE FOOT BRIDGE, DROP SPILLWAY,
AND DOWNSTREAM APRON*

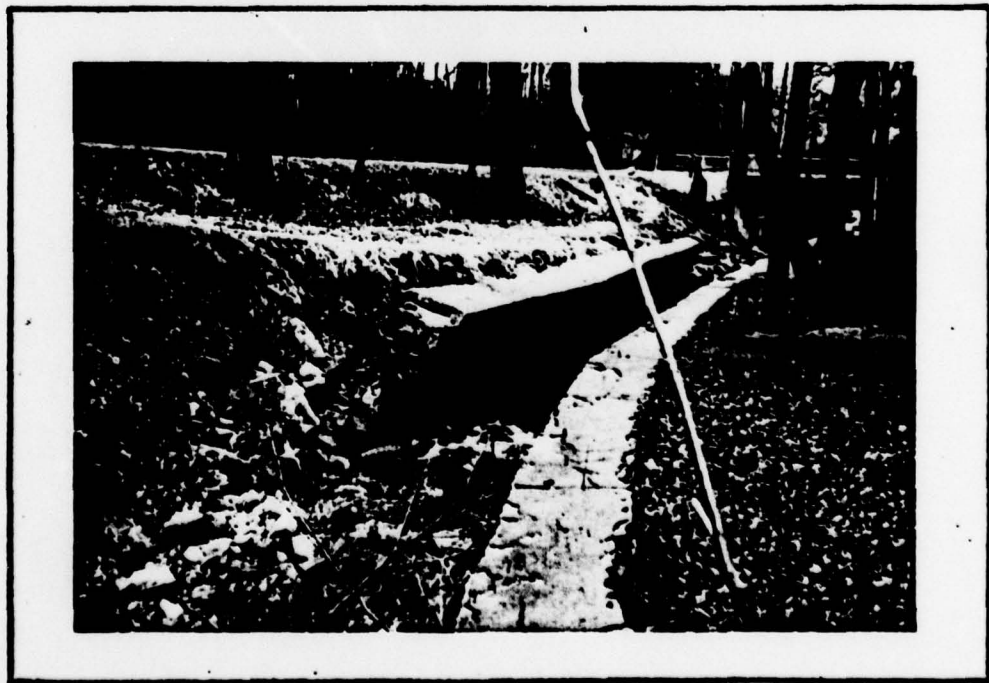
- e. Downstream Channel. The left training wall of the channel downstream of the spillway is in dilapidated condition. Approximately 150 feet downstream of the spillway, the wall has crumbled and a 30-foot long section has toppled into the channel. Portions of the wall have completely disintegrated and both training walls have been undermined in places where they are still standing.

*LOOKING DOWNSTREAM AT THE CRUMBLED AND DISPLACED
LEFT TRAINING WALL IN THE SPILLWAY OUTLET CHANNEL*

THE TRAINING WALLS
SHOULD BE REPAIRED,
RECONSTRUCTED, AND
REPLACED WHERE
NECESSARY.

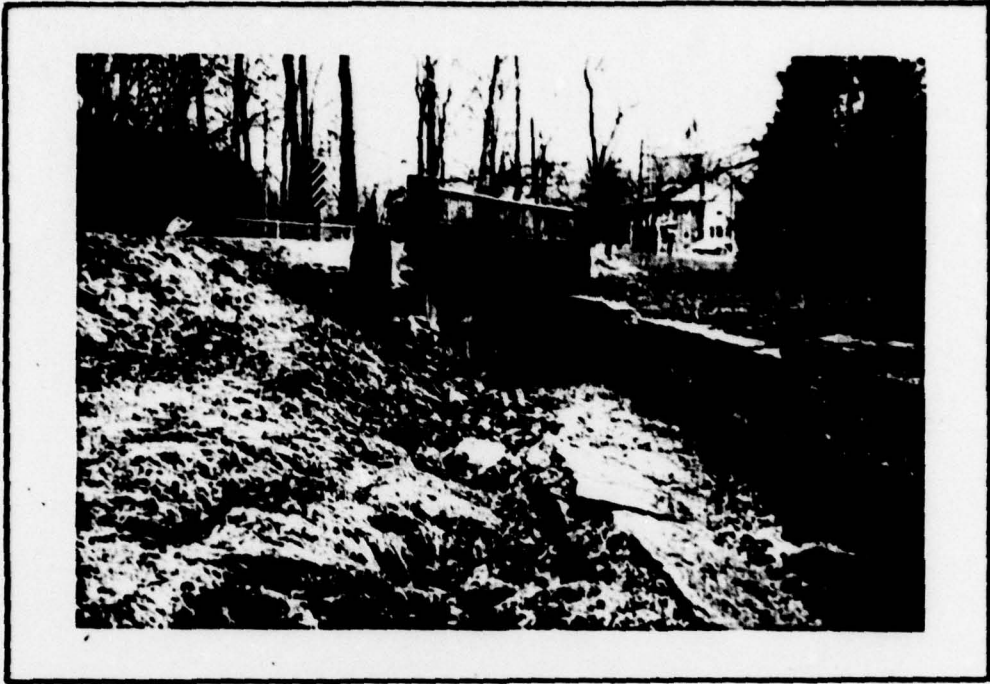
*SPILLWAY OUTLET CHANNEL LOOKING DOWNSTREAM
TOWARDS THE BRIDGE SECTION WHICH IS ABOUT
400 FEET DOWNSTREAM OF THE DAM*

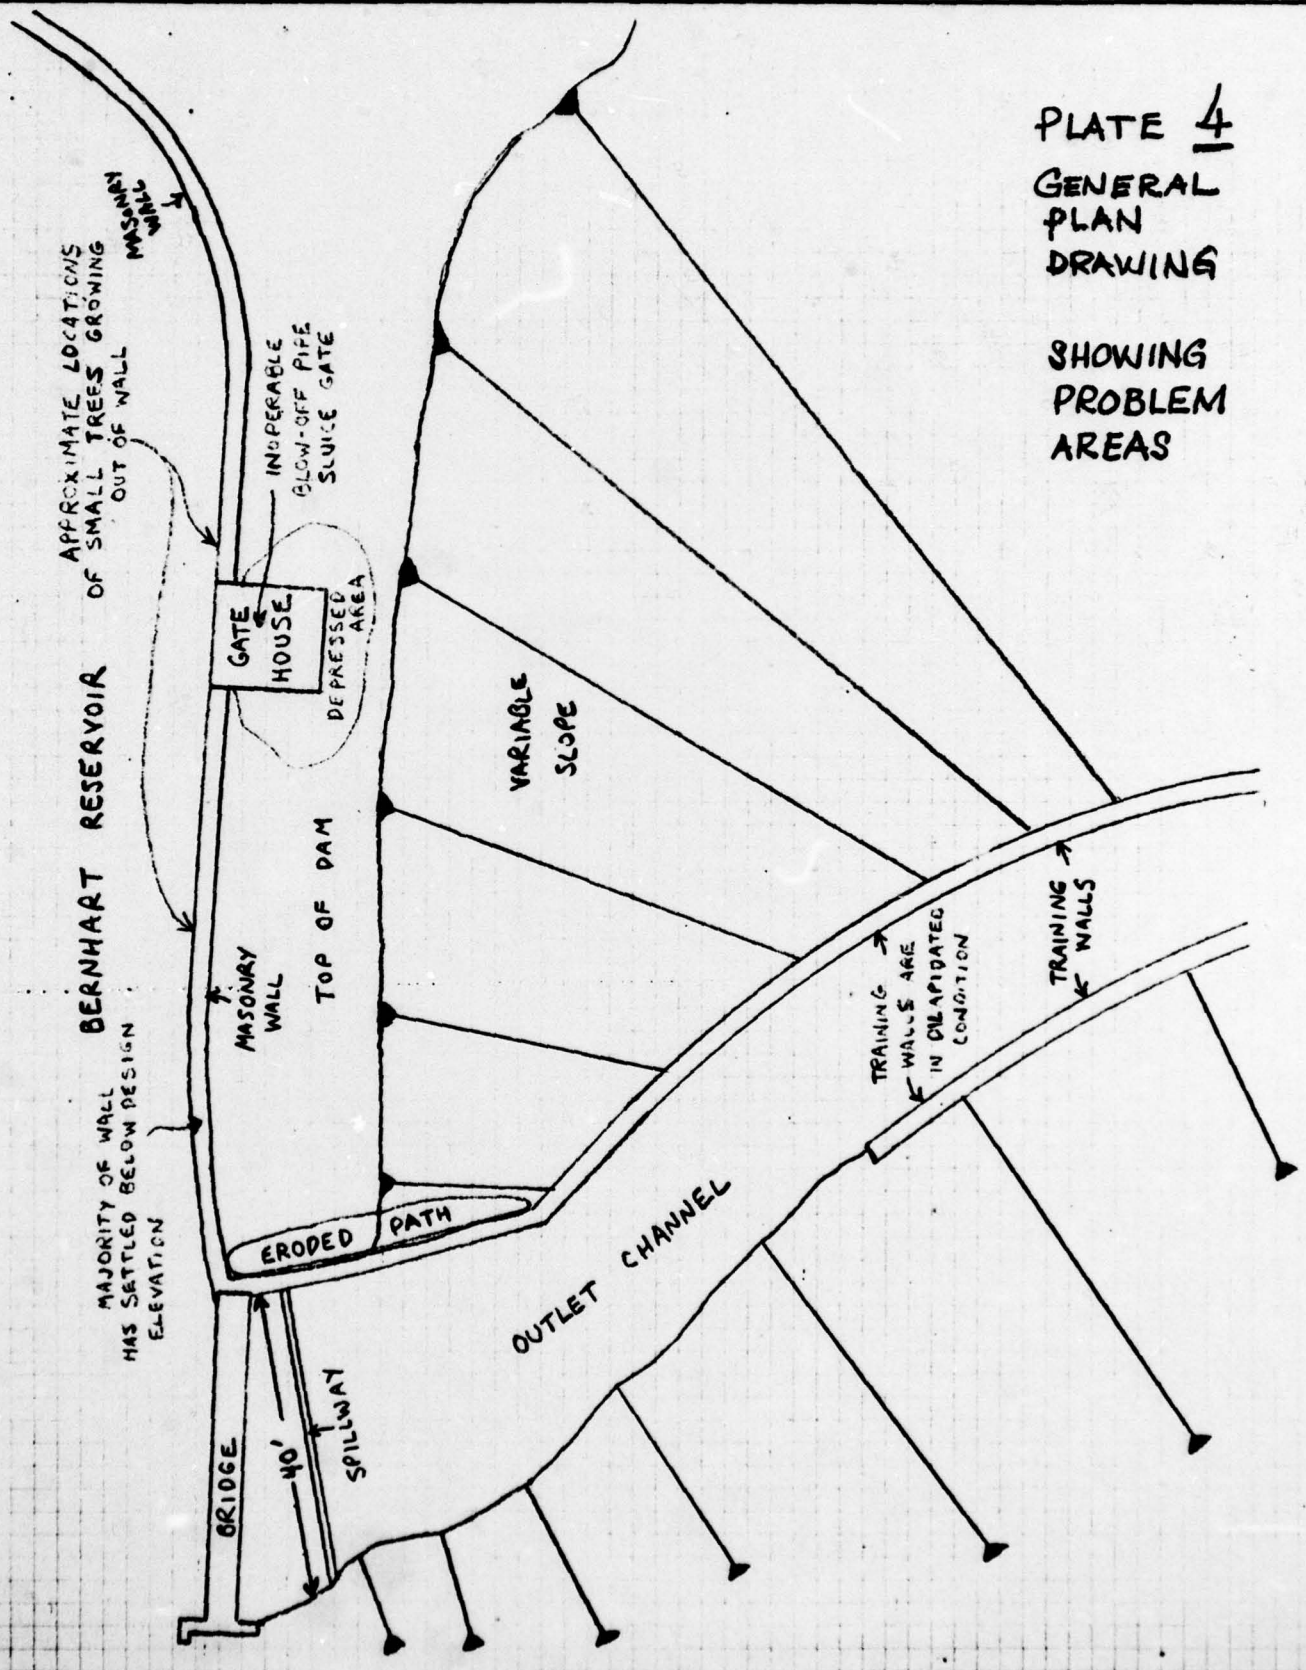
PLATE 4
GENERAL
PLAN
DRAWING

SHOWING
PROBLEM
AREAS
