LAKE SABULA DAM

NDI I.D. NO: PA-425

PHASE I INSPECTION REPORT  
NATIONAL DAM INSPECTION PROGRAM

D'APPOLONIA CONSULTING ENGINEERS  
10 DUFF ROAD

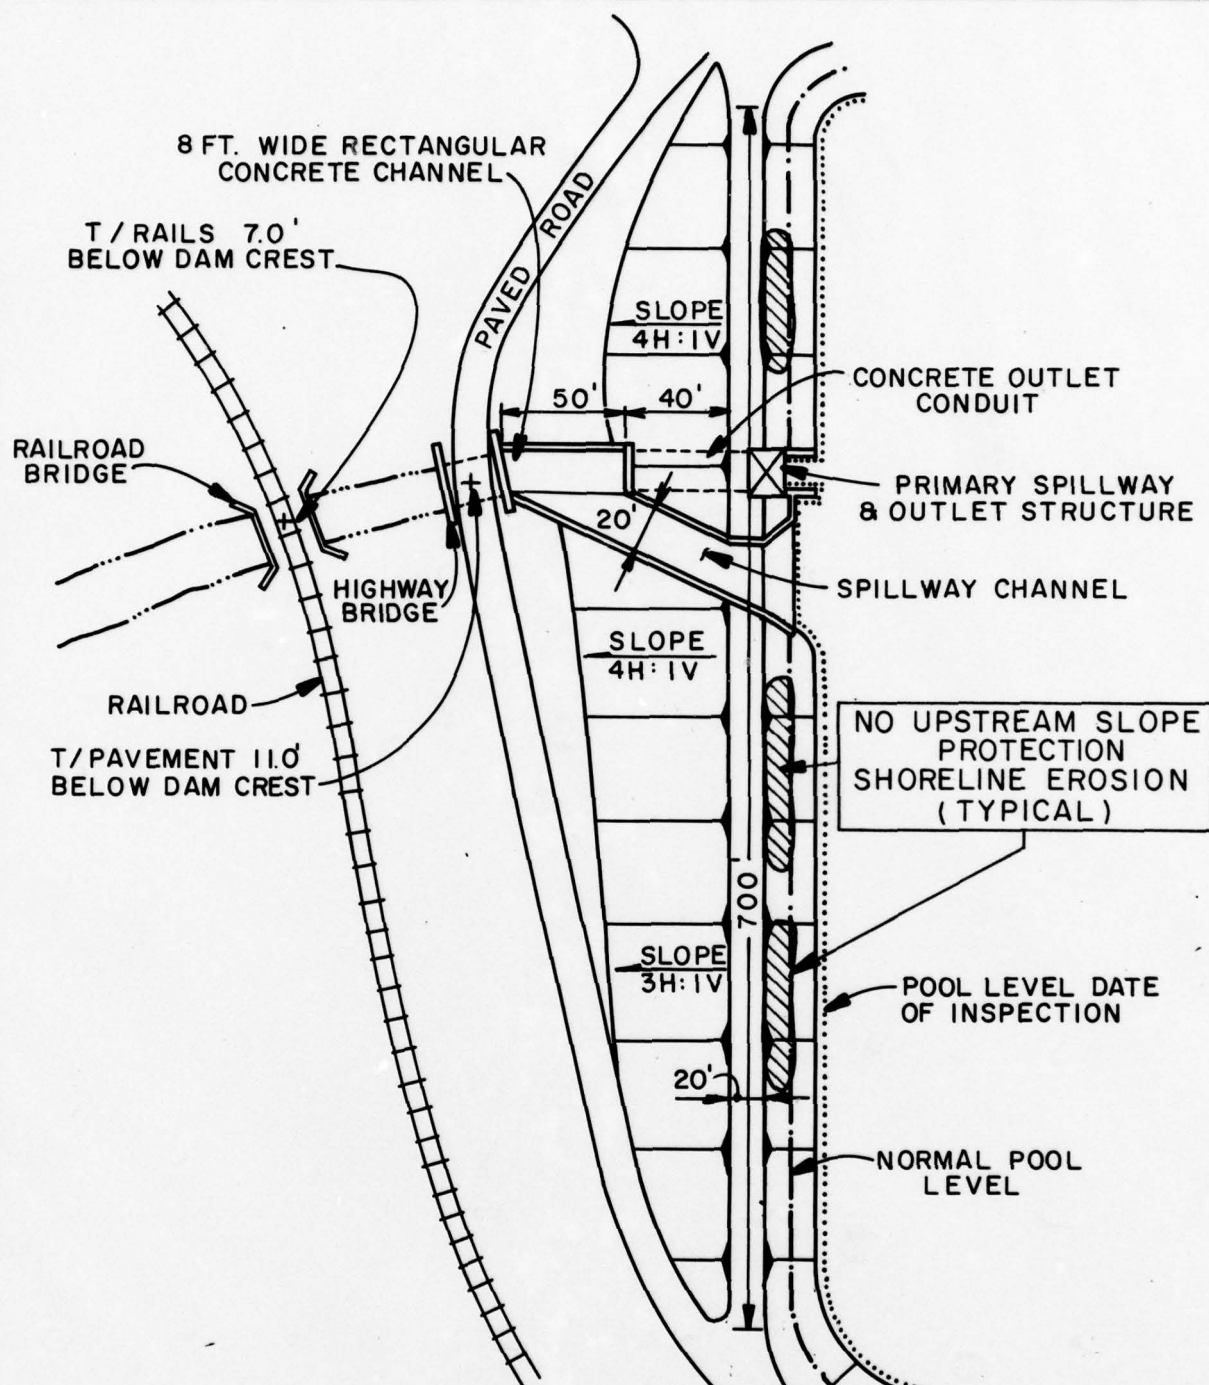
1. POOL LEVEL DATE OF INSPECTION: 5 FT. BELOW SPILLWAY CREST
2. SPILLWAY FREEBOARD = 2.5 FT.

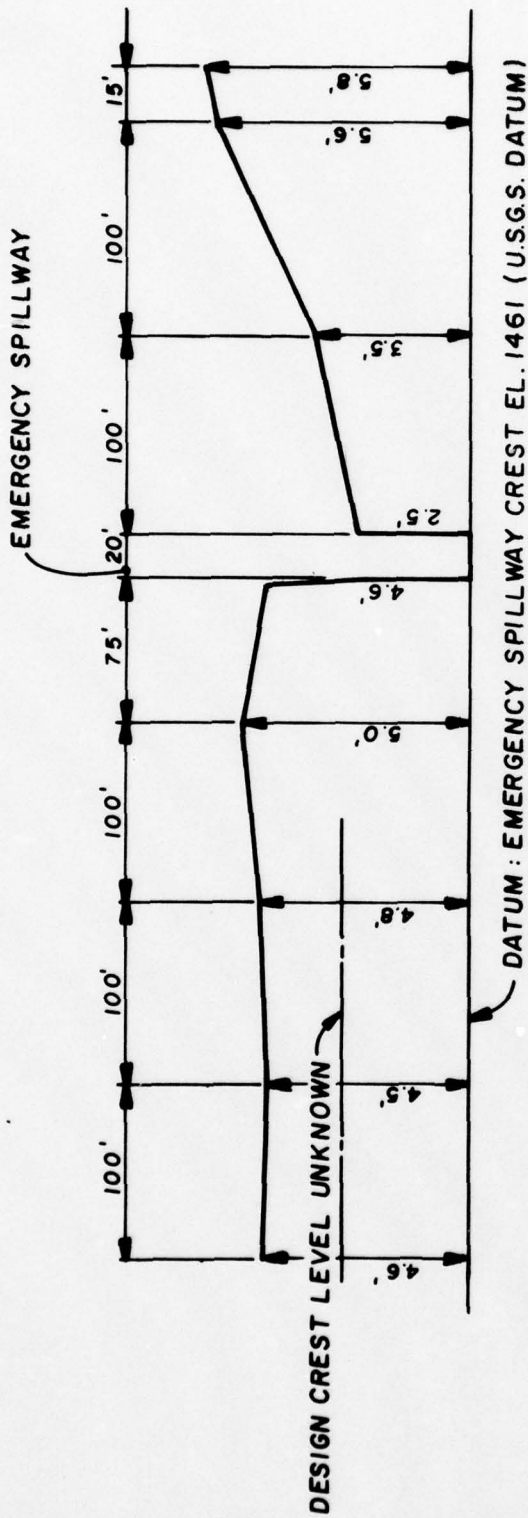
**DAM CREST PROFILE**  
(LOOKING DOWNSTREAM)

The crest of the dam was surveyed relative to the emergency spillway crest level. Freeboard was found to range from 2.5 feet on each side of the emergency spillway to 5.8 feet near the right abutment. The dam crest profile is illustrated in Plate 3.
