# GREEN LANE RESERVOIR DAM

NDI - PA 00618  
PA DER 46-250

PHASE I INSPECTION REPORT  
NATIONAL DAM INSPECTION PROGRAM

Name of Dam: Green Lane Reservoir Dam  
County & State: Montgomery County, Pennsylvania  
Inventory Number: PA00618

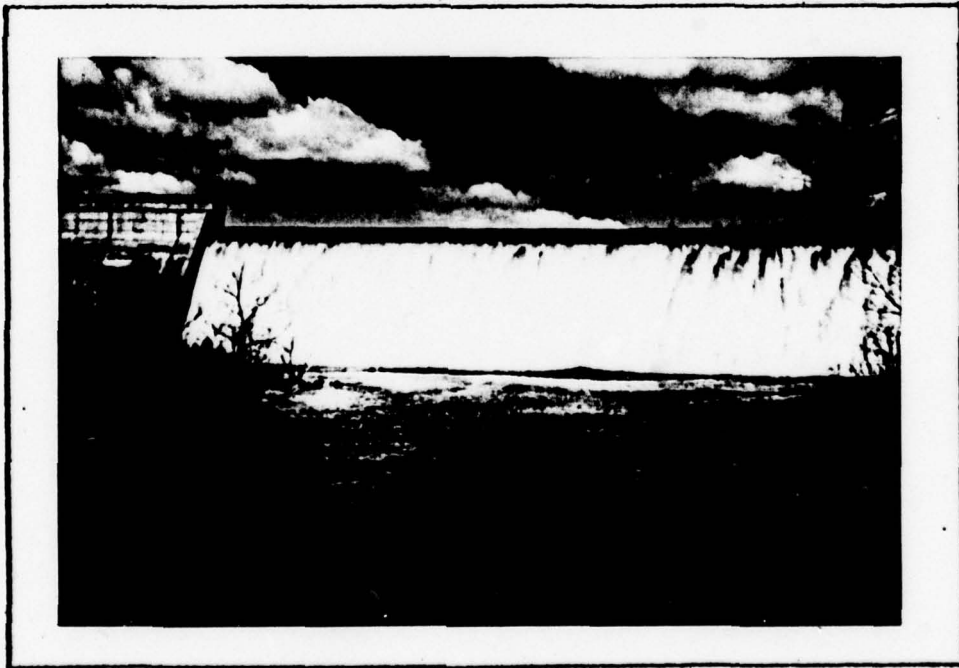
*LOOKING UPSTREAM AT THE  
OVERFLOW SPILLWAY*

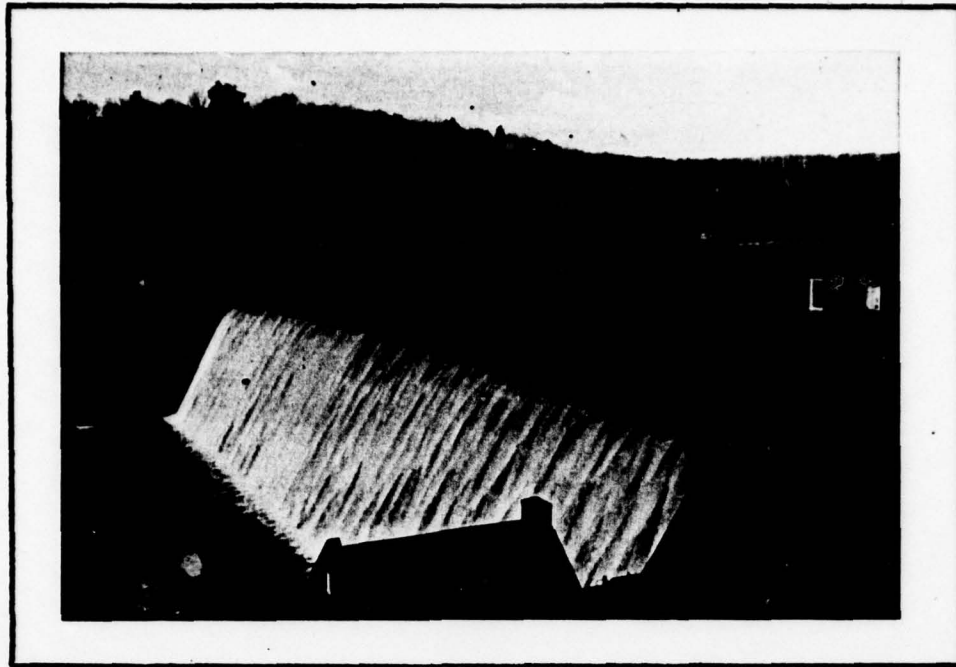
*OVERFLOW SPILLWAY FROM THE LEFT  
ABUTMENT LOOKING SOUTH*

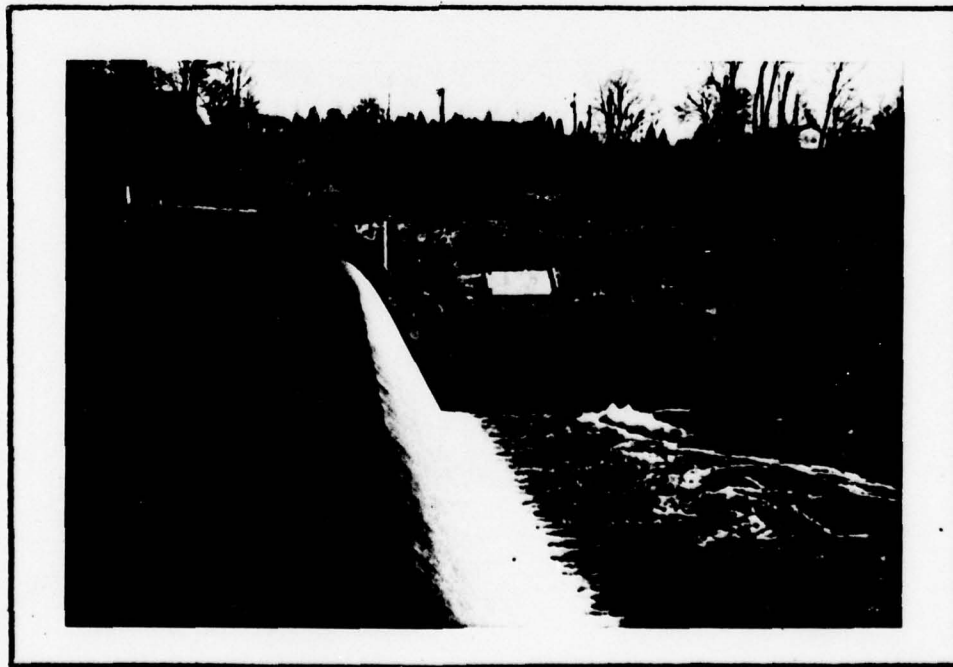
*OVERFLOW SPILLWAY AND GATEHOUSE  
FROM THE RIGHT ABUTMENT LOOKING NORTH*

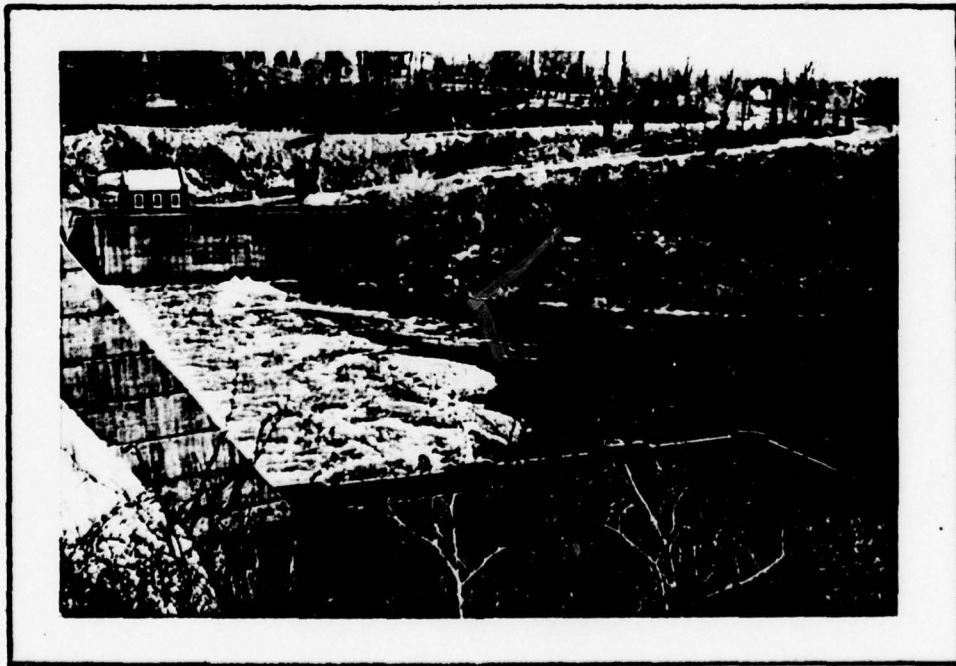
f. Downstream Channel. Sand and gravel deposits, located approximately 200 feet downstream from the spillway toe, were noted within the spillway channel. A thorough investigation to determine the source of these deposits was prevented due to flow conditions at the time of inspection. The deposits could be the result of channel erosion or remnants of former islands in the channel.

a. Safety. The visual inspection of the dam and appurtenances and review of material provided by DER indicates that the structure is in good condition and was built in general compliance with the drawings. Deposits of sand and gravel, however, were observed in the channel immediately downstream from the spillway. Erosion of the channel bed at this location may be occurring.

*OVERFLOW SPILLWAY OUTLET CHANNEL  
SHOWING SAND AND GRAVEL DEPOSITS*

d. Necessity for Further Investigation. A physical inspection of the foundation area immediately downstream of the spillway should be made to assess the extent of any erosive damage that might have occurred.

1. A thorough investigation of the channel bottom immediately downstream from the spillway should be performed to determine the source of the sand and gravel deposits observed during the visual inspection.
2. Seepage occurring at the upstream junction of the 48-inch diameter reservoir drain line and gatehouse should be visually inspected on a regular basis to note any changes in quantity of flow.

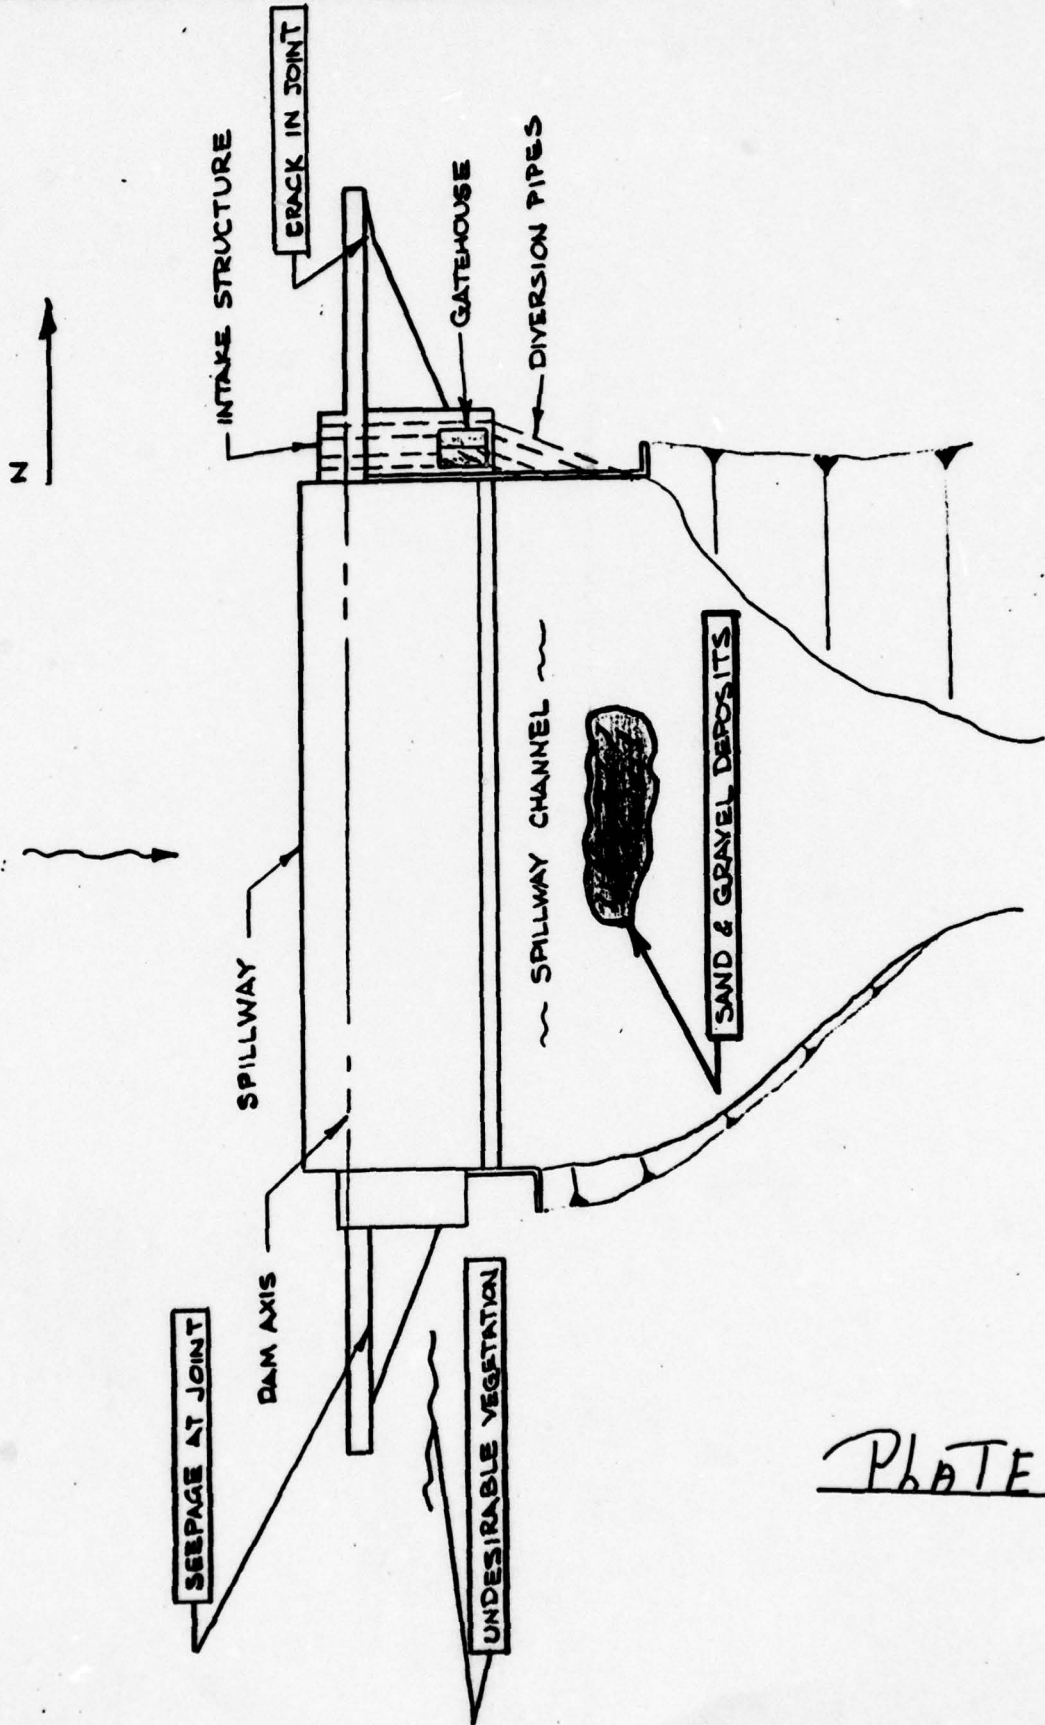
PLATE 9

b. Dam. Spalling of the concrete surface was noted in a few isolated areas on the downstream face of the north non-overflow section of the dam. A crack in the vertical joint nearest to the north abutment was also evident. However, steel was not exposed at any of these locations and no indications of movement could be detected at the joint.

Several calcification deposits were apparent on the downstream face of both the north and south non-overflow sections of the dam. Seepage, in the form of surface moisture, was noted along a horizontal joint in the south non-overflow section of the dam. The quantity of seepage could not be determined, but was minimal.
