KOENIGS CREEK DAM

NDI NO. PA-00668

**PHASE I INSPECTION REPORT
NATIONAL DAM INSPECTION PROGRAM**

Berger Associates, Inc.
Harrisburg, Pennsylvania

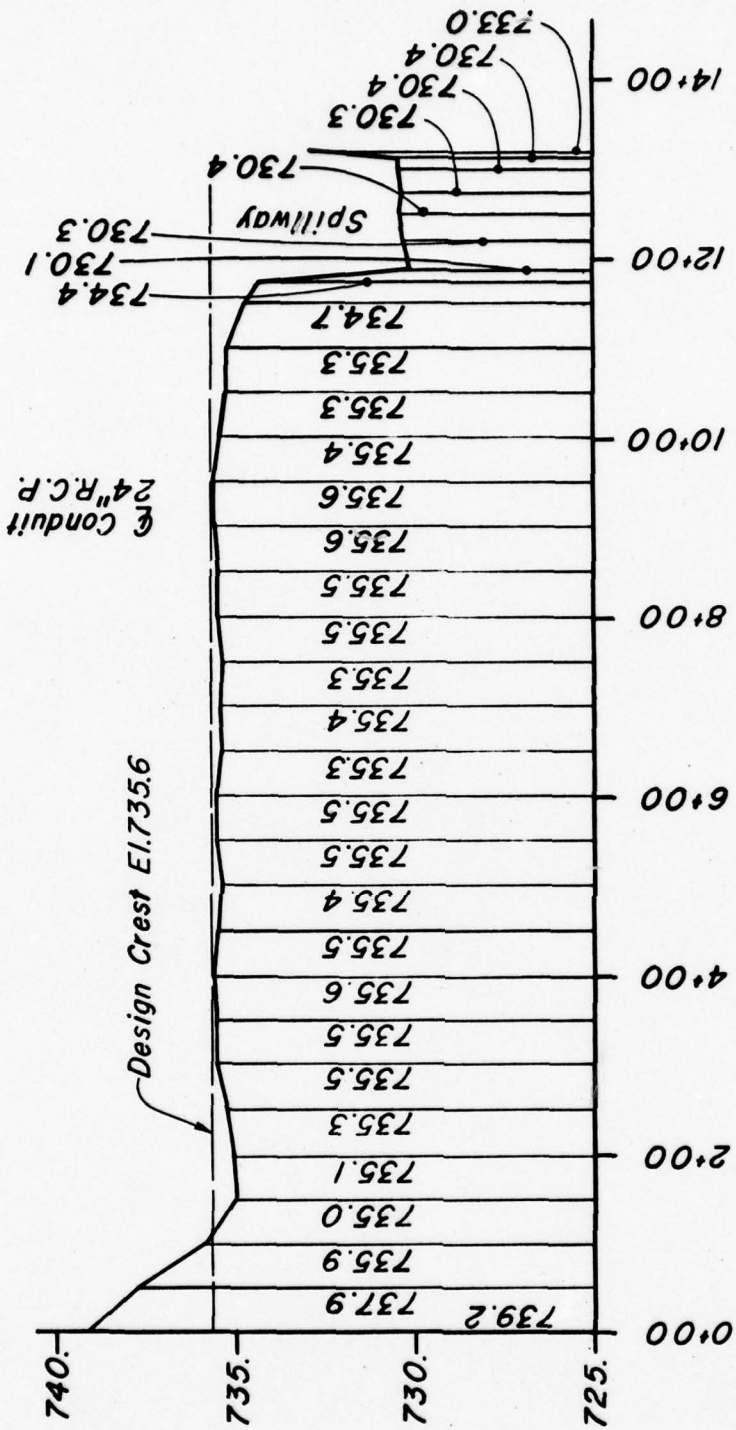
DAM & PROFILE
LOOKING DOWNSTREAM

A surveyed profile along the crest of the dam shows a variation of 0.1 to 0.6 foot below the design elevation. The 0.6 foot occurs at only one point near the left abutment. The average deviation would be about -0.1 foot. The upstream and downstream slopes were found to be essentially as designed. Refer to Appendix A, Plates II and III for survey information and Appendix E for photographs of existing facilities.

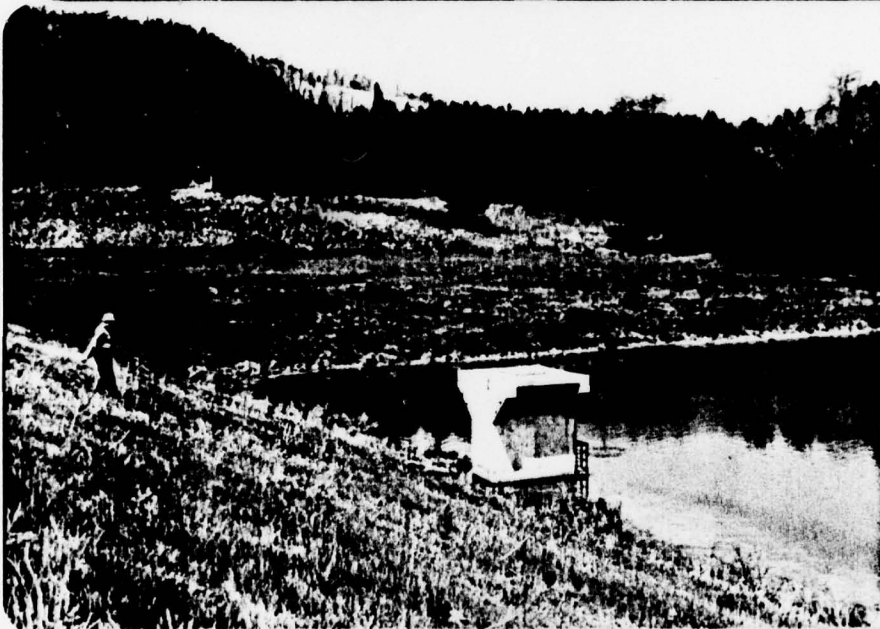
Intake Structure

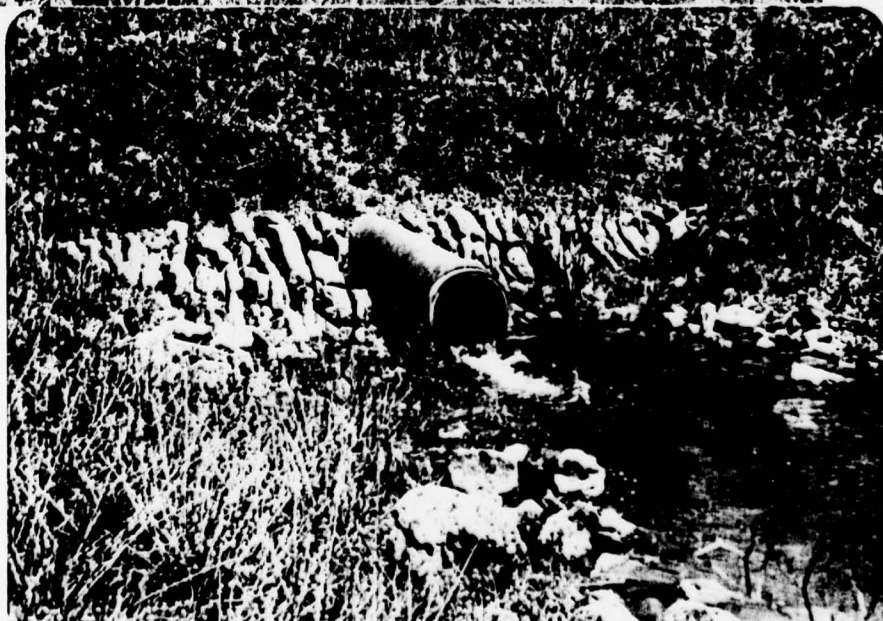
Outlet Pipe

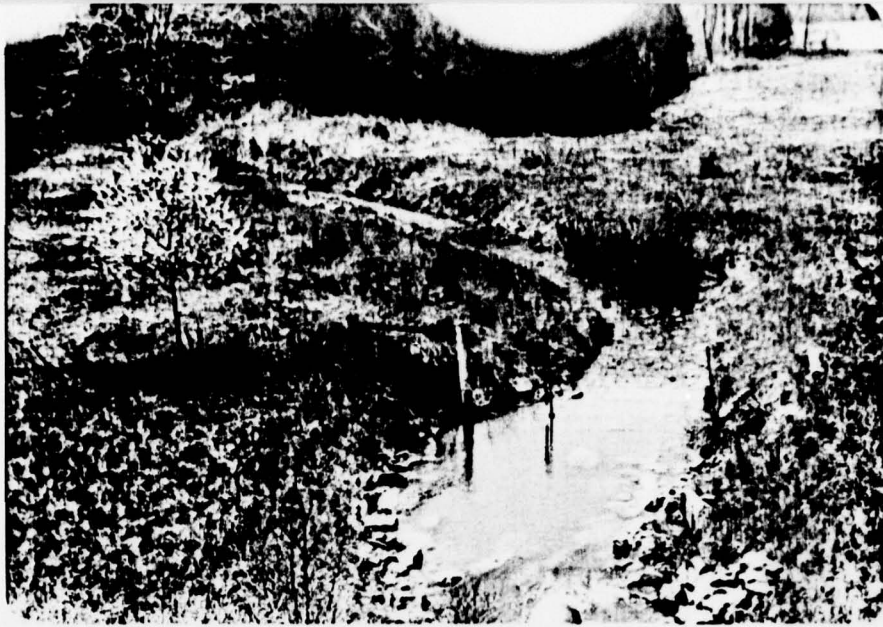
Downstream Channel
Outlet Pipe

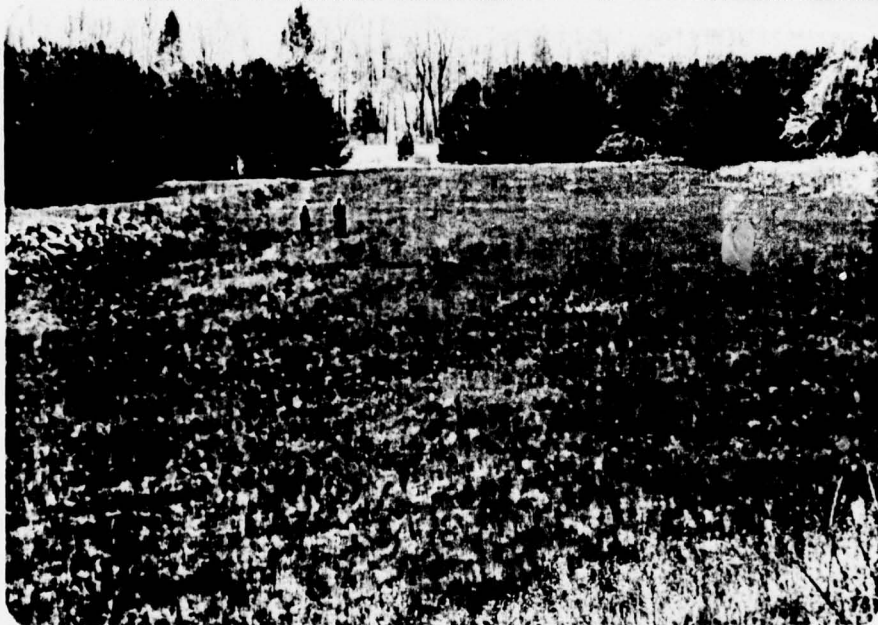
The emergency spillway is covered with a firm stand of grass. It is in very good condition and it appears that erosion will not be a problem in the event of flood flow through this area.

Emergency Spillway
Looking
Downstream
