NESQUEHONING 4TH HOLLOW RESERVOIR

NDI NO. PA-00806
DER NO. 13-104

CARBON COUNTY, PENNSYLVANIA

**PHASE I INSPECTION REPORT
NATIONAL DAM INSPECTION PROGRAM**

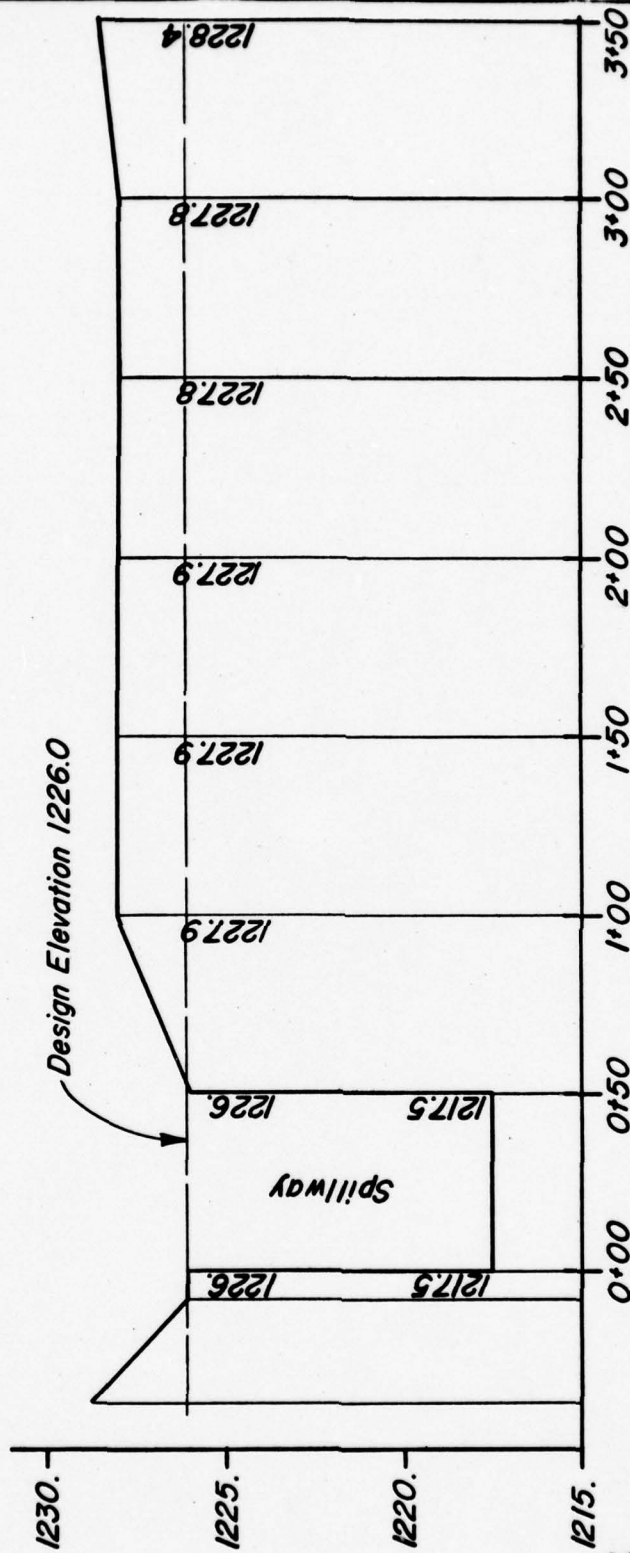
NESQUEHONING 4th
HOLLOW RESERVOIR
DAM
PA.-806
INSPECTION SURVEY
PLATE A-II

The upstream slope was in excellent condition and well protected with heavy riprap. The breast of the dam was level and above the spillway walls (Plate A-II, Appendix A), and covered with gravel. The downstream slope has little or no vegetation in several places, mainly caused by trail bikes. The Borough has installed several fences to discourage this misuse of the facilities. The Borough representative stated that reseeding of the barren spots was planned.

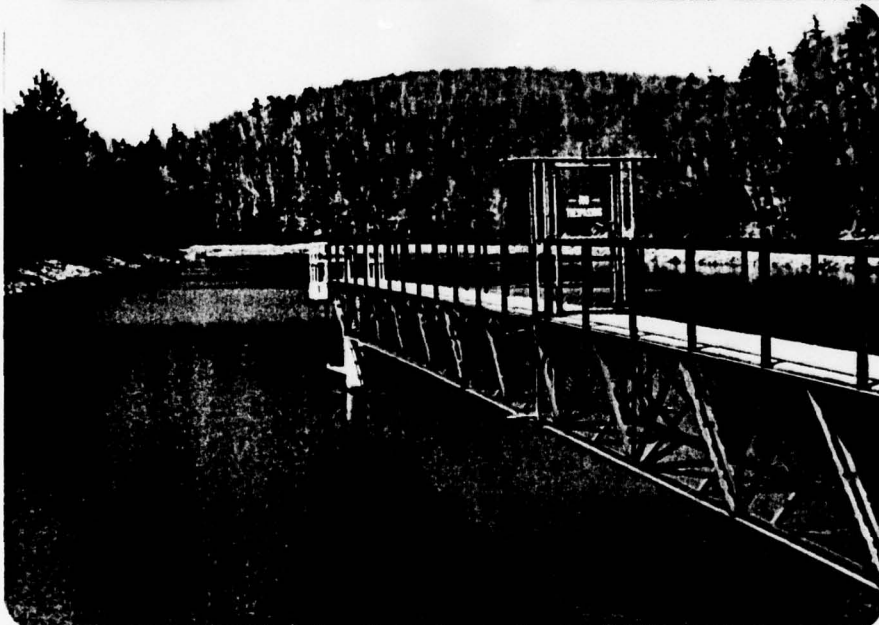
The intake tower is located near the upstream toe of the dam and is accessible with a footbridge from the crest of the dam. The bridge, tower and sluice gate operator stands were all in good condition.

Bridge to intake
Structure.

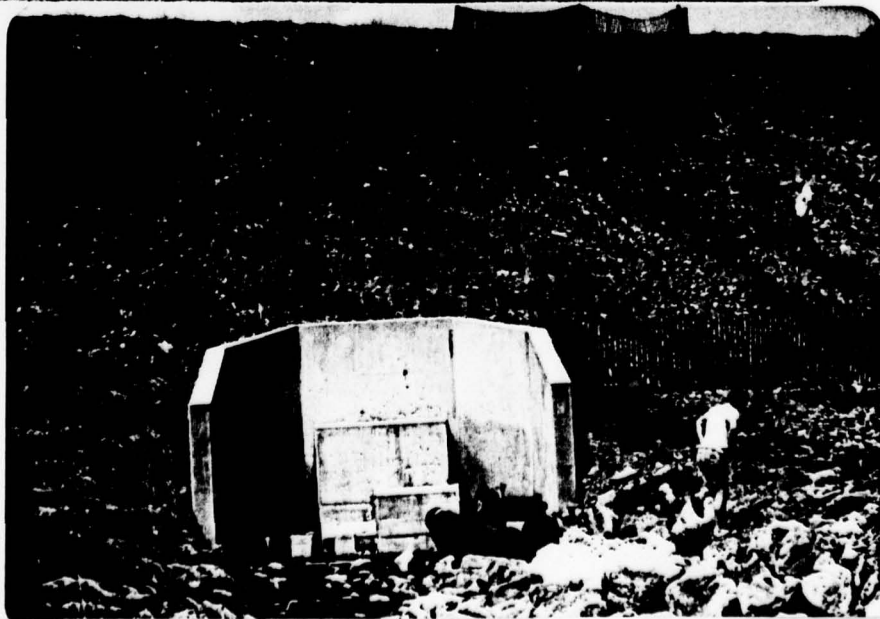
During the drought in 1975, it was decided by the owners to encase the end of the conduit with a concrete structure. This structure has a 12-inch pipe connected to the water supply line and a 24-inch x 24-inch opening which can be closed off with a steel plate (Refer to Appendix E, Plate E-I). When the upstream drawdown sluice gate is opened and this plate is installed, water can be taken out of the reservoir when the pool level falls below the lowest normal intake. Under this condition, the conduit is under pressure.

Conduit Outlet with
Concrete Enclosure

It is recommended that the owner submit engineering data to PennDER indicating the adequacy of the conduit as a pressure line, or remove the concrete structure at the end of the outlet conduit.

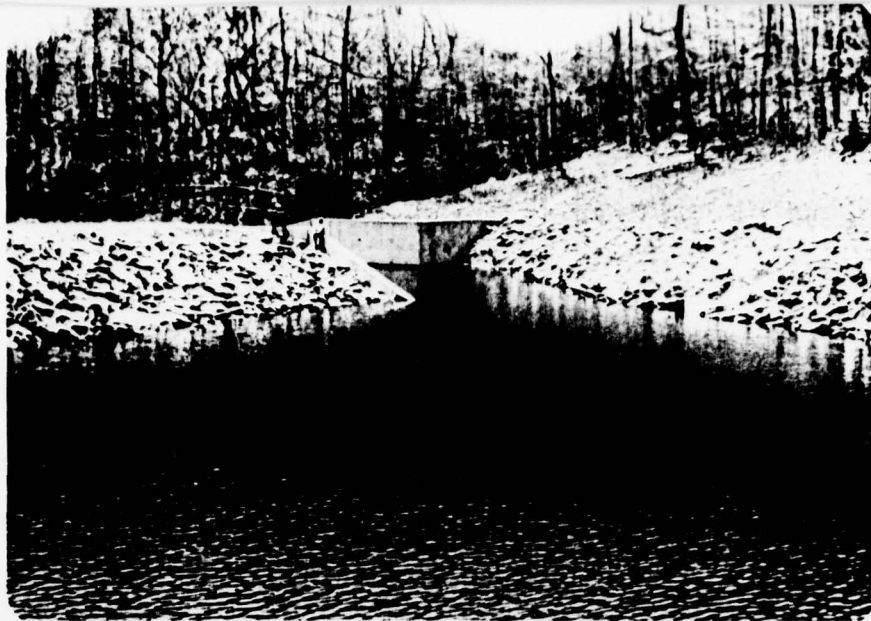
The spillway is located in the right abutment of the dam. The forebay is well protected with heavy riprap and the right forebay wall is butted far into the hillside. Although the approach width appears to be skewed awkwardly and relatively narrow, sufficient width and depth appears to be available during high water. The concrete of the ogee section was in good condition with only one small crack. The walls of the spillway chute and stilling basin are high and will certainly contain any flow over the spillway. All concrete was in good condition.

Forebay Area

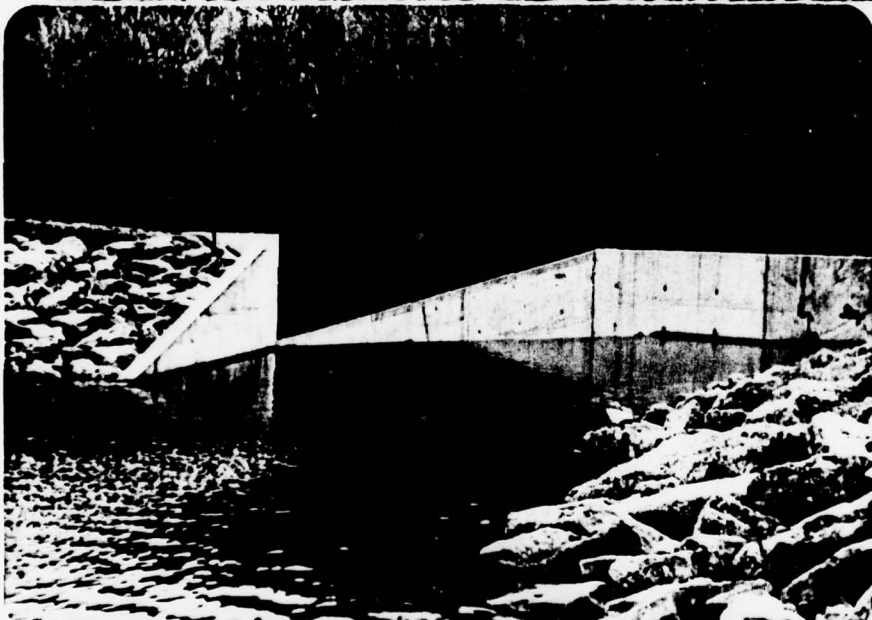
Detail forebay
Walls

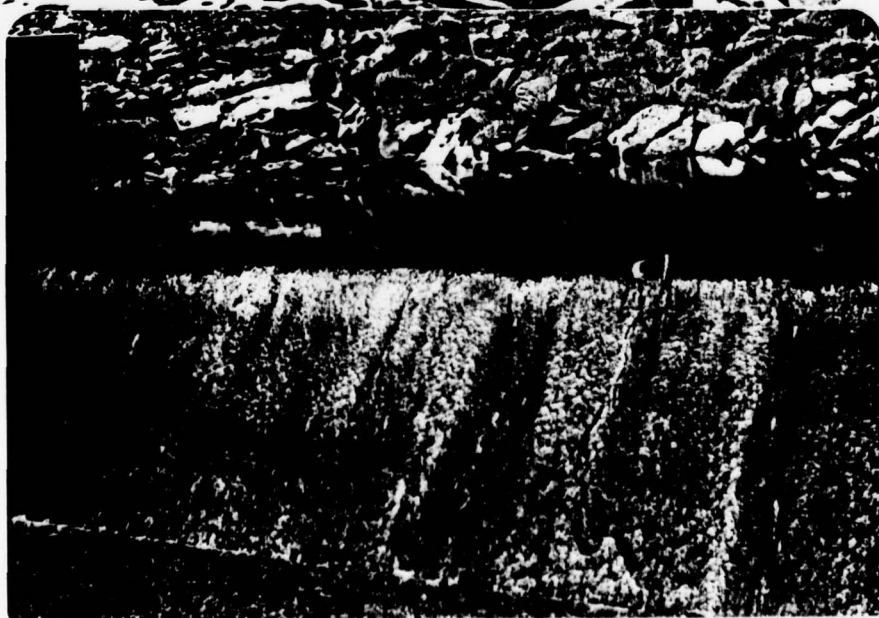
Spillway Ogee
Section

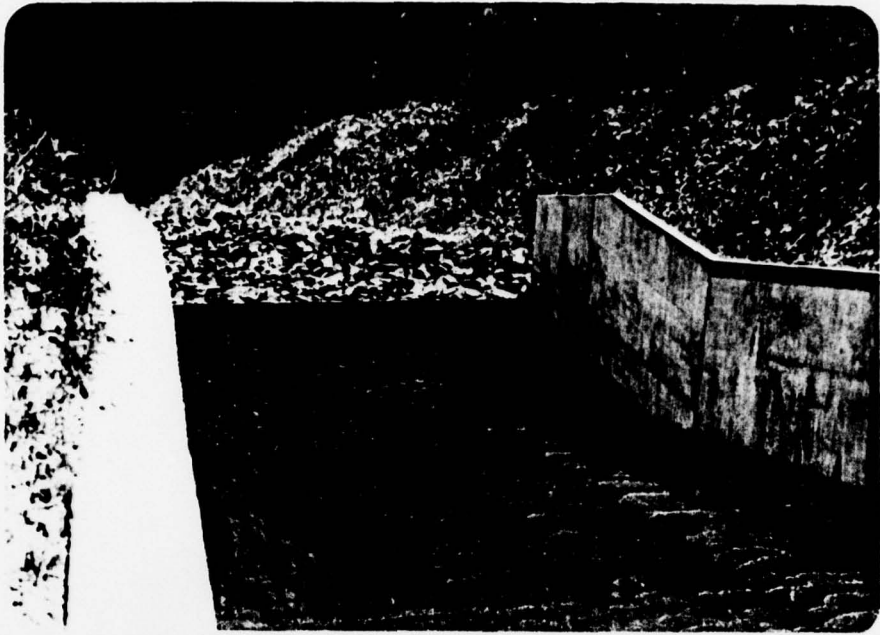
A wet area was located between the outlet structure and stilling basin. No flow of water was detected and it appears that only minor seepage is occurring at this point. An additional wet area was observed on the left hillside downstream of the stilling basin. It appears that this water is coming from the hillside and not from the embankment or dam abutment.

Stilling Basin & Downstream Channel
