SOIL CONSERVATION SERVICE  
DAM PA-464

6  
PHASE I INSPECTION REPORT  
NATIONAL DAM INSPECTION PROGRAM.  
Soil Conservation Service DAM PA-464.  
(Goose Pond Run Dam). NDS ID PA-00812.  
DER ID 45-247. Delaware River Basin,  
Goose Pond Run, Monroe County,  
Pennsylvania. Phase I Inspection Report.

WOODWARD-CLYDE CONSULTANTS  
5120 Butler Pike  
Plymouth Meeting, Pennsylvania 19462

11  
MARCH 1979

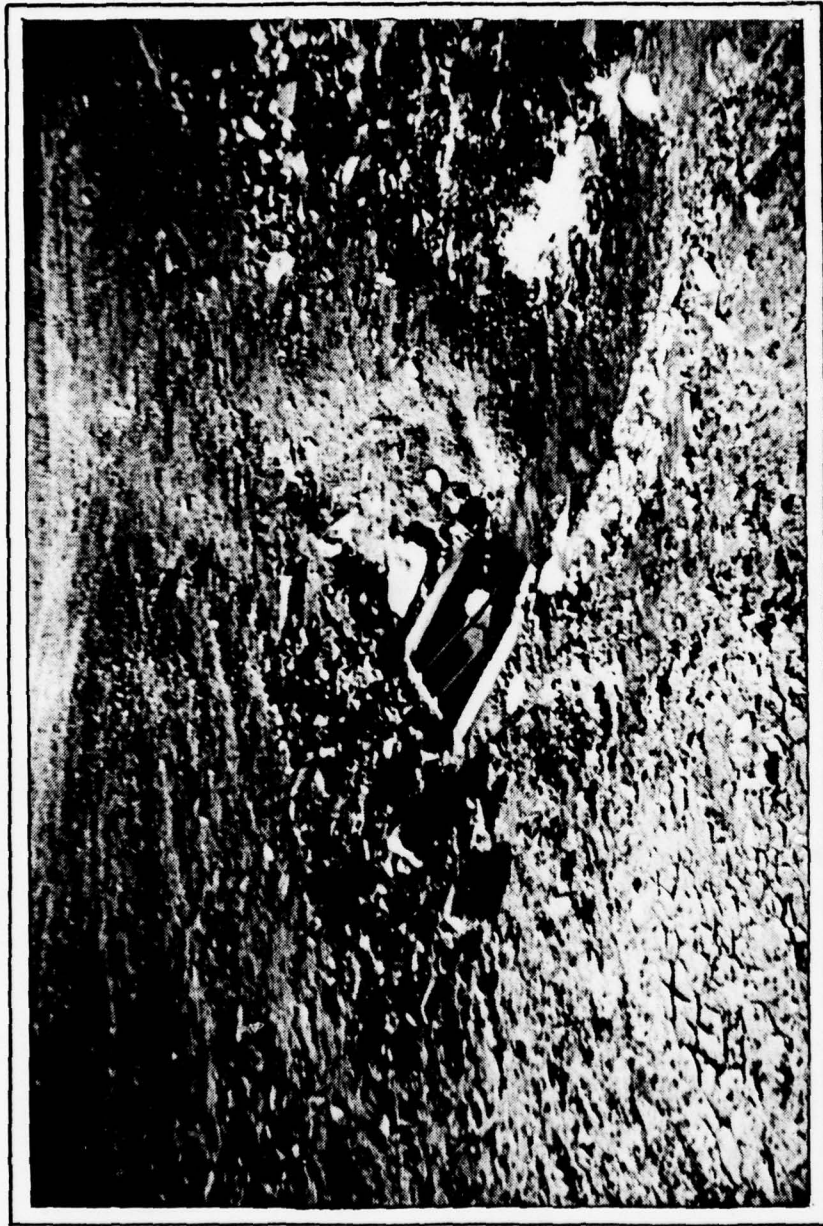
It is noted that the pond drain was open due to a malfunctioning gate allowing for no sedimentation storage.

d. Reservoir. At the time of inspection, the pond drain was open because of a malfunctioning gate, eliminating all storage behind the dam. However, the pond created by the older dam retains a small quantity of water. This dam is considered to be in poor condition. However, if this dam failed at any time, it would have no significant impact on the structural integrity of the dam or its intake system. Reconnaissance of the remaining portion of the reservoir disclosed no evidence of significant siltation, slope instability, or other features that would significantly affect the flood storage capacity of the reservoir.

POND DRAIN INTAKE.

1. The jammed pond drain gate should be repaired.

1. The jammed pond drain valve should be repaired.
2. Debris along the sides of the reservoir should be cleared to some reasonable degree to minimize the potential for clogging the principal spillway intake system.

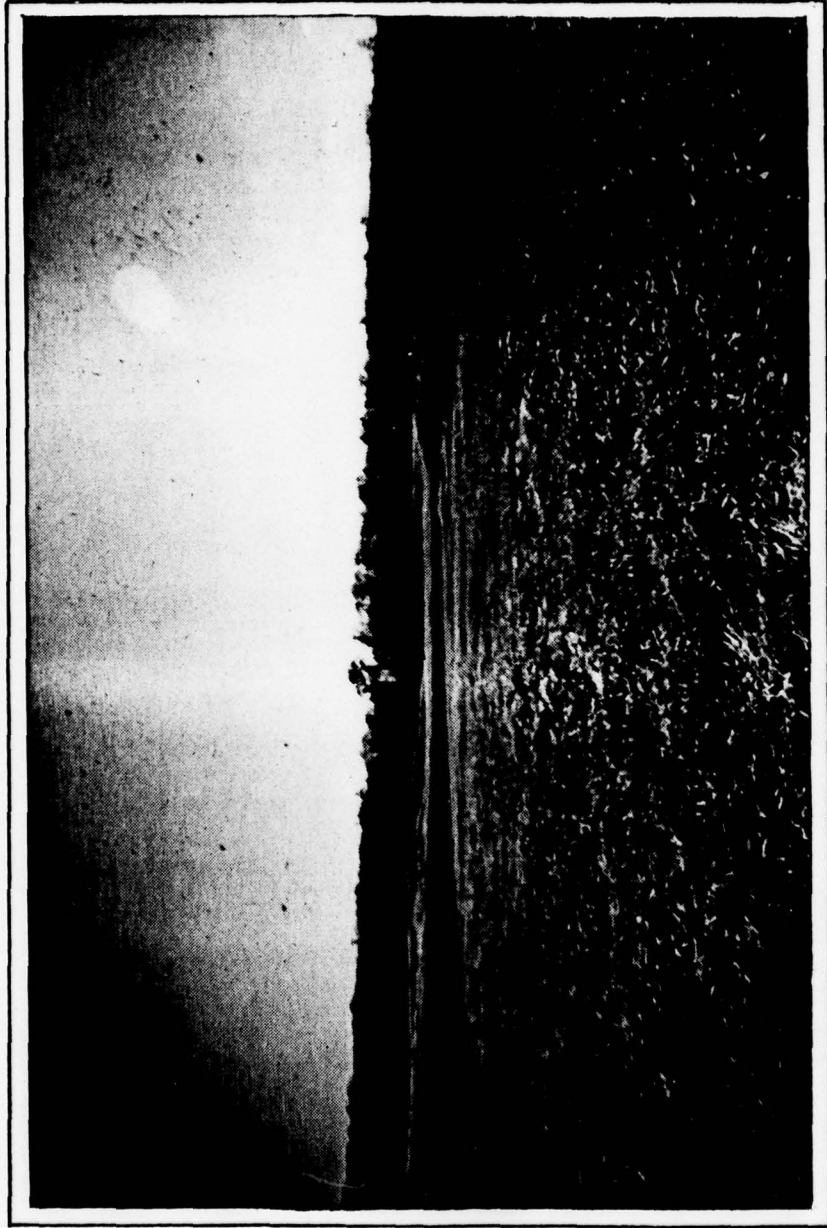
PHOTOGRAPH NO. 5

2. Emergency Spillway. The grass-lined emergency spillway at the left abutment was inspected and found to be quite stable and in good condition. Side slopes are well vegetated and appear to be well maintained. The emergency spillway entrance and exit channels and control section are considered to be in good condition.

OVERVIEW OF EMERGENCY SPILLWAY LOOKING  
DOWNSTREAM. NOTE GRASS COVERED BORROW  
PIT ON THE LEFT SIDE OF THE CHANNEL.

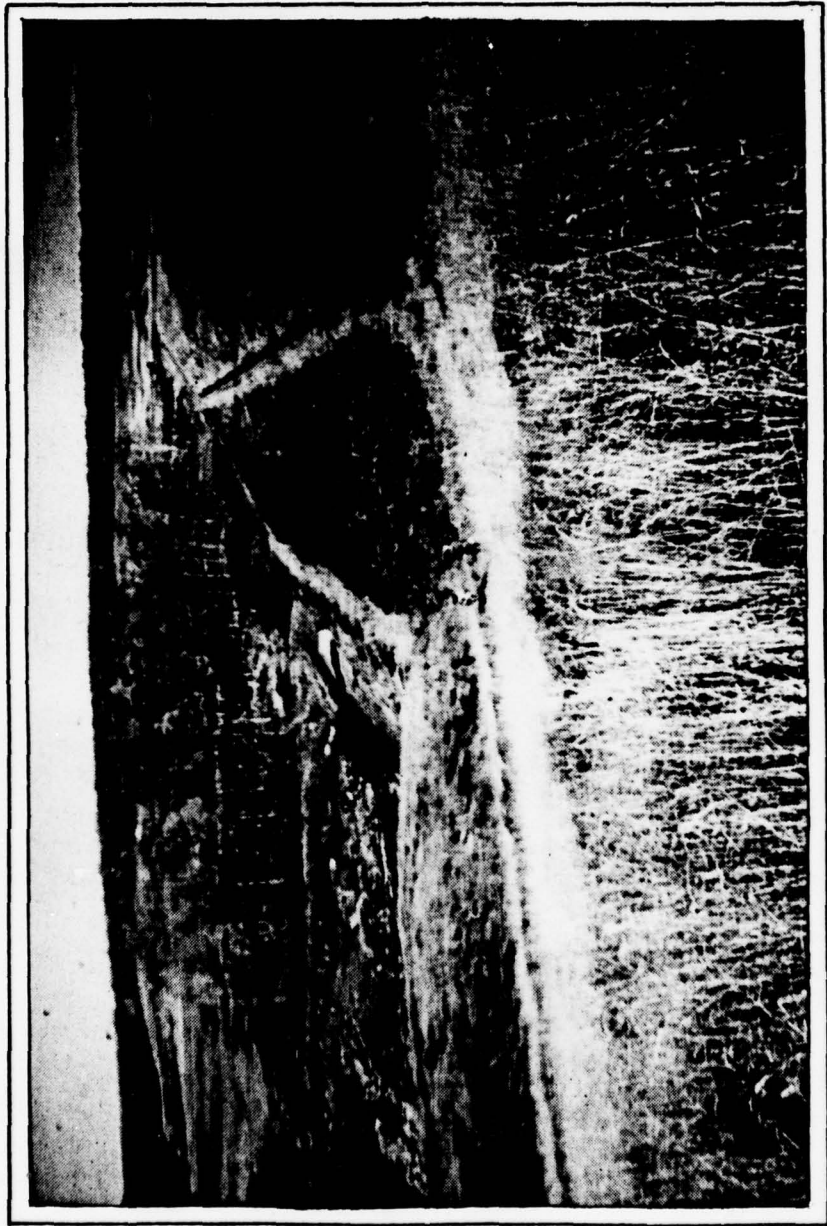
PHOTOGRAPH NO. 6

There were no indications of surface cracks, unusual distortions at or beyond the toe, or significant sloughing or erosion of the embankment or abutment slopes. The downstream slope and the upstream slope above the sediment pool are Crownvetch covered, and the vegetation was considered to be in good condition. A few inches of sediment line the sediment pool.

OVERVIEW OF UPSTREAM SLOPE LOOKING  
TOWARDS LEFT ABUTMENT.

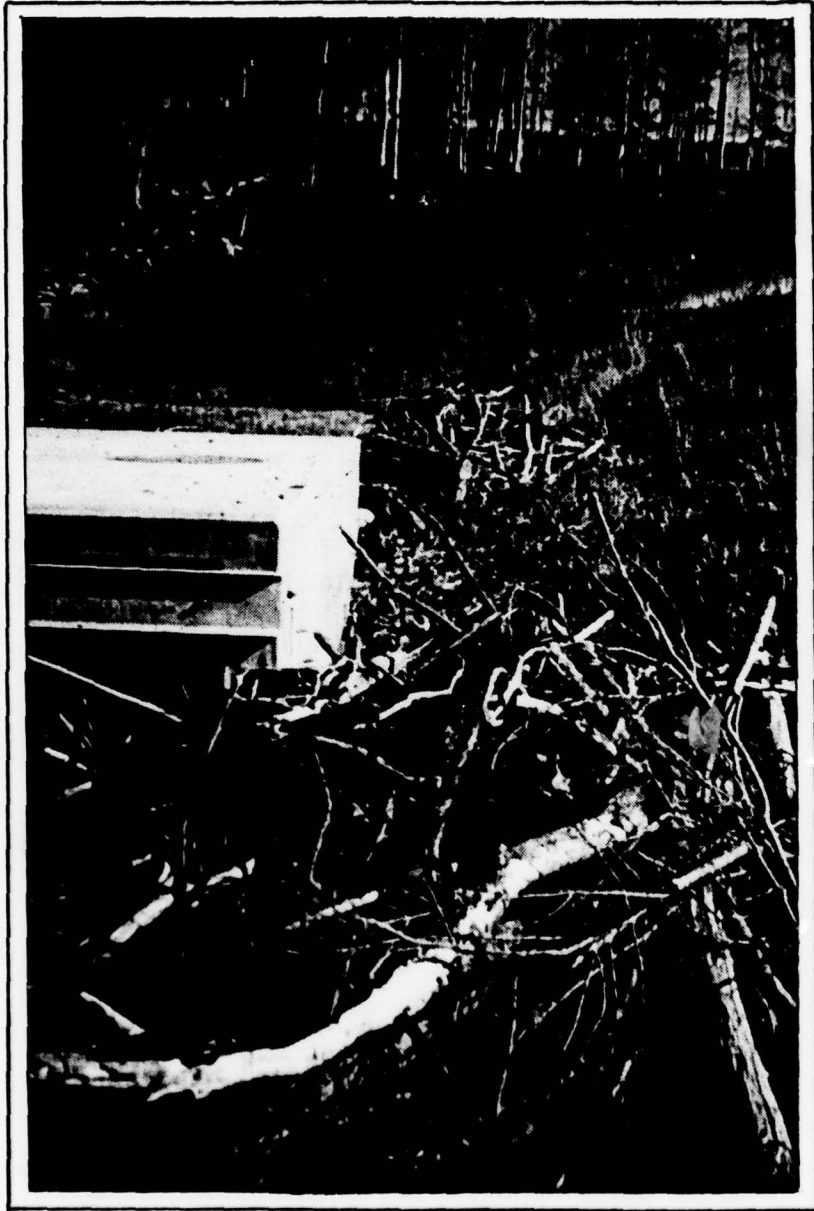
PHOTOGRAPH NO. 8

There is very little debris noted along the reservoir shoreline or along the slopes of the drainage area. However, debris had been collected and piled on the embankment near the riser. All of the drainage area is considered to be well vegetated and stable.

c. Visual Observations. On the date of the inspection, the only conditions observed that would indicate a possible reduction in principal spillway capacity are piles of debris that apparently had been removed from the reservoir area, but not removed from the flood water area. The possibility exists that the debris could lodge in the principal spillway trash racks and reduce the flow capabilities of the principal spillway system. While this is not a dangerous condition, it is considered to be an undesirable condition. Observations regarding the condition of the downstream channel, spillways and reservoir are located in Appendix B and discussed in greater detail in Section 3.

**SLOPES** The reservoir side slopes are moderate to steep and generally wooded. There is considerable debris, including fallen trees, that could block the principal spillway. There are two piles of debris near the riser that appear to have been cleaned from the riser. This debris should be removed or burned to insure that it cannot block the riser inlet again.

TRASH REMOVED FROM INTAKE RISER  
AND PILED AROUND STRUCTURE.

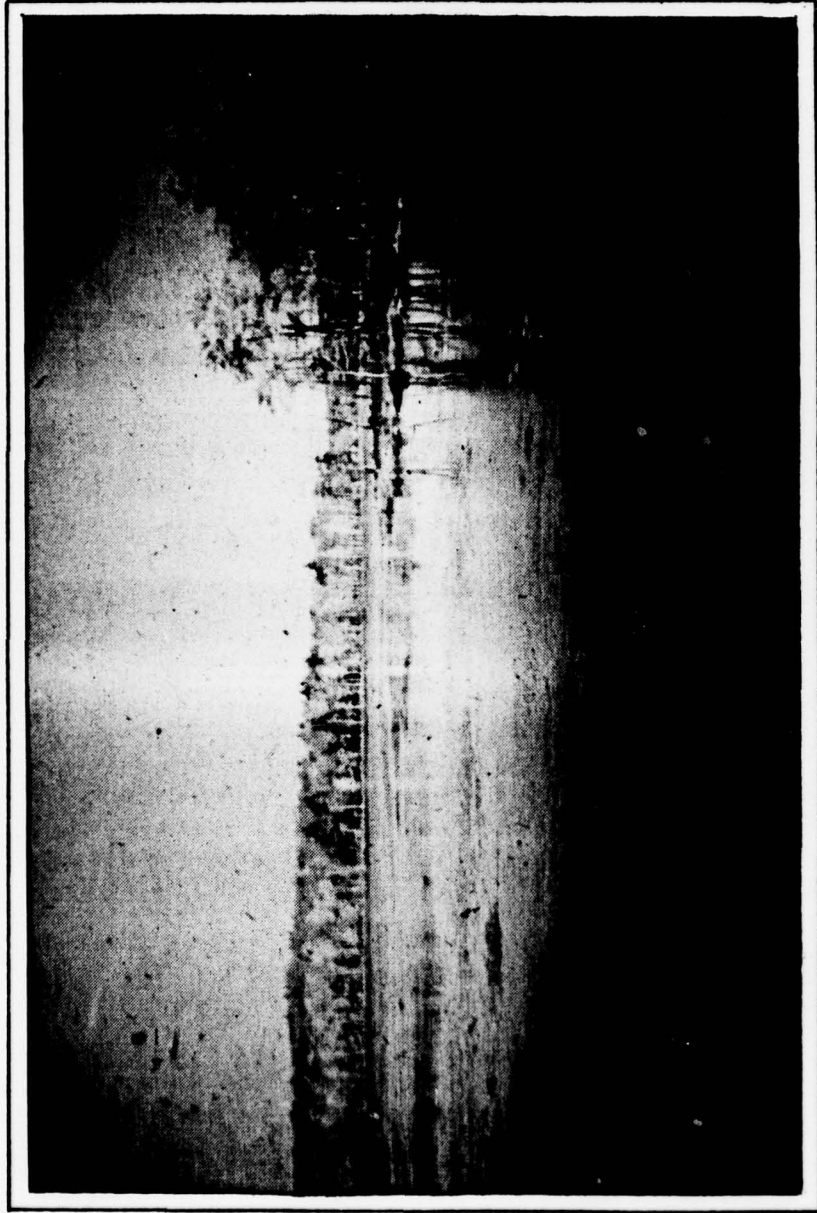
PHOTOGRAPH NO. 9

OVERVIEW OF UPSTREAM LAKE.  
RANSBERRY POND
