MOUNT AIRY DAM

NDS I.D. NO. PA 00811
DER I.D. NO 45-243

6 PHASE I INSPECTION REPORT
NATIONAL DAM INSPECTION PROGRAM

11 APR 1979

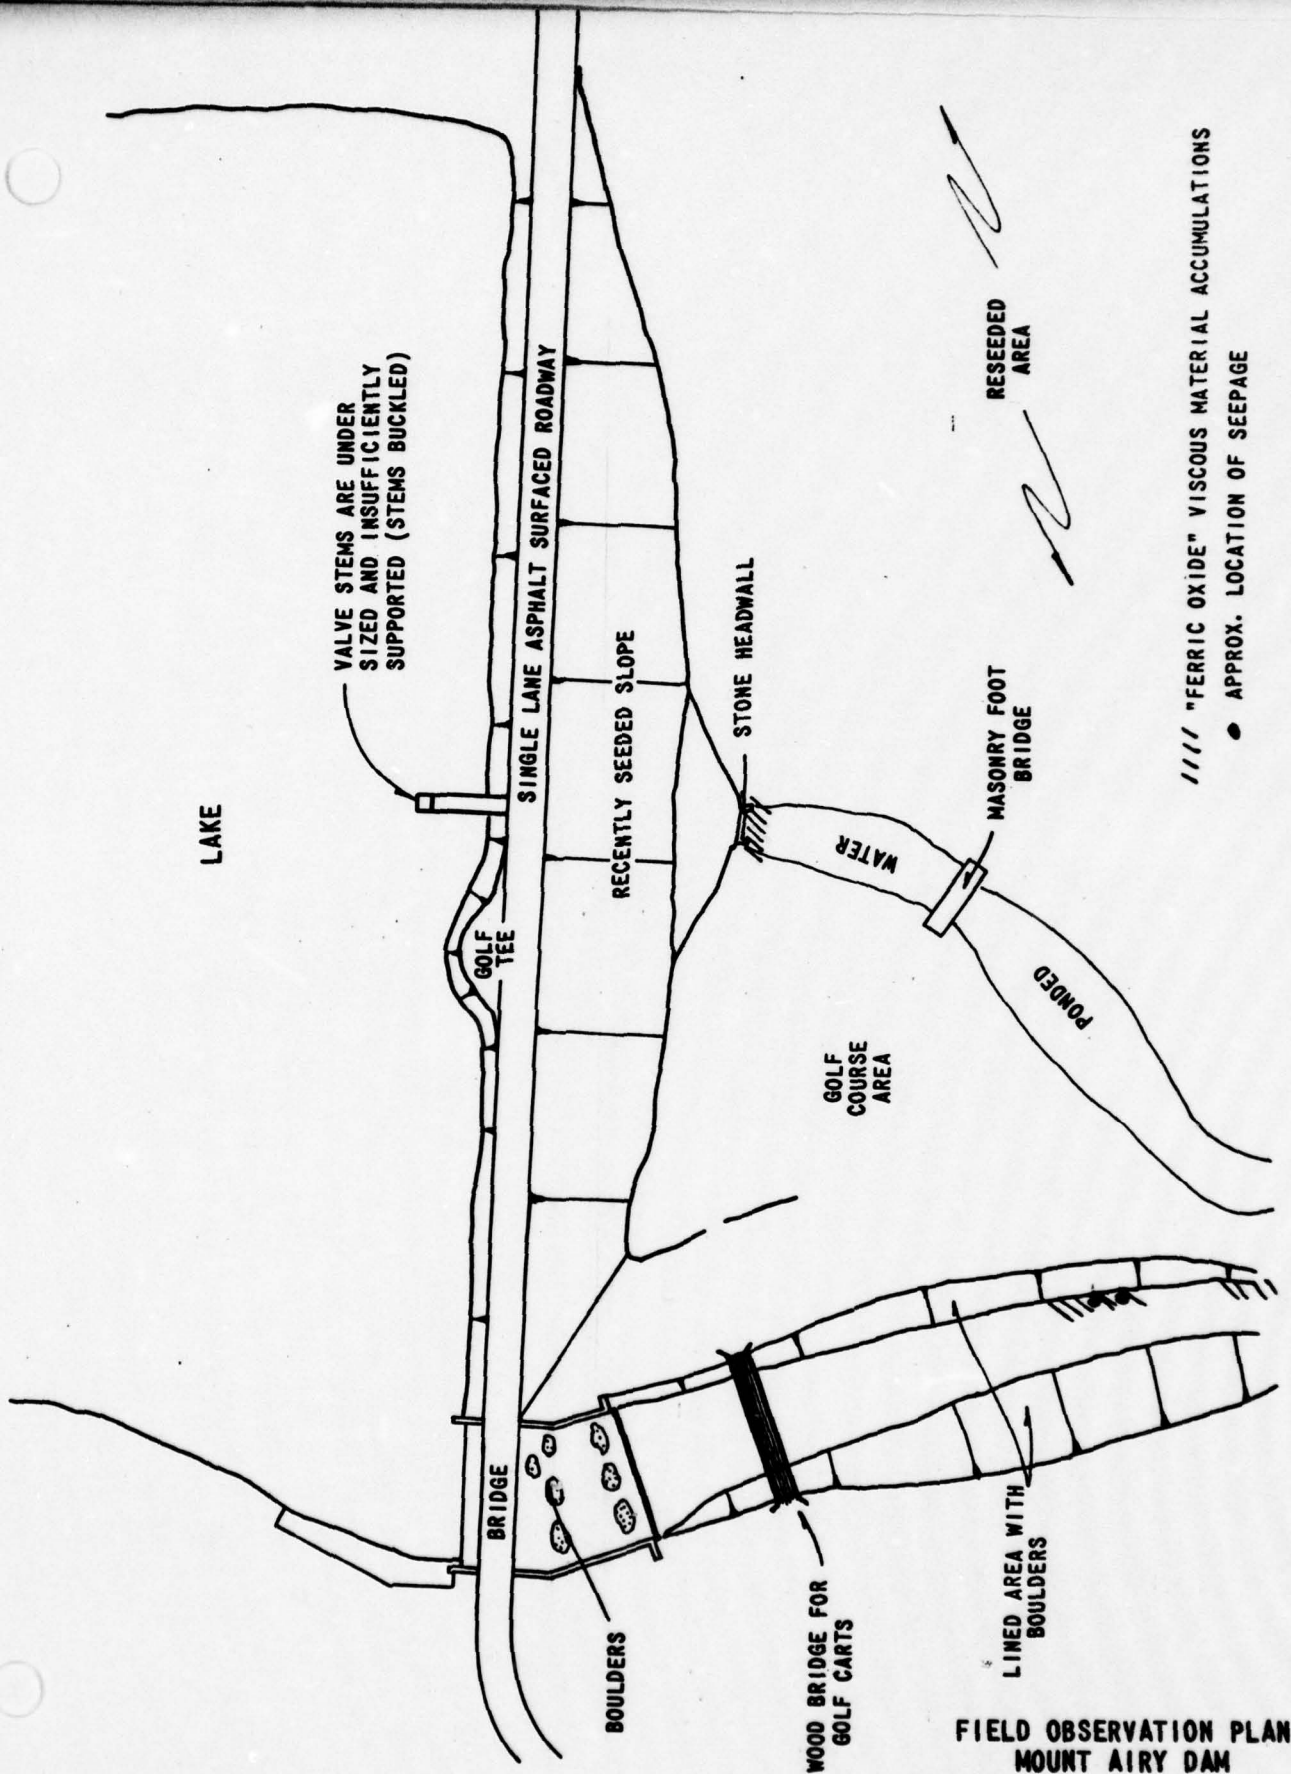
SHEET 5a OF 11

Could not see embankment drainage system as they outletted through the wing walls of the outlet structure which since has been buried, see next sheet.

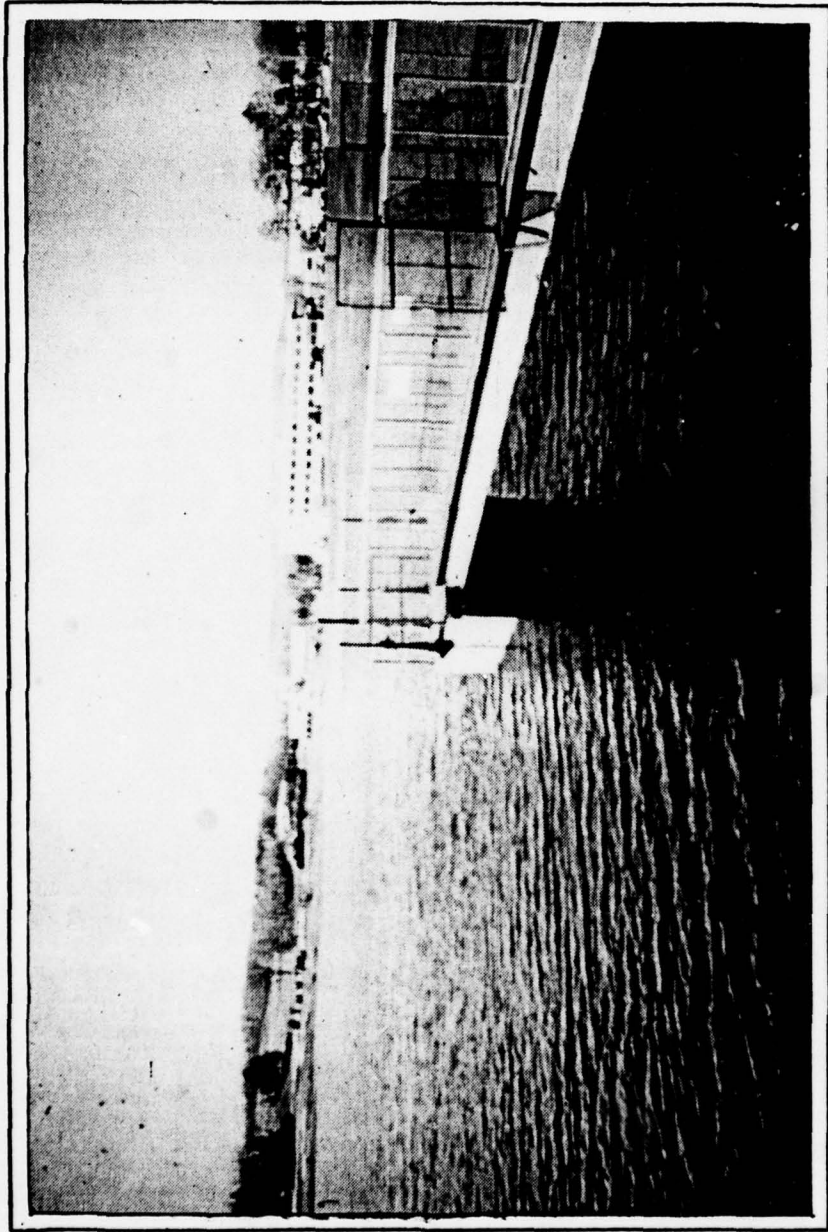
PHOTOGRAPH NO. 1

As previously mentioned, the intake tower was inspected and the only significant deficiency observed was the sluice gate stems. These stems have buckled and are in poor condition.

VIEW OF INTAKE TOWER AND FOOT BRIDGE
CONNECTING DAM CREST TO THE TOWER.

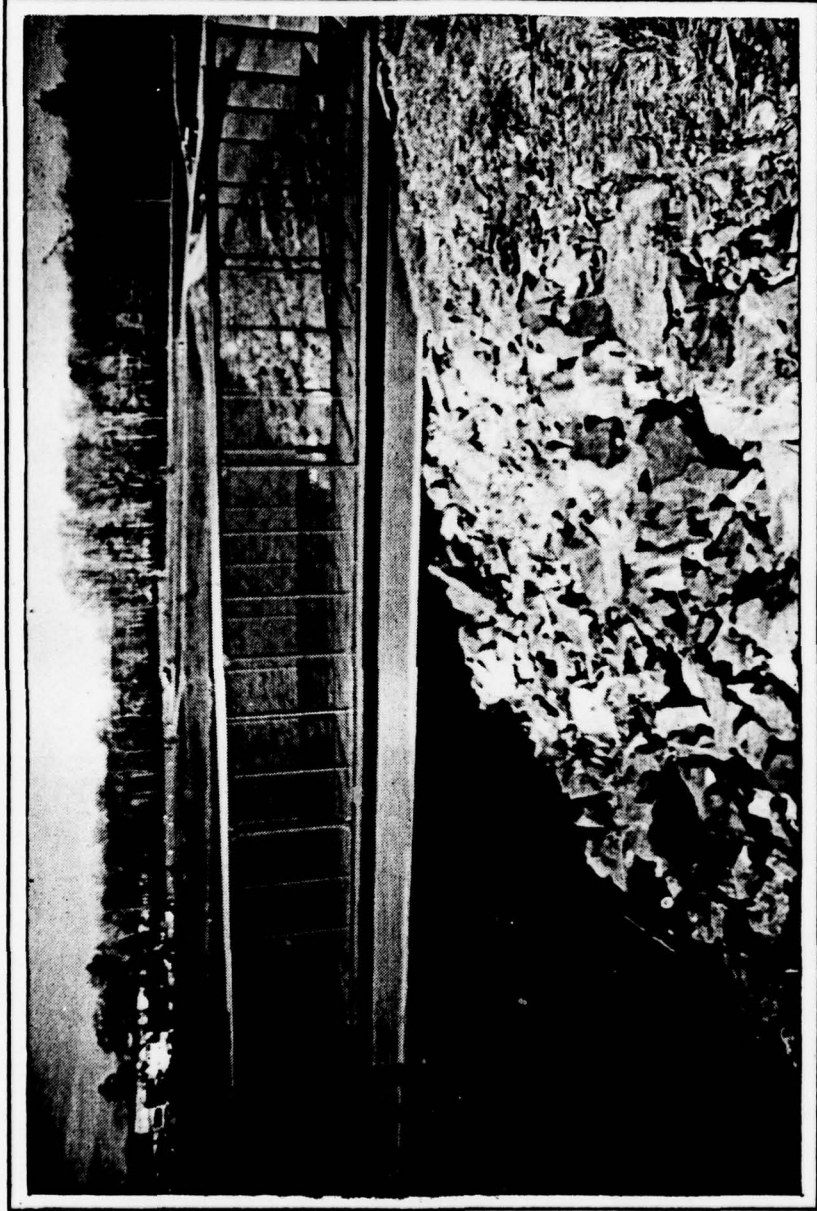
PHOTOGRAPH NO. 7

a. Evaluation. Visual inspection and review of available documentation indicates that the embankment and appurtenant structures, with the exception of the sluice gate stems, are in generally good condition. Crest settlement was observed adjacent to the left spillway wall. There was also minor erosion on the downstream slope which was being stabilized with grass. Crest undulations were minor. The maximum differential crest variation was measured as 0.5 foot, and the right abutment is about 0.8 foot lower than the top of the bridge deck. The horizontal alignment of the crest is very good and the crest is covered with at least 3.5 inches of asphalt. The upstream riprap slope undulated showing signs of slight erosion, probably due to settlement and/or wave action.

The upstream riprap slope undulates with signs of erosion probably due to settlement and/or wave action. This condition should be monitored and corrected as necessary to minimize degradation of the slope.

VIEW OF UPSTREAM RIPRAP LOOKING
TOWARDS LEFT ABUTMENT.

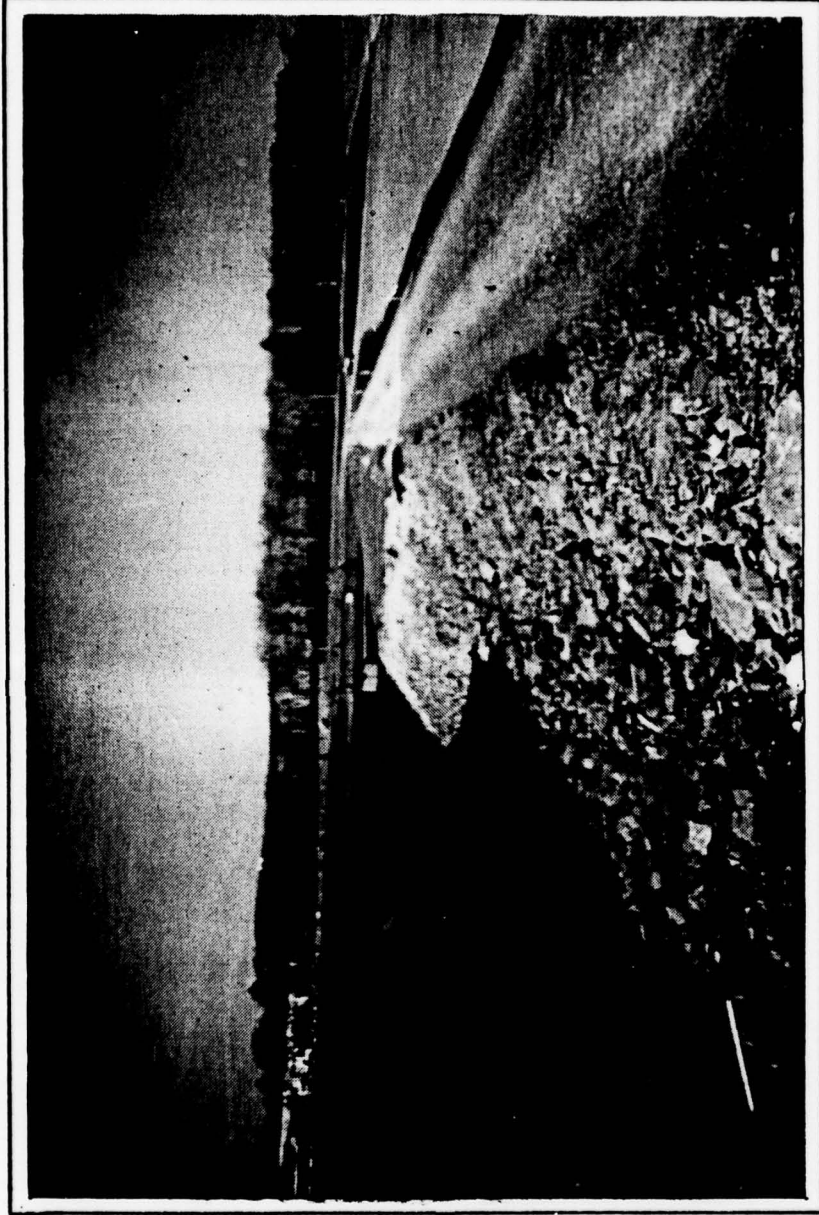
PHOTOGRAPH NO. 8

VIEW OF DAM CREST LOOKING FROM
EMERGENCY SPILLWAY TOWARDS LEFT
ABUTMENT. BULGE IN UPSTREAM
SLOPE IS A GOLF TEE.

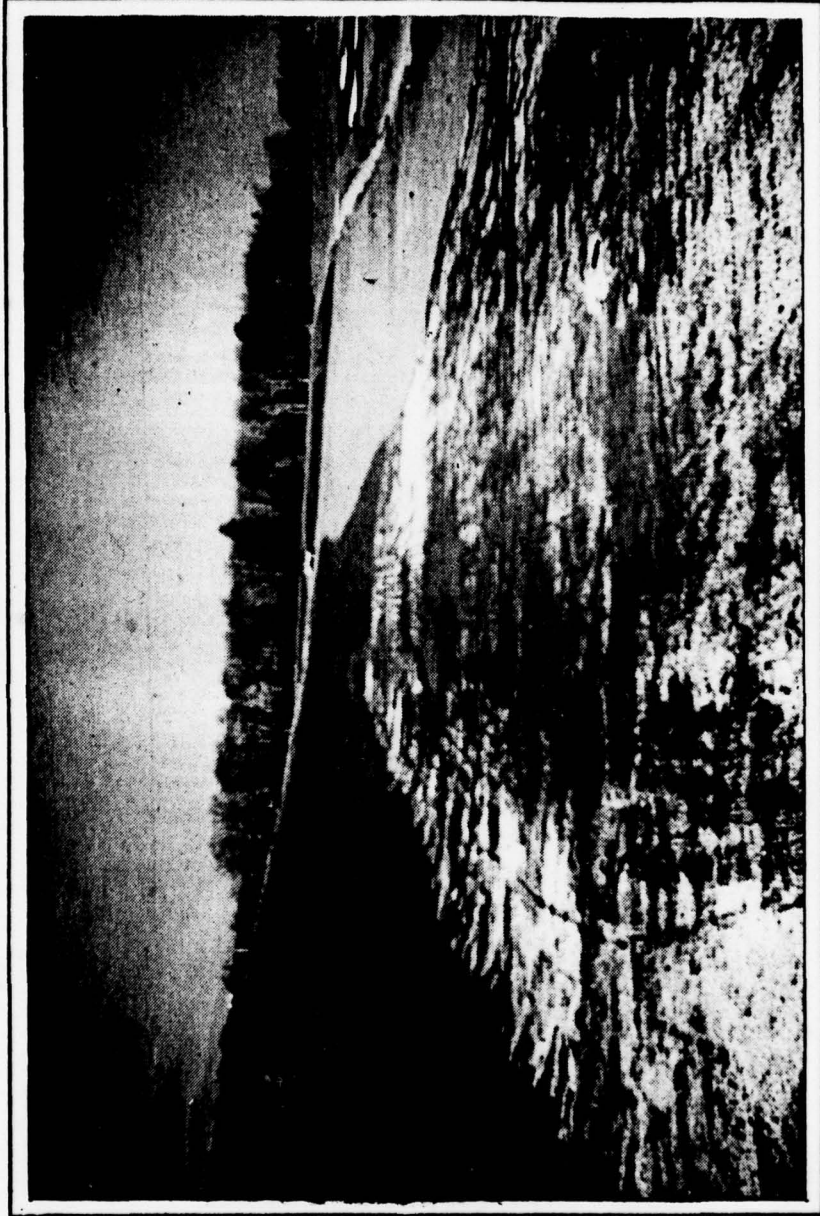
PHOTOGRAPH NO. 9

The upstream riprap surface undulated showing signs of slight erosion. The quality of the rock was assessed to be very good. No indications of surface cracks were noted on the embankment crest or on the slopes. Some minor erosion was noted on the downstream slope. However, the slope had recently been seeded and the grass was not yet established.

VIEW OF DOWNSTREAM SLOPE. AREA
WAS RECENTLY SEEDED WITH GRASS.

5. Erosion of the downstream slopes should be monitored and, if it continues to occur, the area should be dressed, fertilized and reseeded.
6. As noted on sheet 6, Appendix B, a joint in the intake tower is leaking. This should be repaired.
