**DELAWARE RIVER BASIN
LEAVITT BRANCH, BRODHEAD CREEK
MONROE COUNTY
PENNSYLVANIA
NDS ID PA. 00814
DER ID 45-250**

**SOIL CONSERVATION SERVICE DAM PA-463
(LEAVITT BRANCH DAM)**

**PHASE I INSPECTION REPORT
NATIONAL DAM INSPECTION PROGRAM**

MARCH 1979

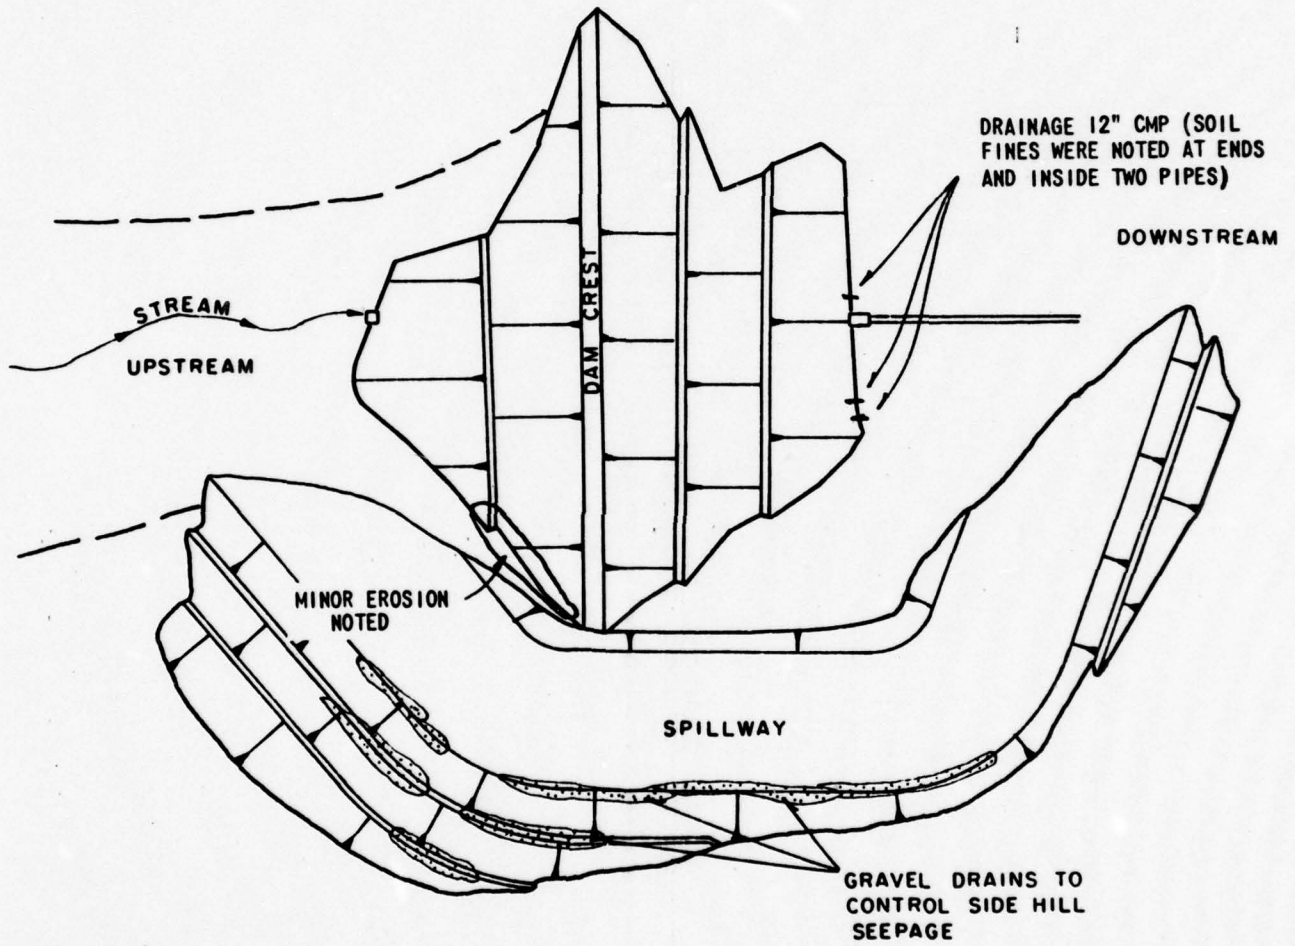
SEEPAGE LOCATION PLAN
 SHEET 5A OF 11

No seepage was observed at the base of the dam, but a flow of approximately 5 to 7 gallons per minute was observed from beneath a 12-inch diameter corrugated metal drainage pipe adjacent to the toe of the right abutment. Two other 12-inch diameter corrugated metal drainage pipes were also noted near the downstream toe. These pipes were observed to be dry. A review of the "as-built" drawings showed that these pipes were part of the redesigned drainage system incorporated in the dam. Deposits of fine sand were noted in and at the ends of two pipes. It appears that this sediment may be related to piping beneath the drainage pipe. However, the sand deposits were observed to not exceed one or two cubic feet per pipe, and there is no evidence of ground loss or erosion. Embankment drains which discharge through both sides of the impact basin were also inspected. There was no noticeable flow from either of these two pipes.

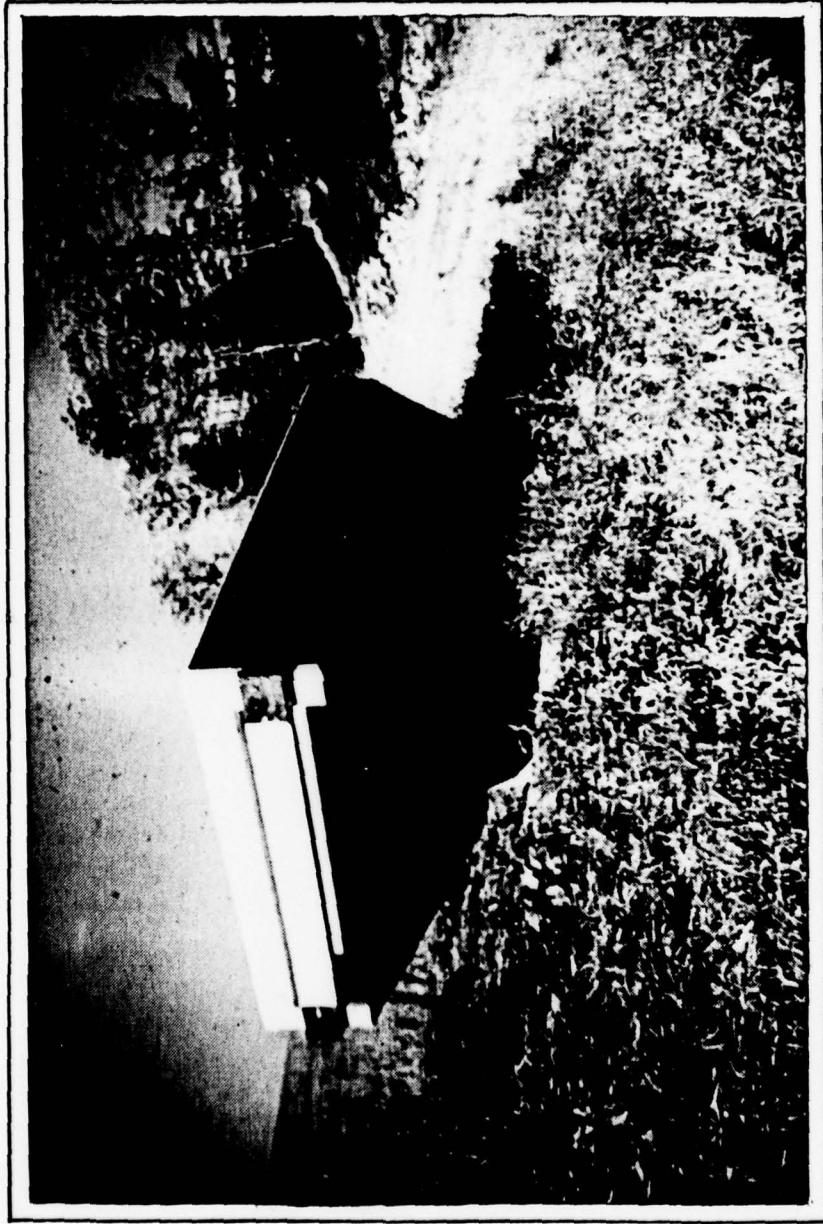
VIEW OF INTAKE RISER ON UPSTREAM SLOPE.

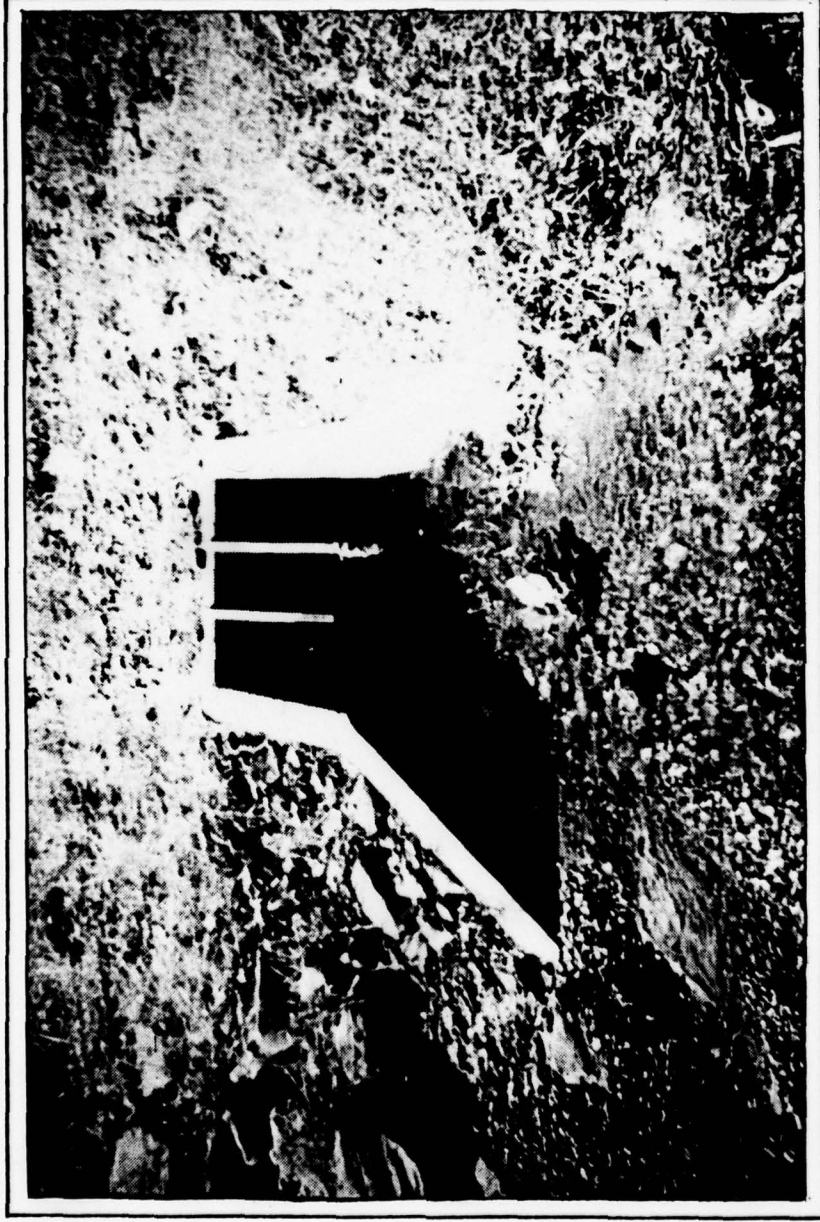
VIEW OF POND DRAIN INTAKE.

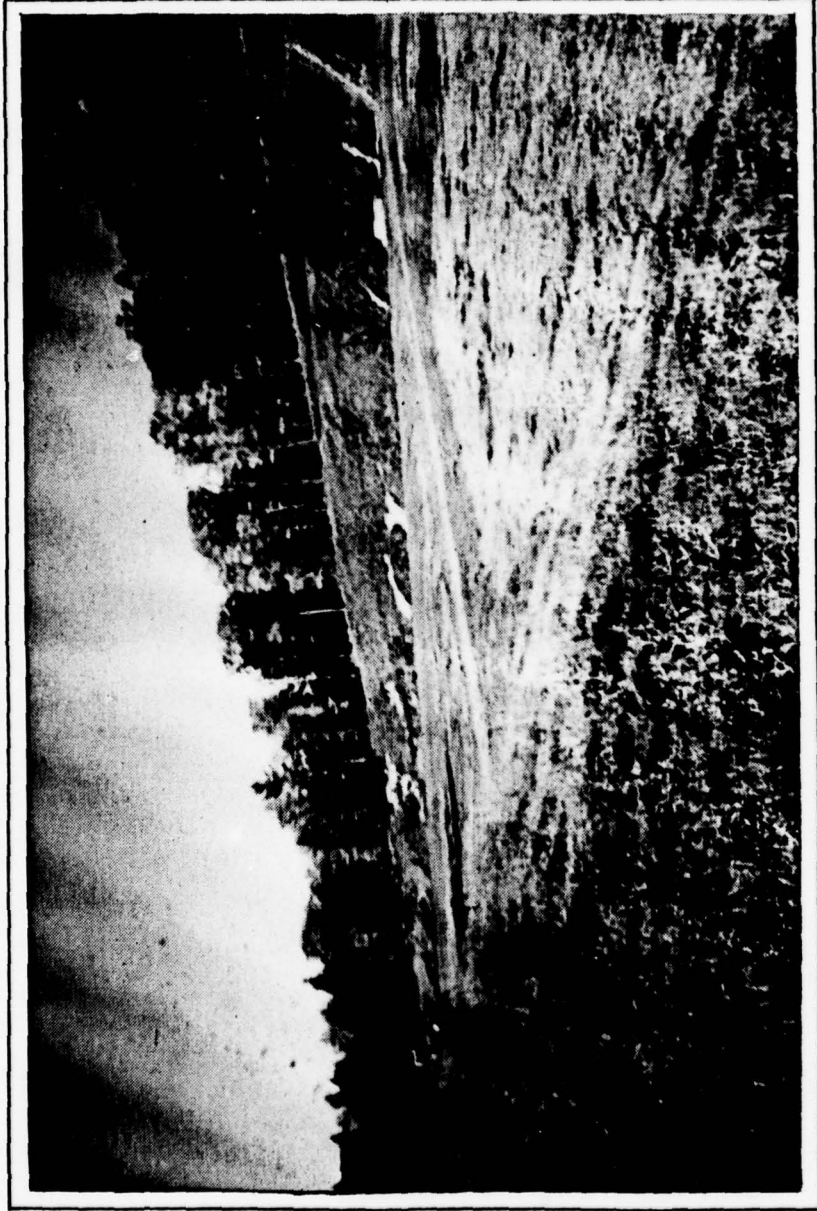
APPROACH CHANNEL	Grass channel observed to be in good condition. At the right edge of the channel along the channel bottom, a drainage trench was excavated and filled with gravel to control side hill seepage. The drainage system appears to be functioning properly.	
------------------	---	--

EMERGENCY SPILLWAY LOOKING DOWNSTREAM.
NOTE THE SEEPAGE DRAINS IN THE SLOPES
OF THE RIGHT ABUTMENT.

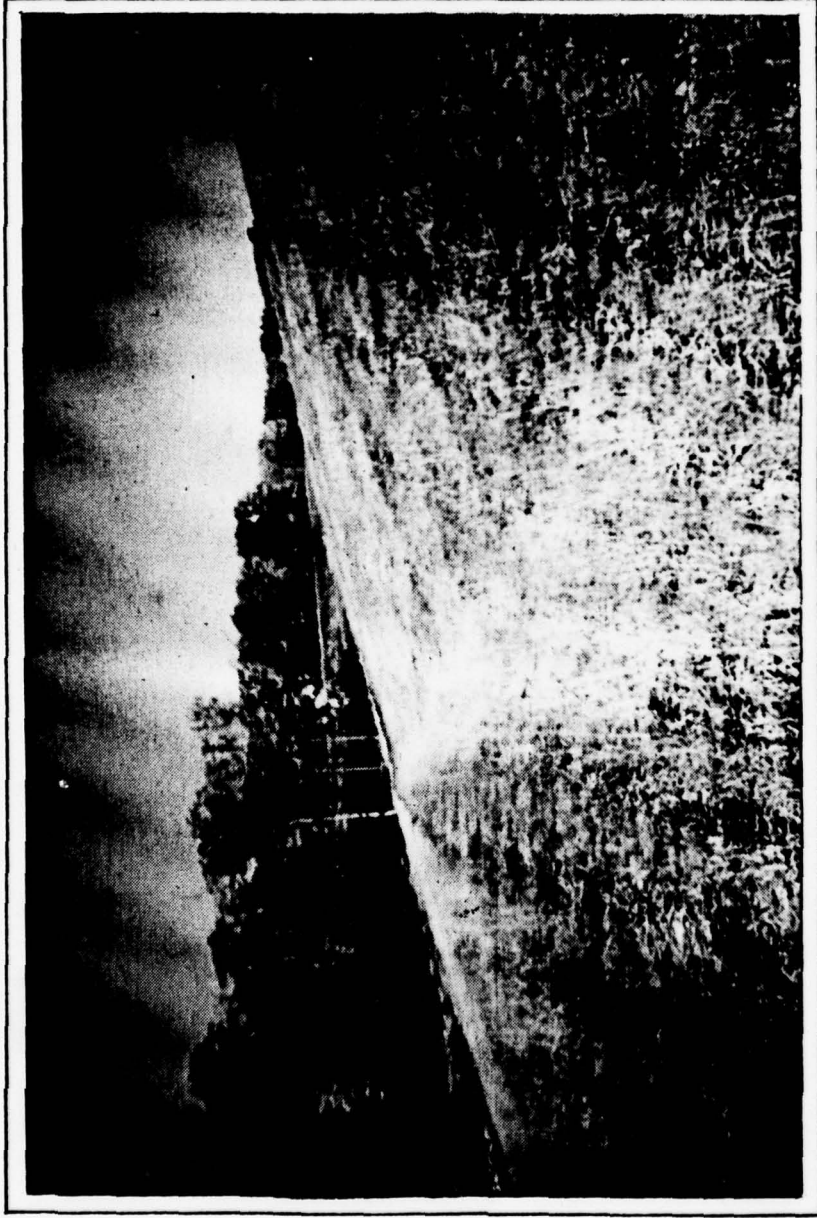
PHOTOGRAPH NO. 5

OVERVIEW OF DOWNSTREAM SLOPE LOOKING
TOWARDS THE RIGHT ABUTMENT.

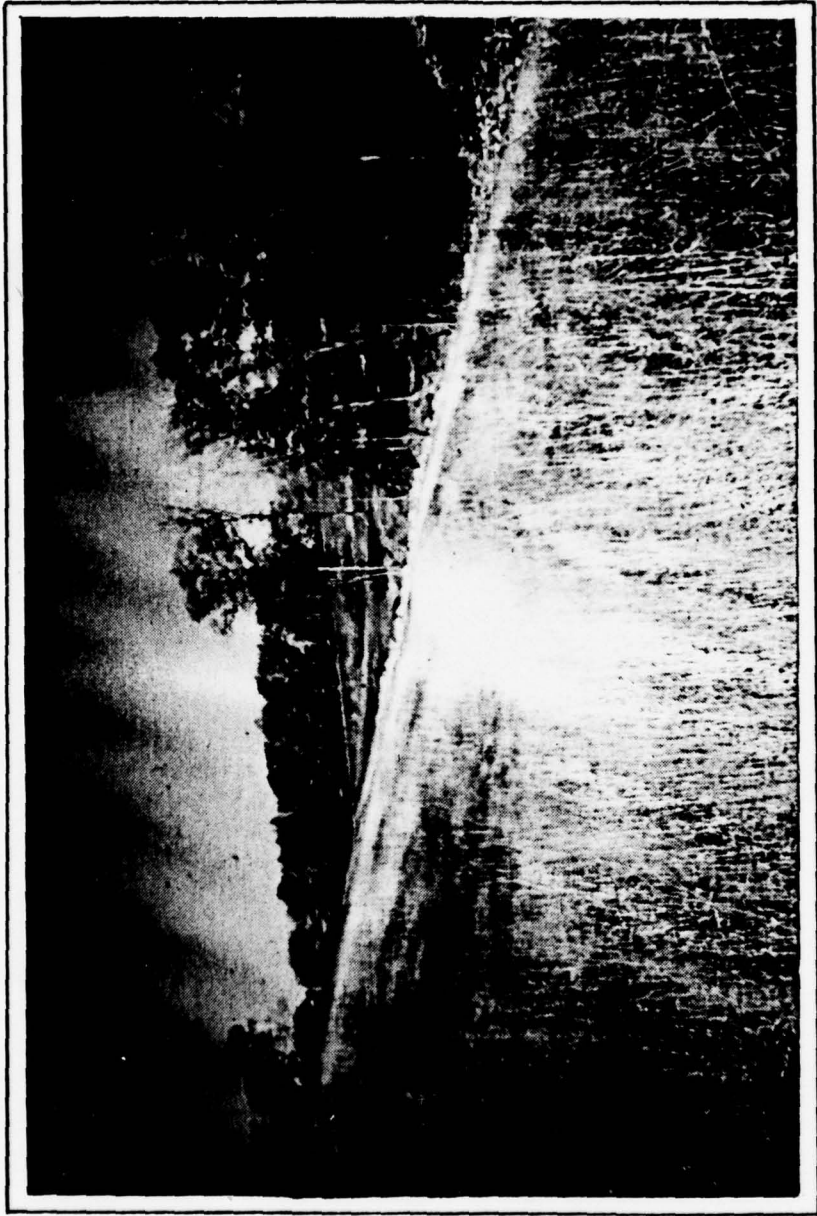
PHOTOGRAPH NO. 6

b. Dam. Careful inspection of the embankment revealed no signs of surface cracks, unusual movements or cracking at or beyond the toe. Some minor erosion and two depressions were observed on the upstream side of the dam just below the first bench. These benches are graded towards the embankment but do not drain laterally. As a result, there is standing water on the benches. No unusual distortions were observed relative to the vertical and horizontal alignment of the crest when checked with survey equipment.

OVERVIEW OF UPSTREAM SLOPE LOOKING
TOWARDS THE RIGHT ABUTMENT.

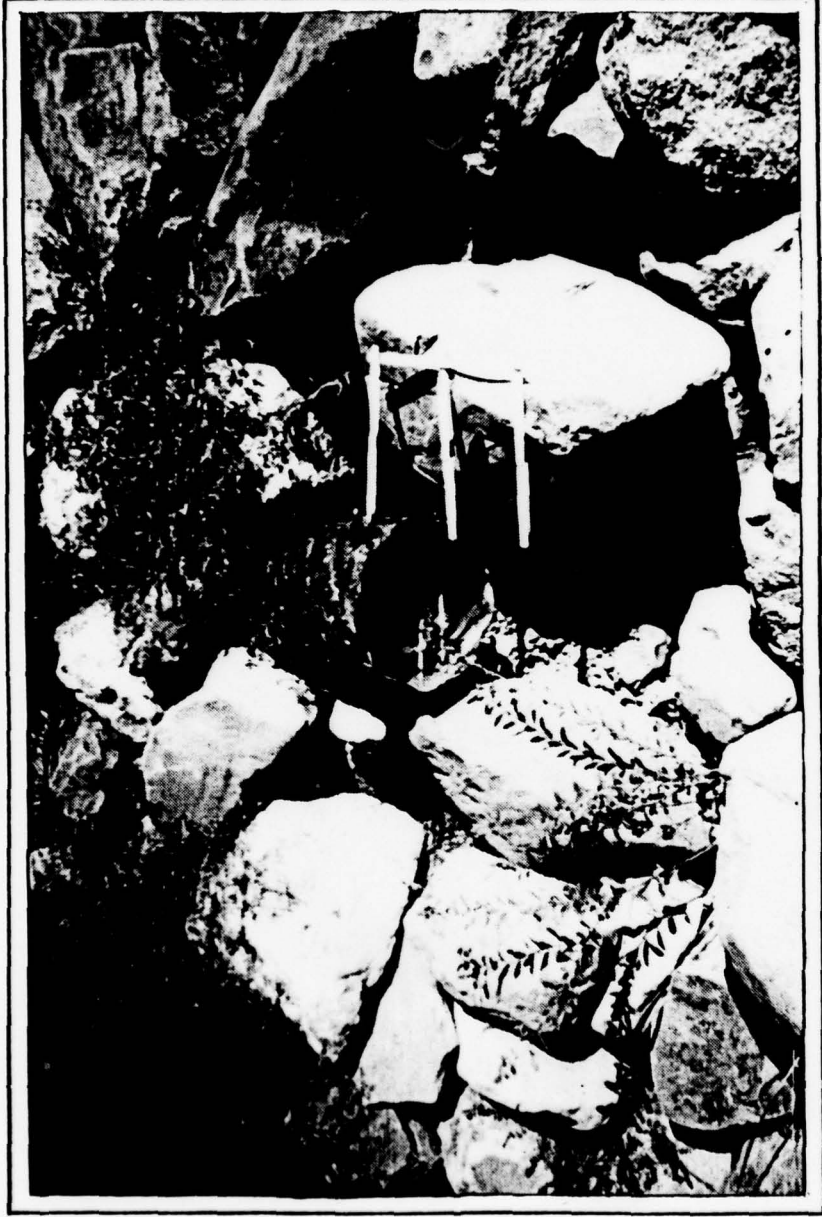
PHOTOGRAPH NO. 8

EMBANKMENT DRAIN THROUGH ROCK TOE.
