DELAWARE RIVER BASIN
SANDO CREEK, MONROE COUNTY
PENNSYLVANIA
HDS ID PA. 00637
DER ID 45-155

EAST STROUDSBURG DAM

PHASE I INSPECTION REPORT NATIONAL DAM INSPECTION PROGRAM

APRIL 1979

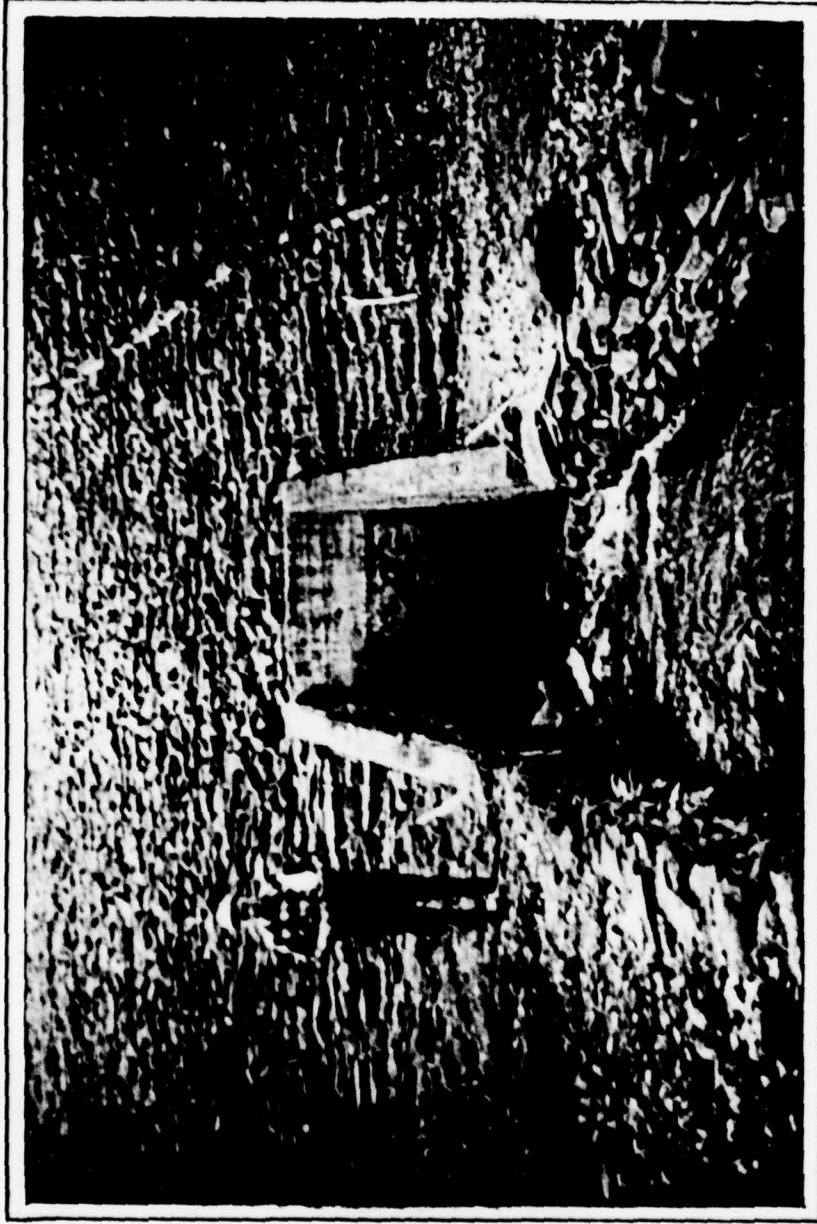
PHOTOGRAPH NO. 1

OUTLET OF DISCHARGE PIPE.

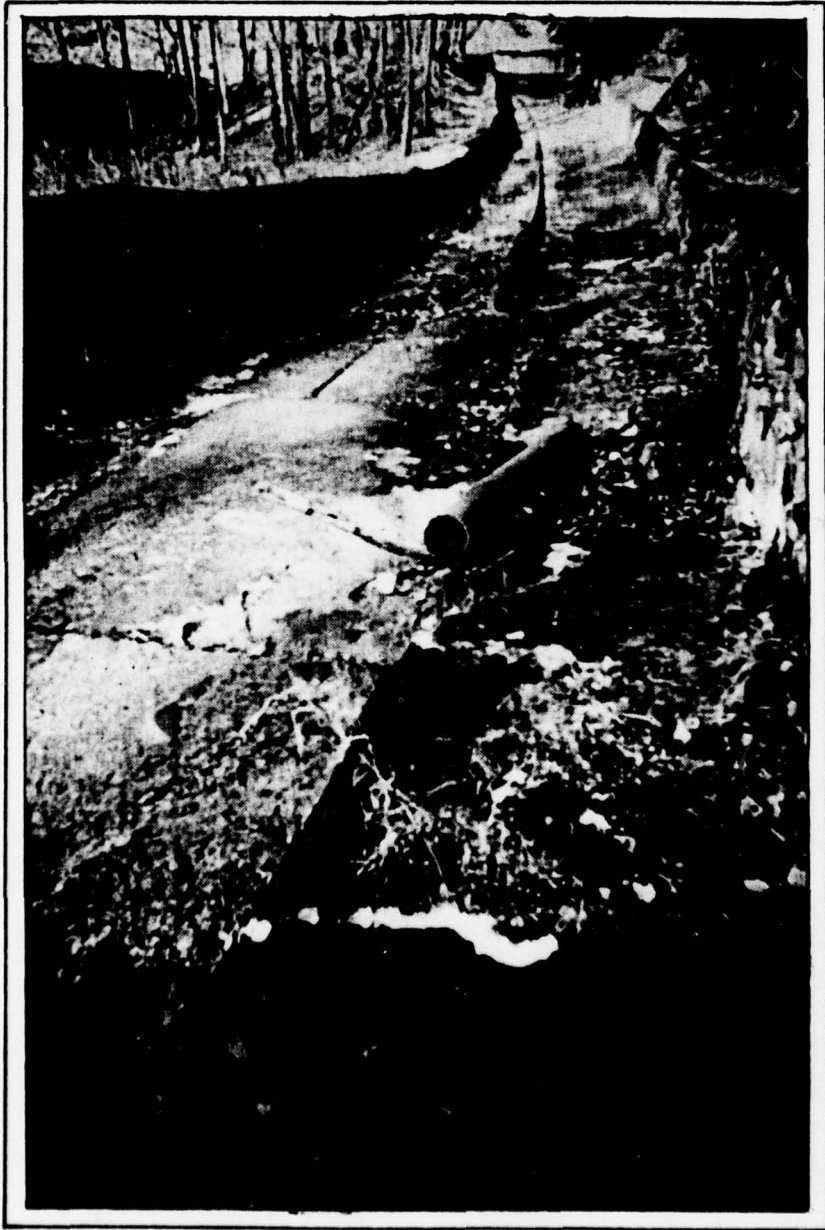
The spillway and wasteway channel, as previously mentioned, was in fair condition near the top and in very poor condition at the base. In the event of extremely high flows, it is expected that large portions of the discharge channel will be washed away.

The lower 100 feet of the spillway wasteway channel is in very poor condition. The upper part of the channel and weir are in fair condition. Overall deterioration and poor condition of the structure can be seen in Photograph 11, Appendix D.

DETERIORATED SECTIONS OF
THE SPILLWAY.
