**DELAWARE RIVER BASIN  
SWIFTWATER CREEK, MONROE COUNTY**

**PENNSYLVANIA  
NDS ID PA. 00776  
DER ID 45-134**

# LAKE SWIFTWATER DAM

**PHASE I INSPECTION REPORT  
NATIONAL DAM INSPECTION PROGRAM**

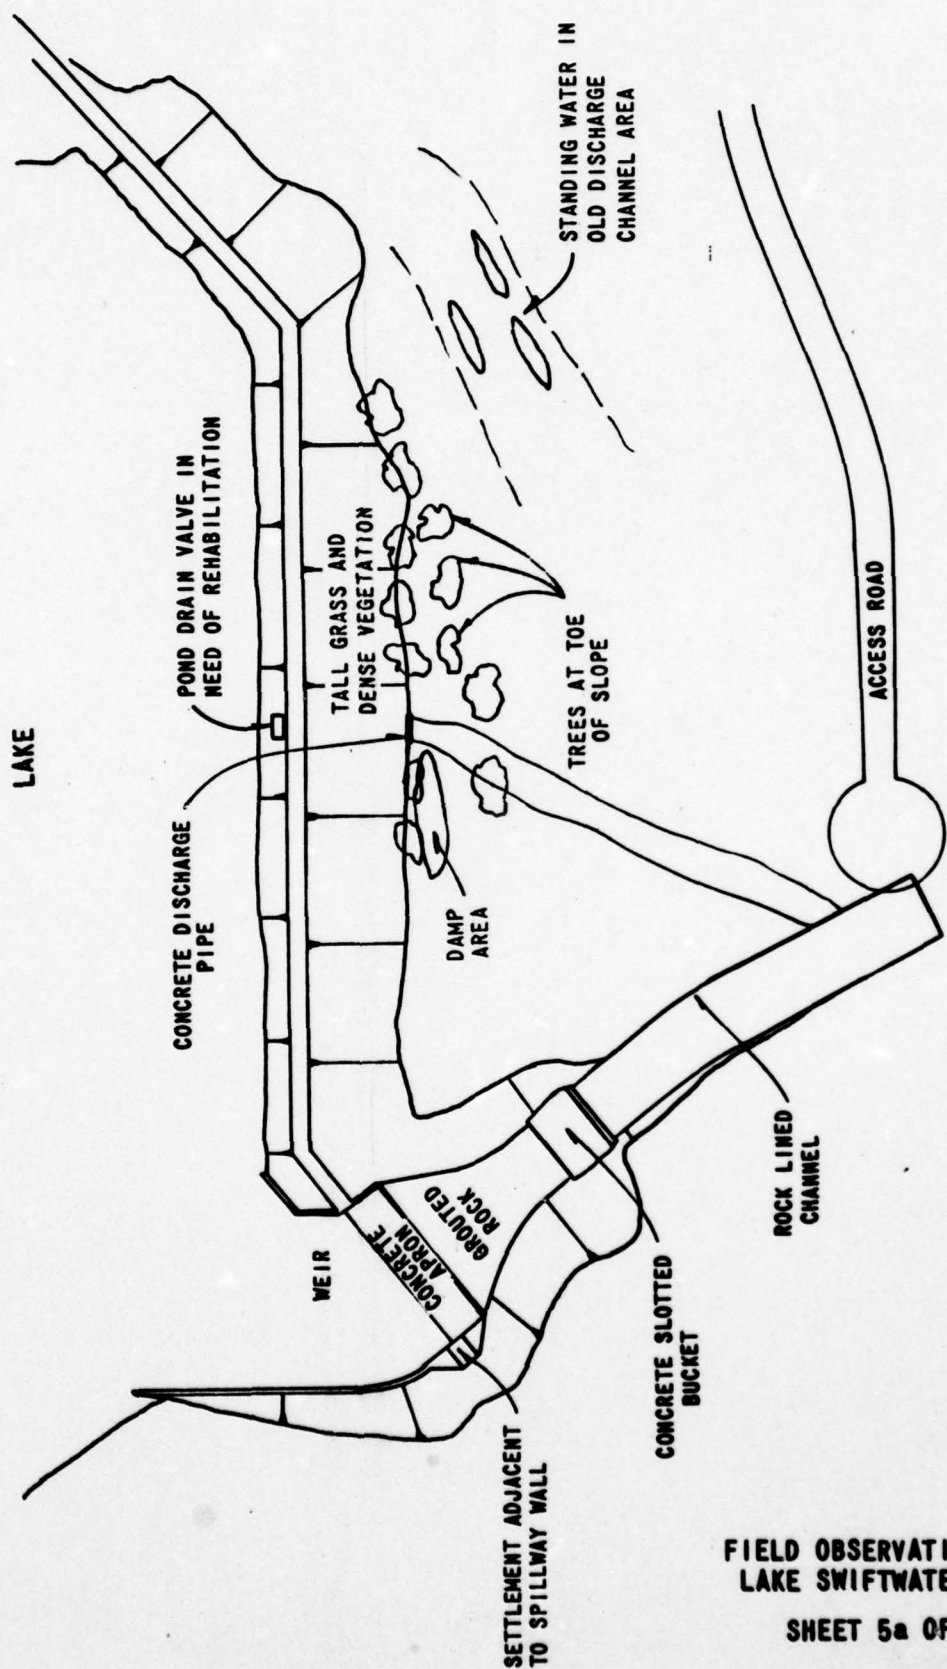
FIELD OBSERVATION PLAN  
 LAKE SWIFTWATER DAM  
 SHEET 5a OF 11

b. Dam. During the visual inspection, there were no indications of distortion in alignment or grade that would be indicative of movement of the embankment or foundation. Inspection of the downstream slope and adjacent downstream areas disclosed some marshy areas located along the old spillway channel, as shown on sheet 5a. A pool of stagnant water was also noted at the pond drain outlet, but there was no evidence observed of seepage into the pool from the edge of the pond or surrounding area. The upstream slope was inspected and found to be in reasonably good condition with extensive vegetation between the riprap. The location of the original spillway, which was replaced with an embankment, was clearly defined by a difference in vegetation. The junction between these two areas is assessed to be excellent. The upstream slope of the original embankment shows signs of undulation, which is not considered to be significant but rather expected for a structure of this age. The crest has a measured width of 10 feet, and a level profile along the crest showed the maximum difference in elevation was 14 inches. The low point is at the junction of the embankment and left abutment, as shown on Plate 5a, Appendix B.

Inspection of the dam disclosed no evidence of apparent past or present movement that would indicate existing instability of the structure. The seepage and standing water noted along the old spillway discharge channel appear to be stable and apparently have been stable for many years. The observed seepage was clear with no signs of piping. The spillway is in fair condition with some spalling, which should be monitored yearly and after each severe storm and repaired as necessary. The pond drain gate is considered to be in poor condition and should be rehabilitated. The low point on the dam is shown on sheet 5a, Appendix B, which is the first point of overtopping.
