MINSI DAM

PHASE I INSPECTION REPORT NATIONAL DAM INSPECTION PROGRAM

JUNE 1979

6 National Dam Inspection Program. Minsi Dam (NDS ID PA 00788 DER ID 48-139), Delaware River Basin, East Branch Martin's Creek, Northampton, County, Pennsylvania. Phase I Inspection Report.

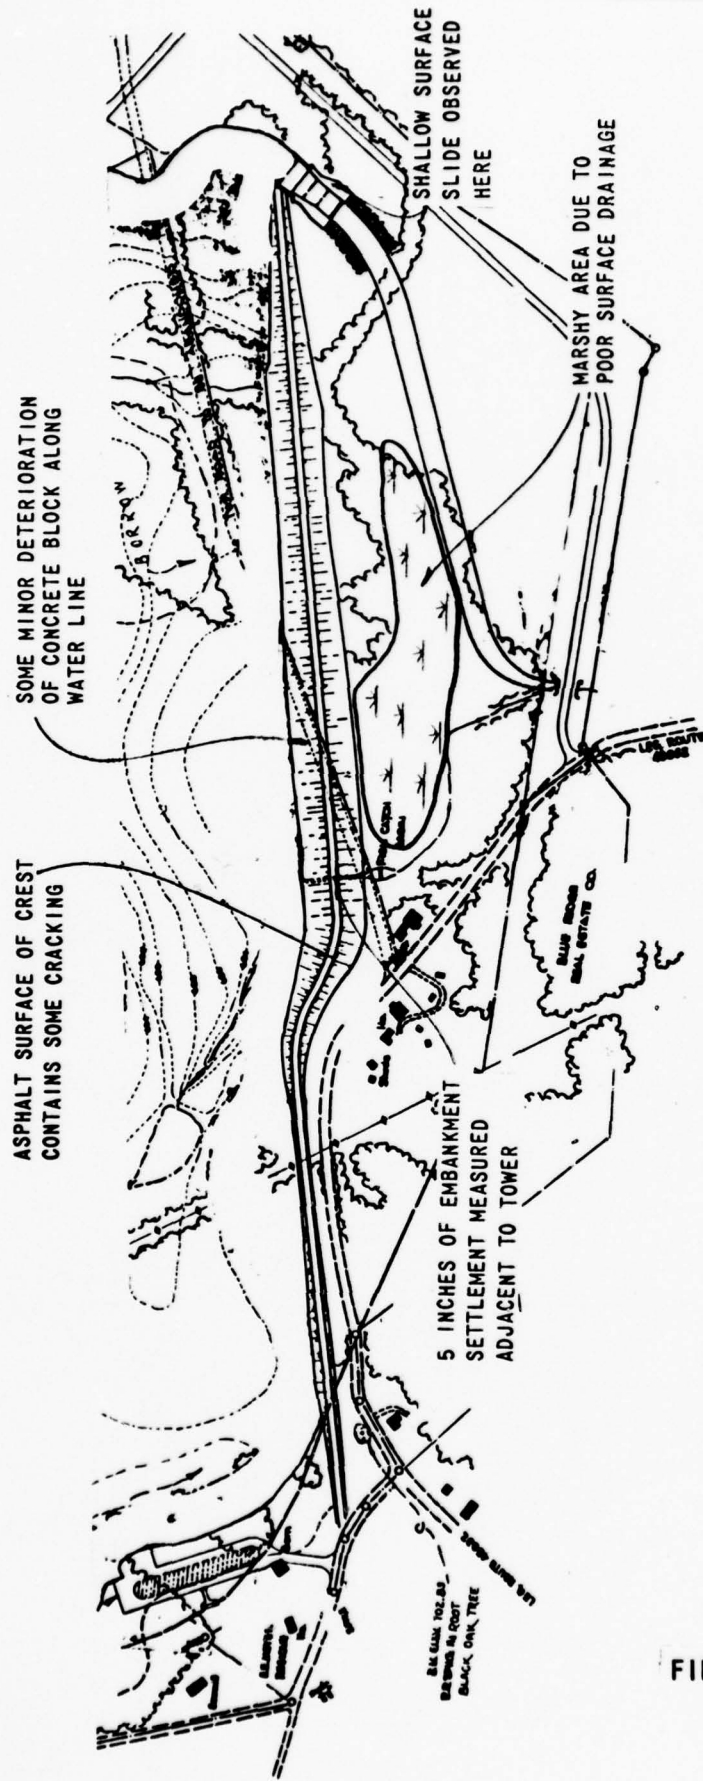
SHEET 5A OF 11

In summary, visual inspection of the structure disclosed no evidence of apparent past or present movement of the dam or its appurtenant facilities. Seepage or wet areas noted along the downstream toe, as shown on sheet 5a, were traced and assessed to be from natural drainage toward the toe of the dam, possibly from natural springs which are common to this swampy area.

FIELD OBSERVATION PLAN
MINSI DAM

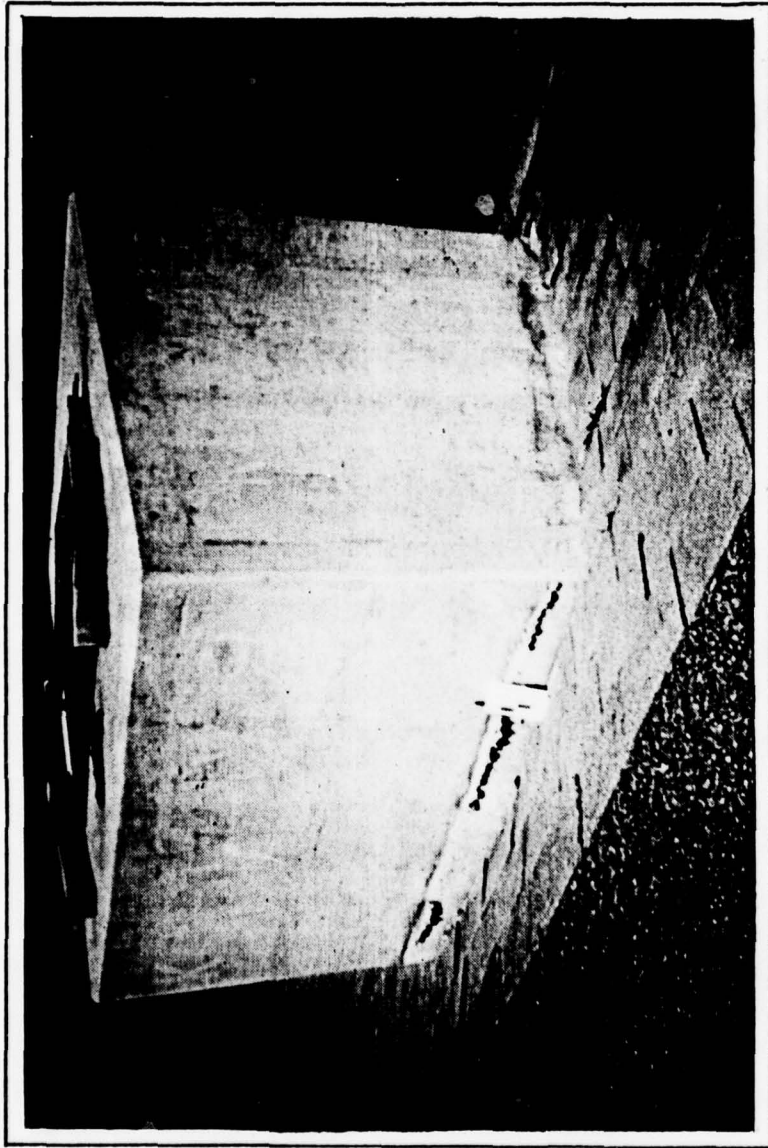
PHOTOGRAPH NO. 1

OVERVIEW OF PRINCIPAL SPILLWAY
INLET STRUCTURE.

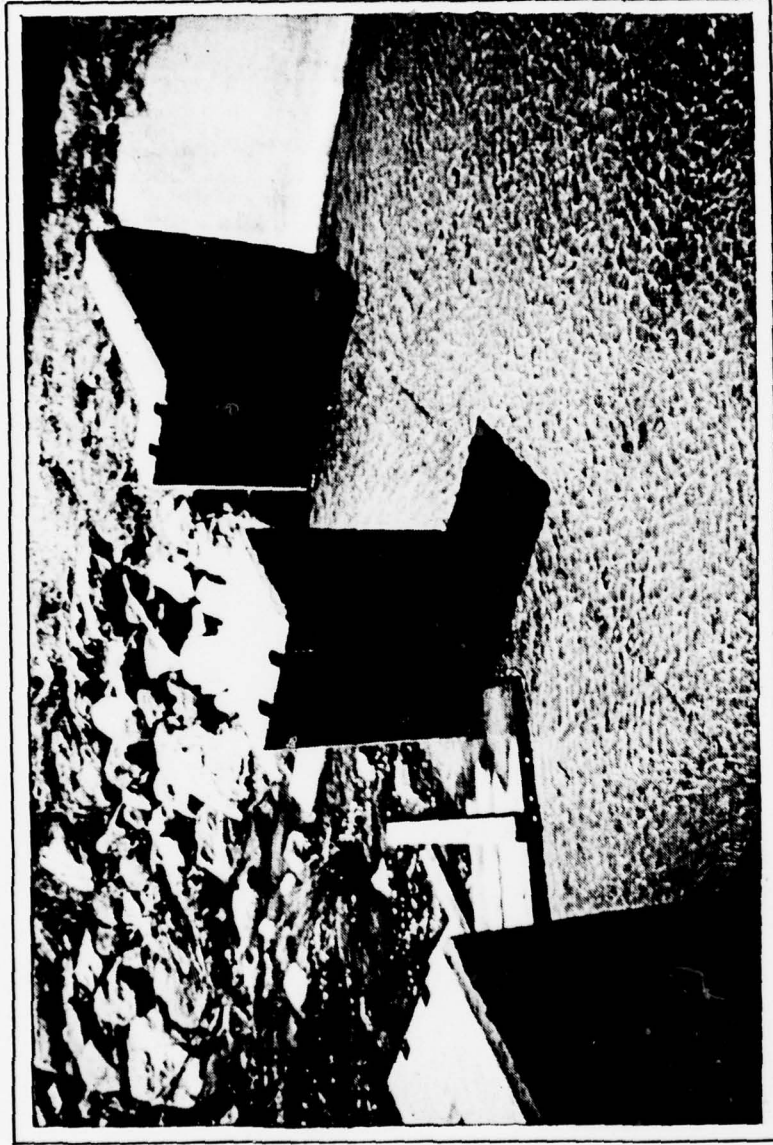
PHOTOGRAPH NO. 3

STILLING BASIN OF PRINCIPAL SPILLWAY.
NOTE TRACKS IN STRUCTURE FOR
FLASHBOARDS FOR INSTALLATION AS
FISH CATCH BASIN.

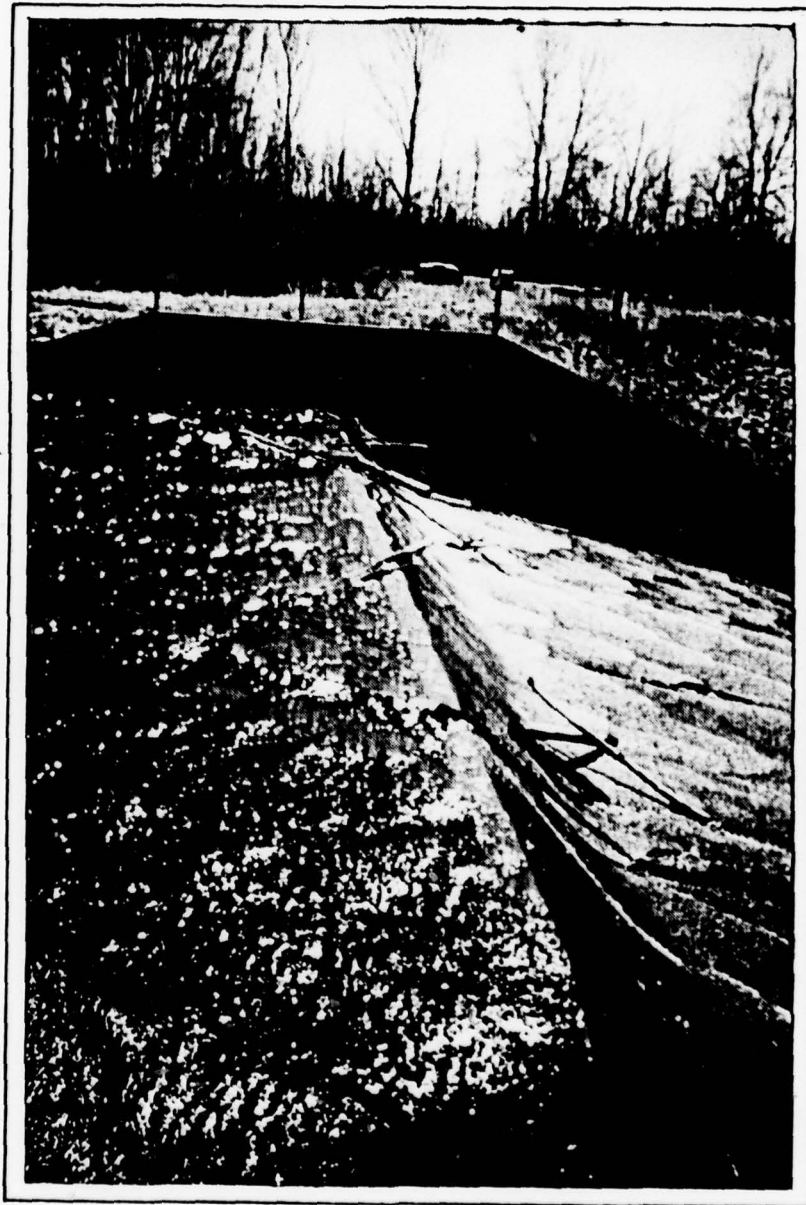
PHOTOGRAPH NO. 5

OVERVIEW OF EMERGENCY SPILLWAY
LOOKING TOWARDS THE LEFT
ABUTMENT.

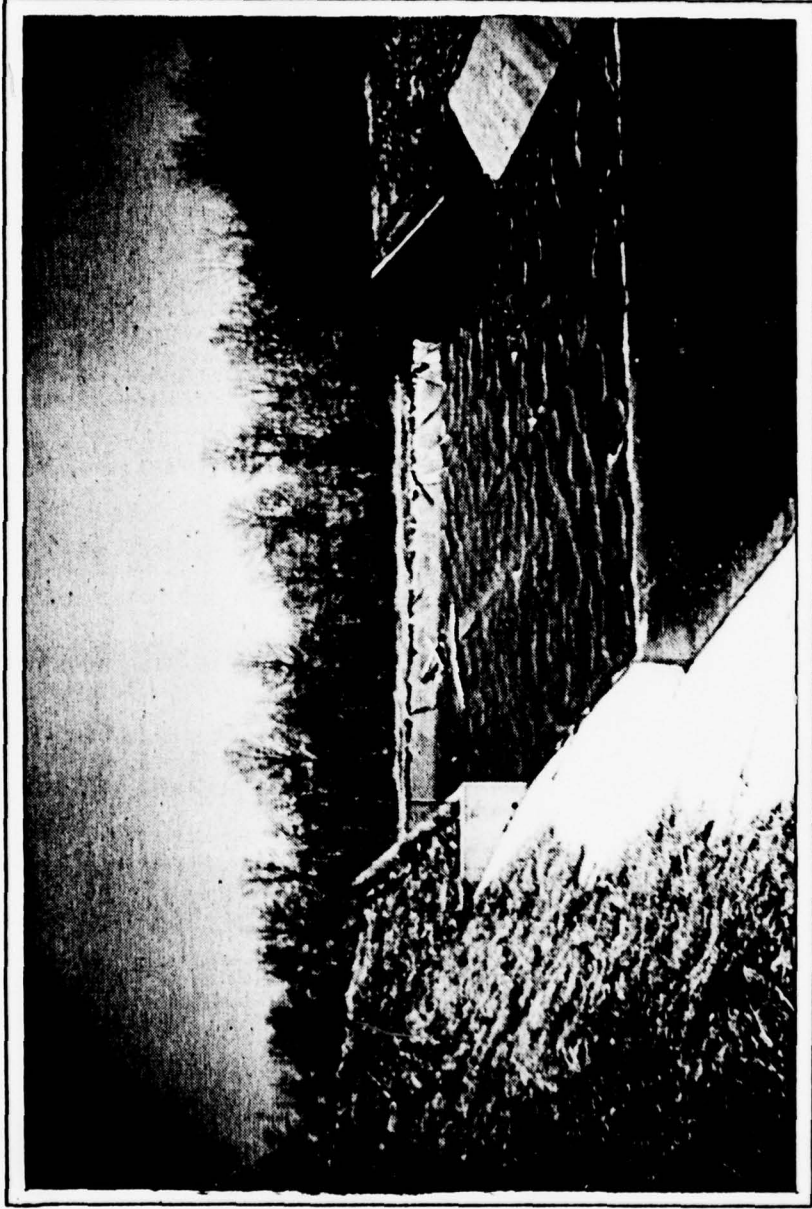
PHOTOGRAPH NO. 6

EMERGENCY SPILLWAY LOOKING UPSTREAM.

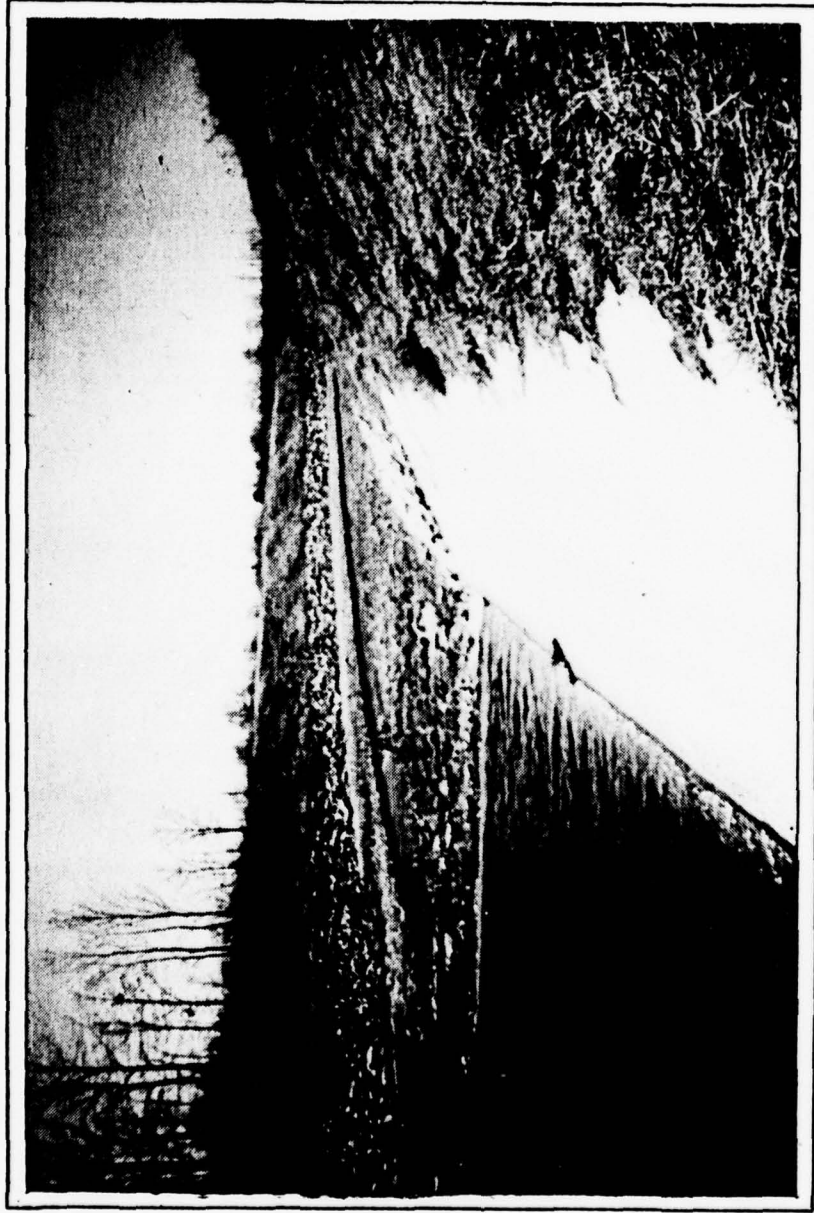
PHOTOGRAPH NO. 7

OVERVIEW OF EMERGENCY SPILLWAY
DISCHARGE CHANNEL.

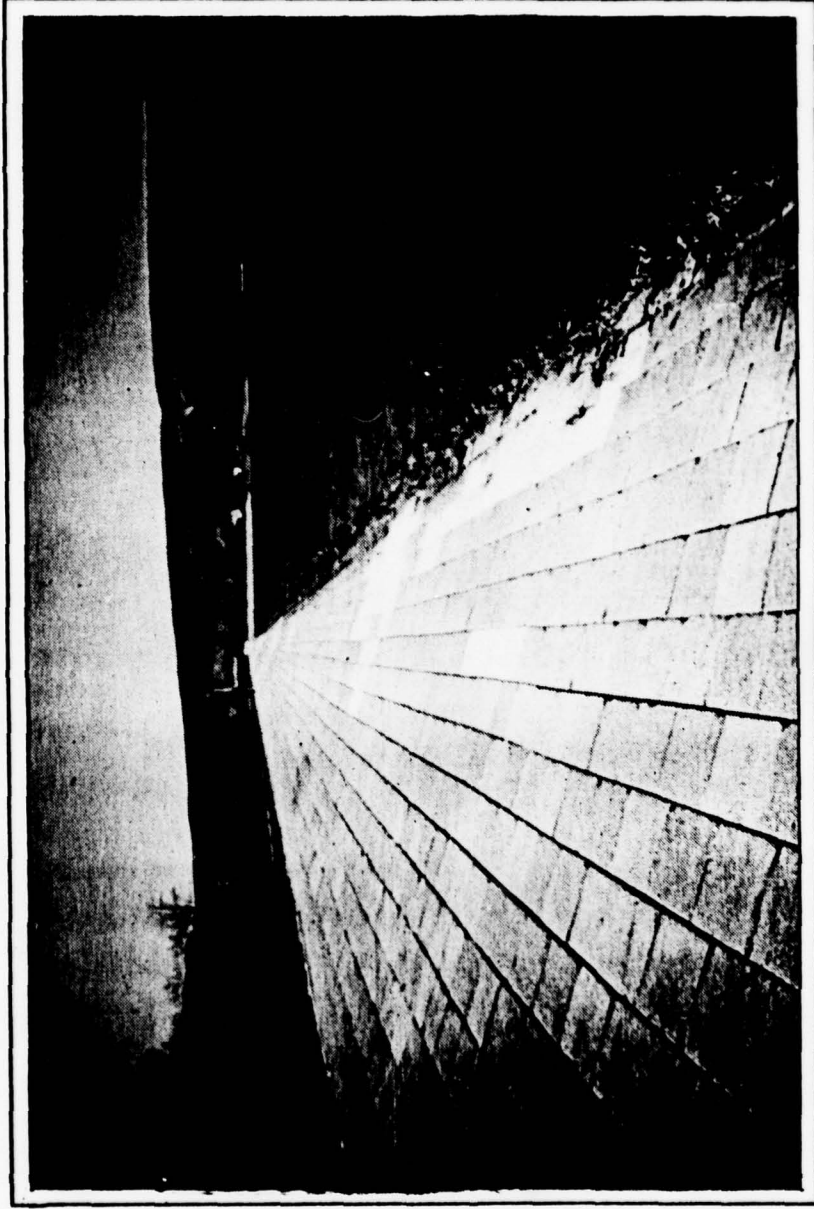
PHOTOGRAPH NO. 8

TYPICAL VIEW OF UPSTREAM SLOPE
PROTECTED WITH CONCRETE BLOCKS.

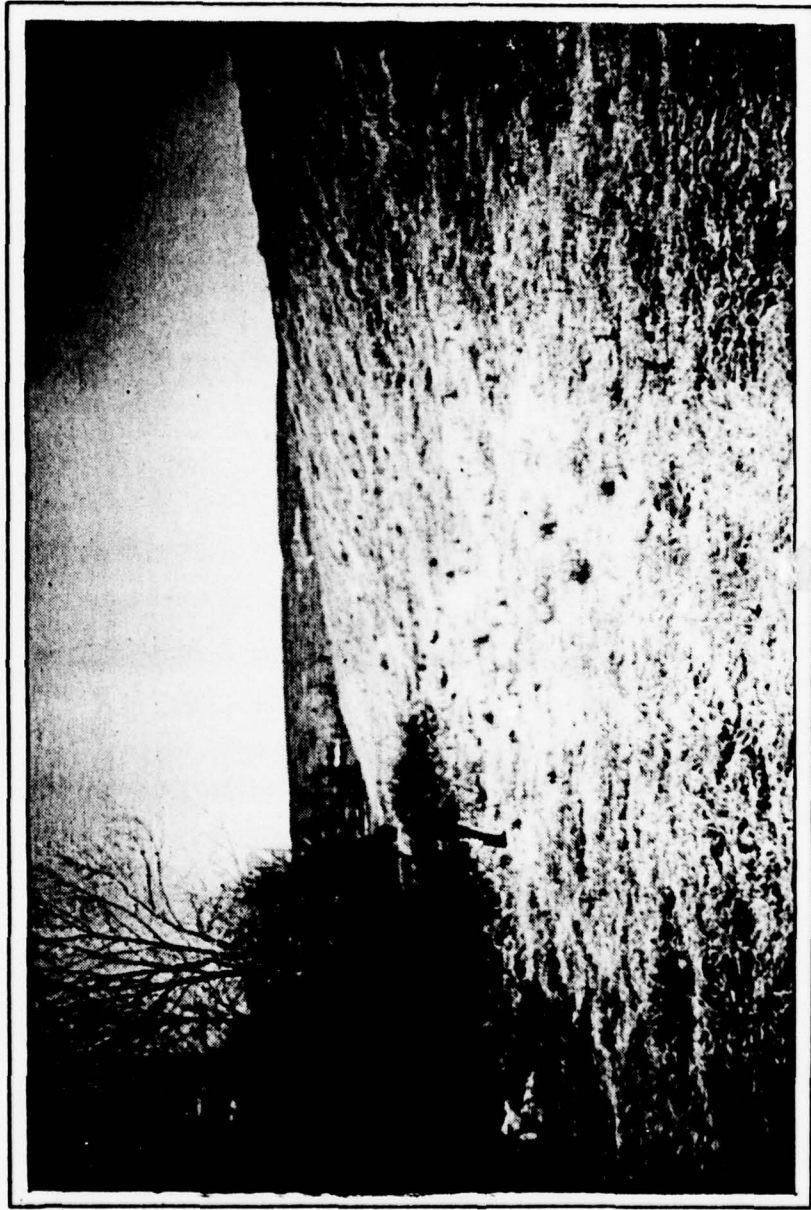
PHOTOGRAPH NO. 9

TYPICAL VIEW OF DOWNSTREAM SLOPE.

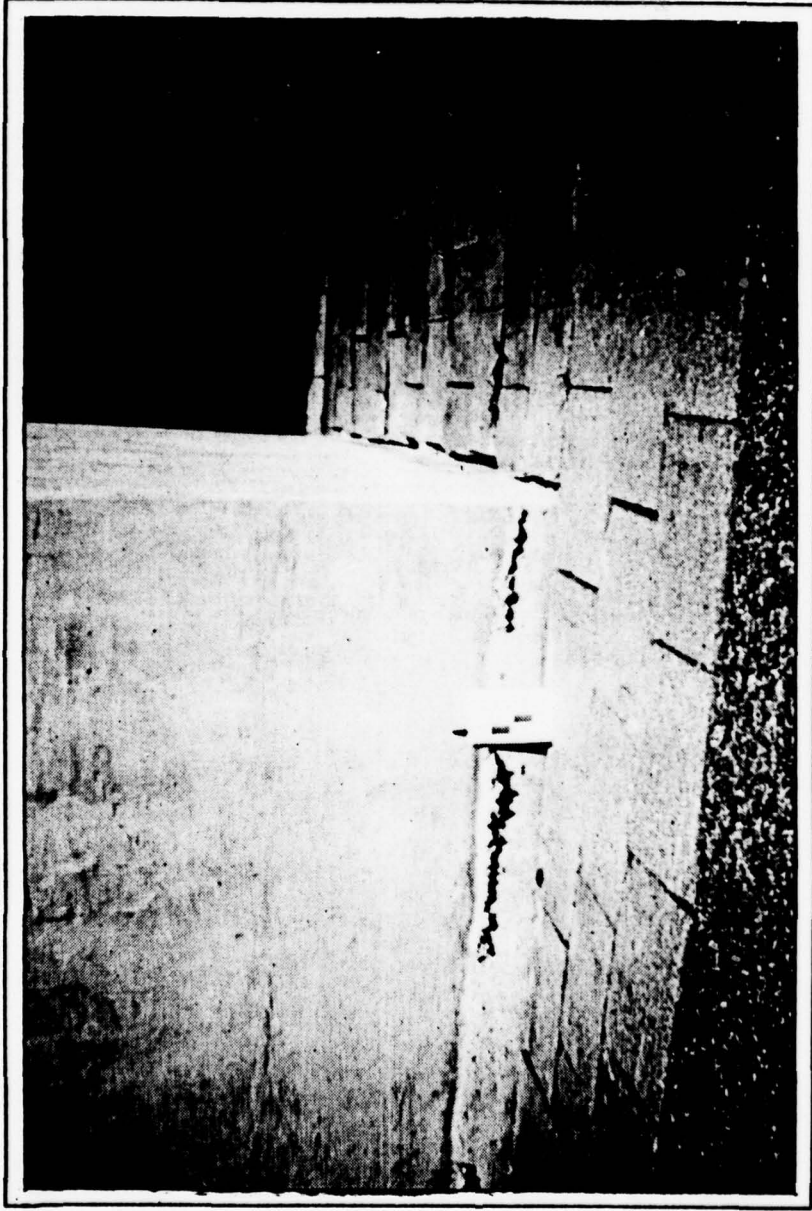
PHOTOGRAPH NO. 10

a. Visual Observations. Field inspection disclosed no evidence of potential instability of the embankment or its components. Embankment slopes are reasonably uniform with no signs of displacement or sloughing. Settlement of the embankment on the order of five inches was noted adjacent to the control tower. Considering the compaction problems noted and discussed in Section 3, this settlement could be expected.

SETTLEMENT AROUND THE PRINCIPAL
SPILLWAY INLET TOWER. SETTLEMENT
AVERAGED ABOUT FIVE INCHES.

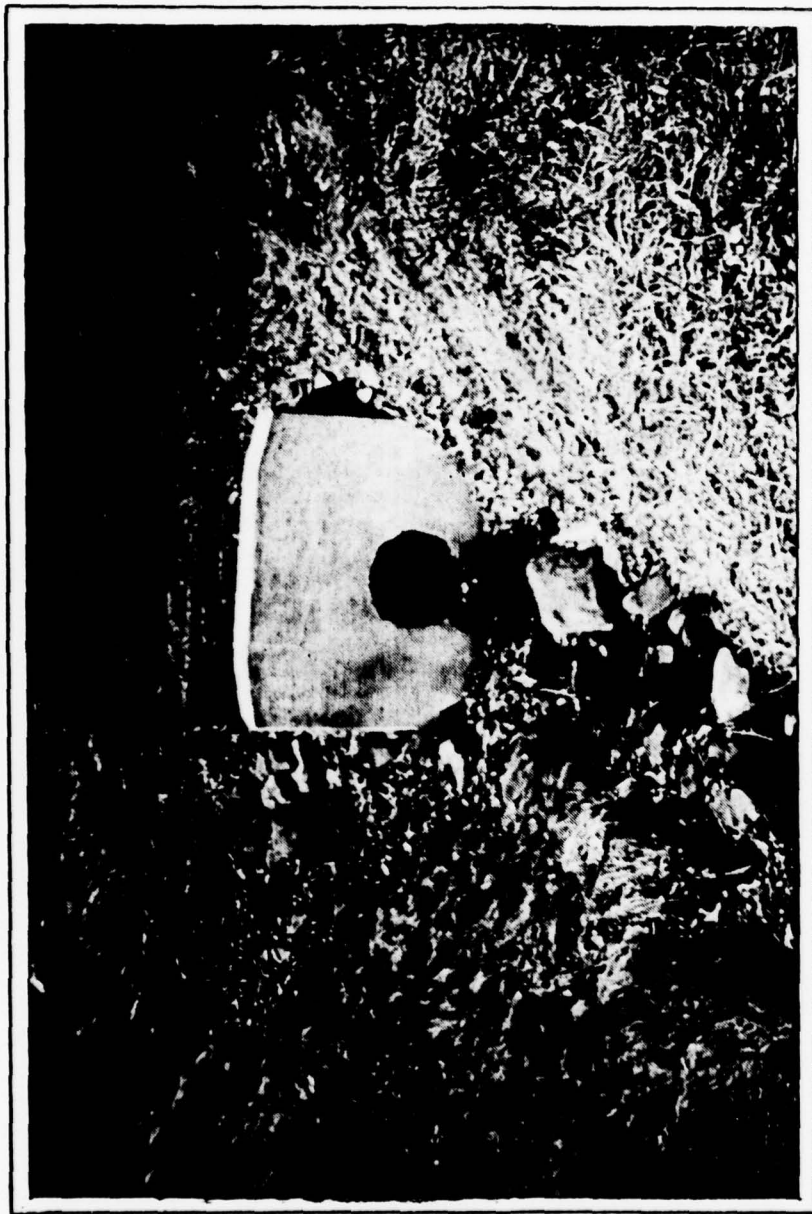
PHOTOGRAPH NO. 13

DRAINAGE CULVERT ALONG DOWNSTREAM
TOE OF DAM ADJACENT TO ROADWAY.
THE EMBANKMENT IS ON THE RIGHT AND
THE ROAD ON THE LEFT.

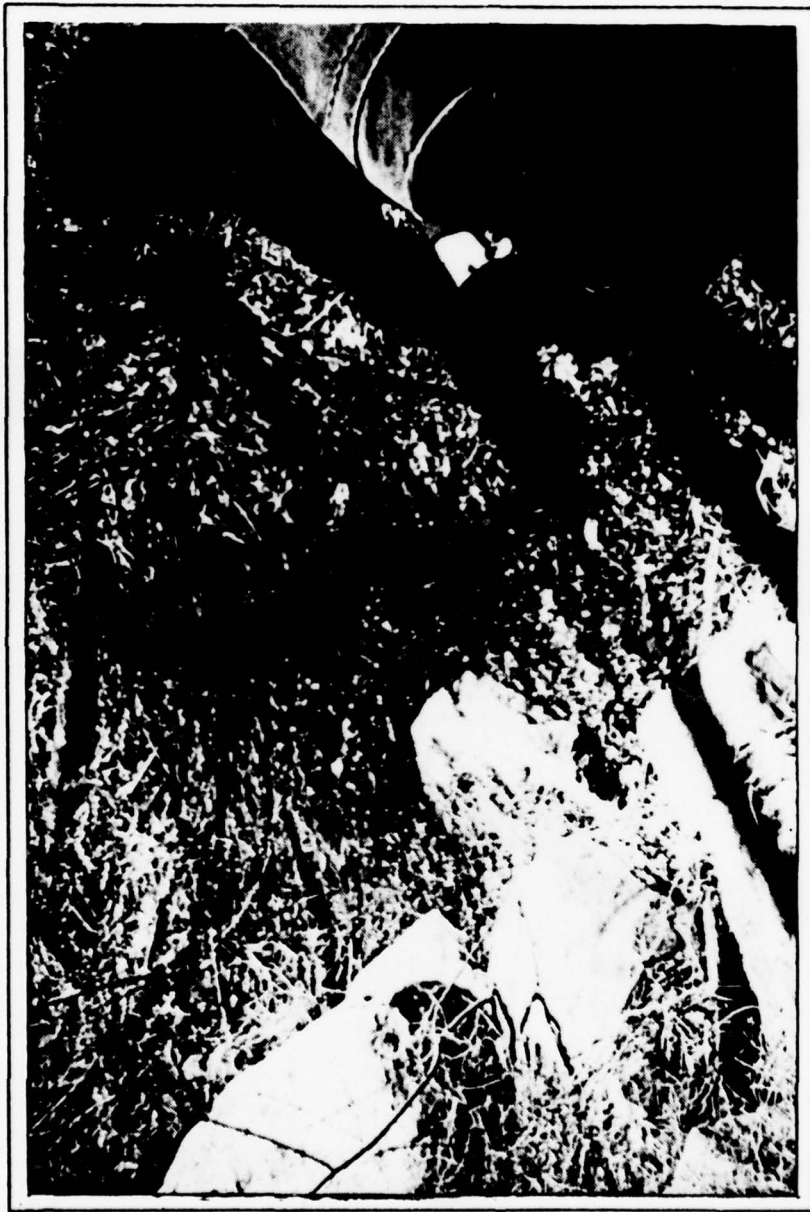
PHOTOGRAPH NO. 14

There was no exterior evidence indicating abnormal seepage through the embankment. Wet zones at the downstream toe were traced to topographic conditions where surface runoff drains towards the toe of the dam.

None observed. The marshy areas with standing water just beyond the downstream is attributed to poor drainage and the natural topography. There was no evidence found of seepage through the dam.

STAGNANT WATER ALONG THE TOE OF
DAM CAUSED BY POOR SURFACE DRAINAGE
AWAY FROM STRUCTURE.

1. The marshy area at the toe of the structure should be regraded and drained away from the dam. Subsequently, seepage should be monitored to determine whether it flows through the embankment. Should it be determined that seepage flows through the embankment, appropriate remedial measures should be taken to control this flow.
2. Concrete block on the upstream slopes should continue to be monitored, especially during the spring of each year. Deteriorated block should be removed and replaced with new block.

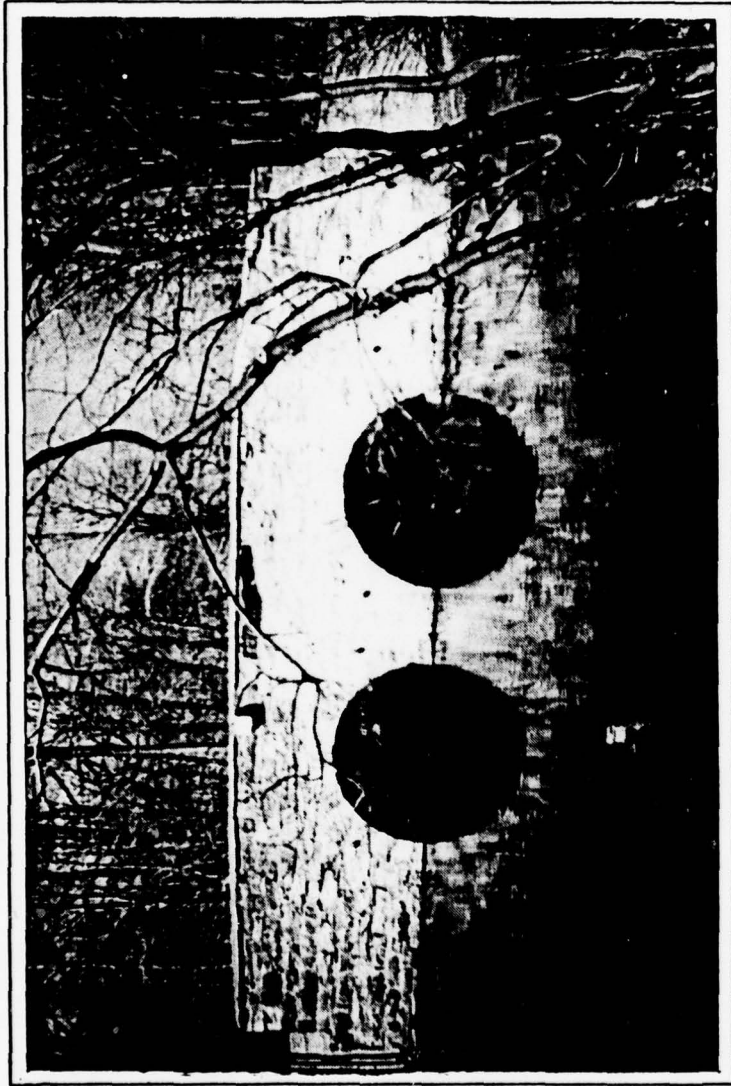
PHOTOGRAPH NO. 15

VIEW OF DOWNSTREAM BRIDGE.
