6 National Dam Inspection Program. Saw Mill Dam (NDS ID PA 00324; DER ID 46-261), Delaware River Basin, Saw Mill Creek, Montgomery County, Pennsylvania. Phase I Inspection Report.

SAW MILL DAM, MONTGOMERY COUNTY PENNSYLVANIA

NDS I.D. NO. PA 00324
DER I.D. NO. 46-261

PHASE I INSPECTION REPORT
NATIONAL DAM INSPECTION PROGRAM

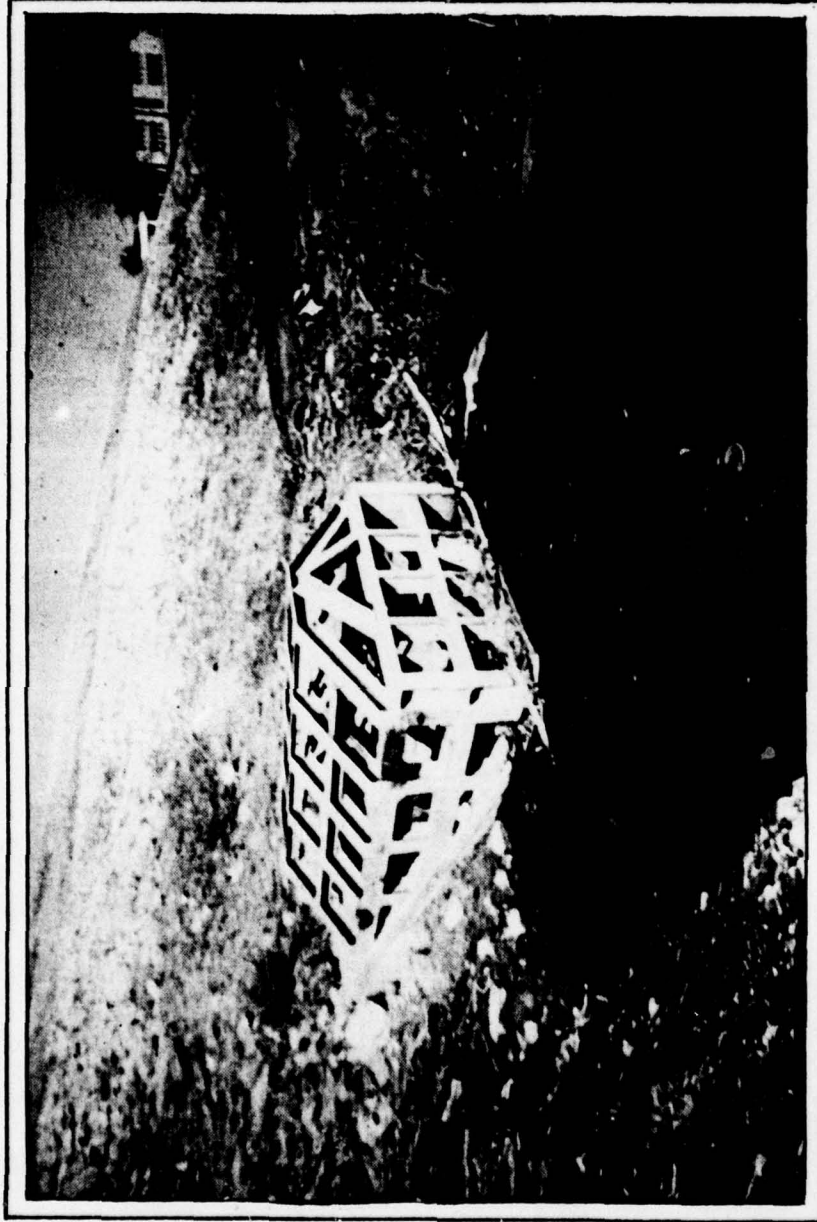
PHOTOGRAPH NO. 1

c. Visual Observations. On the date of inspection, the only condition observed indicating a reduction in principal spillway capacity was the accumulation of debris in the trash rack. Observations regarding the condition of the downstream channel, spillway and reservoir are located in Section 3 and Appendix B.

The structure appears to be in good condition with no spalling or cracking of concrete observed. The trash racks were partially clogged and it is reported that maintenance crews must clean these racks several times a year. Silt and miscellaneous debris are also deposited in the approach channel.

VIEW OF GATED PRINCIPAL INTAKE
STRUCTURE SHOWING TRASH RACK.
NOTE TRASH ACCUMULATIONS.
