# POLE RUN DAM NO. 4

## PHASE I INSPECTION REPORT NATIONAL DAM INSPECTION PROGRAM

NDS I.D. NO. PA 00686  
DER I.D. NO. 54-36

WOODWARD-CLYDE CONSULTANTS  
5120 Butler Pike  
Plymouth Meeting, Pennsylvania 19462

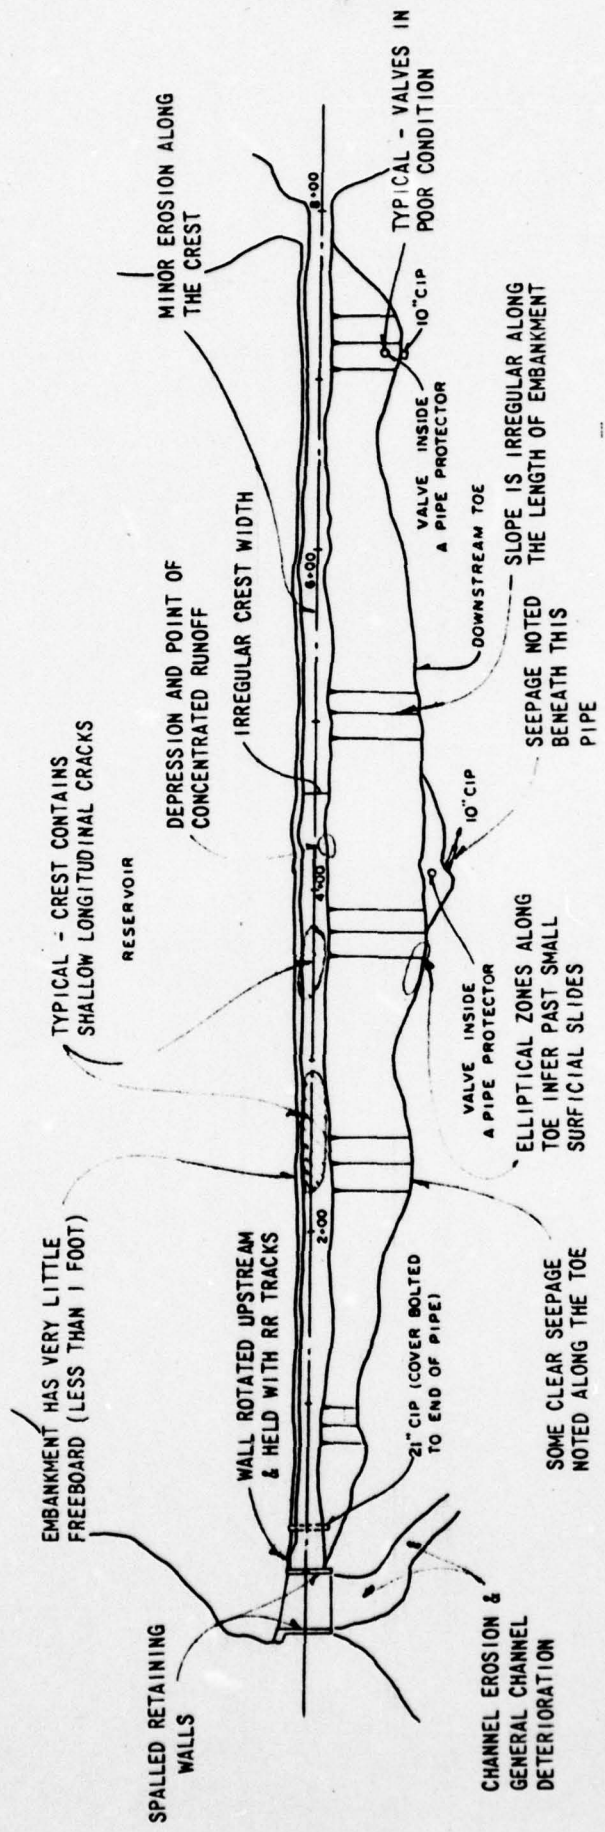
FIELD OBSERVATION PLAN  
 POLE RUN DAM NO. 4  
 SHEET 5A OF 11

There were no riprap failures observed and junctions between the embankment and abutments are in reasonably good condition. Clear seepage was noted along the downstream toe and beneath the main discharge pipe at the low section of the embankment, as shown on sheet 5a.

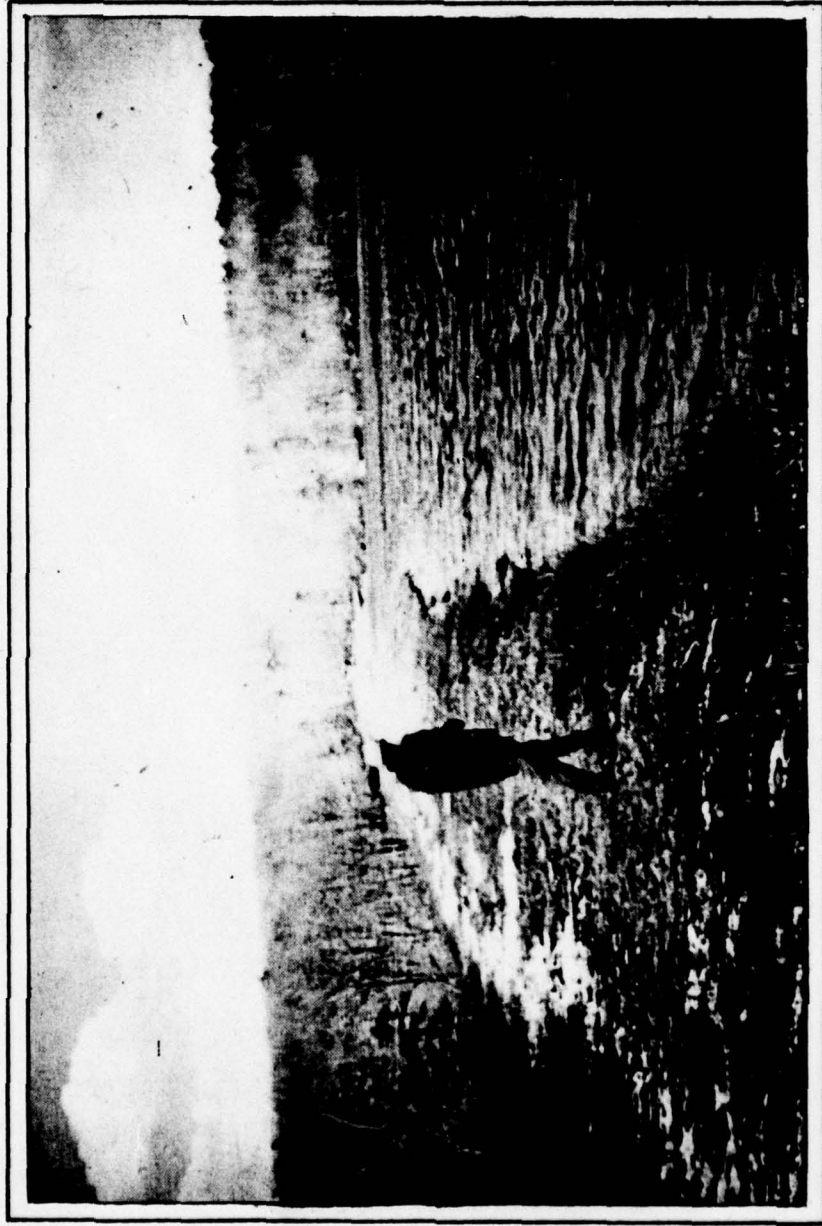
PHOTOGRAPH NO. 5

TYPICAL VIEW OF UPSTREAM SLOPE LOOKING  
FROM THE LEFT END OF THE DAM.

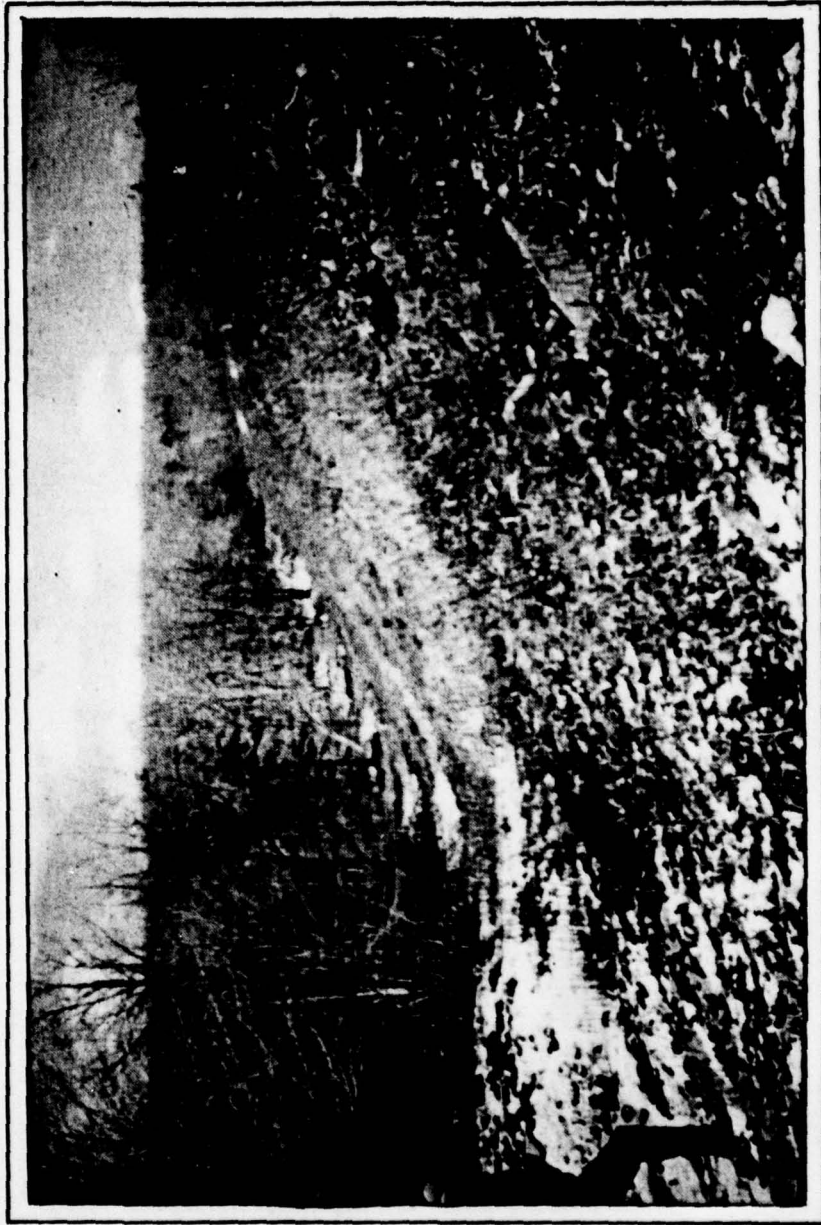
PHOTOGRAPH NO. 6

TYPICAL VIEW OF DOWNSTREAM SLOPE.
