PENNSYLVANIA
NDS ID PA. 00682
DER ID 54-12

PARK PLACE DAM NO. 3

PHASE I INSPECTION REPORT
NATIONAL DAM INSPECTION PROGRAM

11 MAY 1979

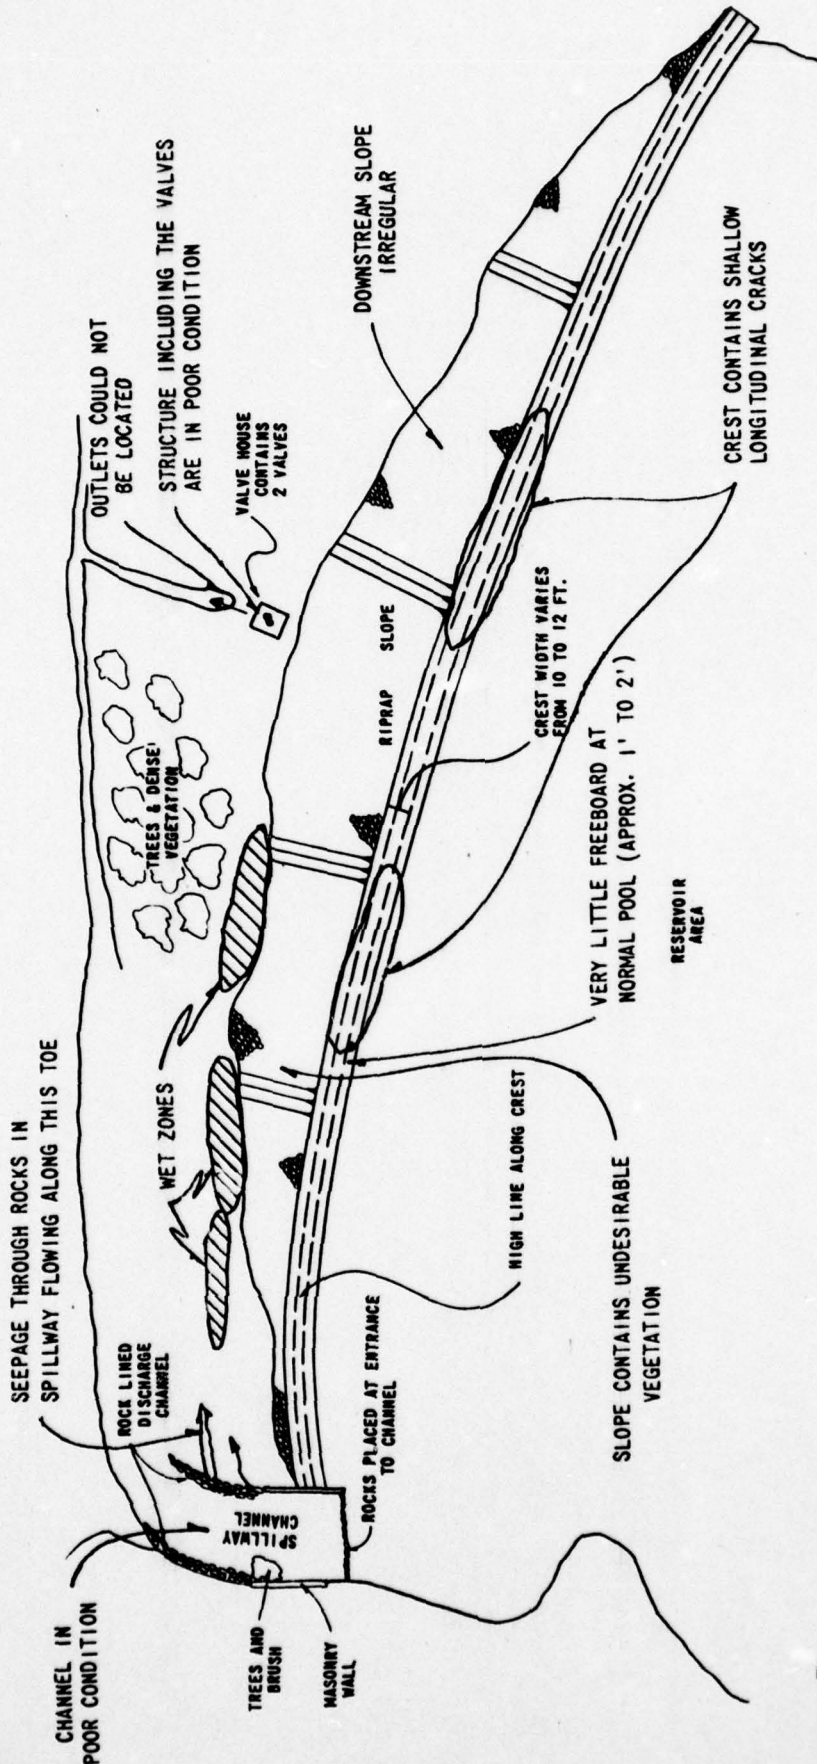
FIELD OBSERVATION PLAN
 PARK PLACE DAM NO. 3
 SHEET 5A OF 11

Some longitudinal cracking was noted along the downstream and upstream sides of the crest, as shown on Sheet 5a. These cracks do not appear to be deep and may be associated with freeze-thaw cycles. See photographs 9 and 10.

As shown on Sheet 5a, water was located at several places along the downstream toe on the left side of the valve house. The water appears to be coming from the spillway, where leakage occurs through the rocky, poorly defined downstream channel, passing along the toe of the dam. There was no direct evidence of seepage noted through the embankment. However, seepage should not be discounted, as inspection reports dating back as far as the 1930's noted seepage several hundred feet left of the valve house. The seepage noted during this 1979 inspection was traced upslope to the emergency spillway. There was no seepage observed on the right side of the valve house.

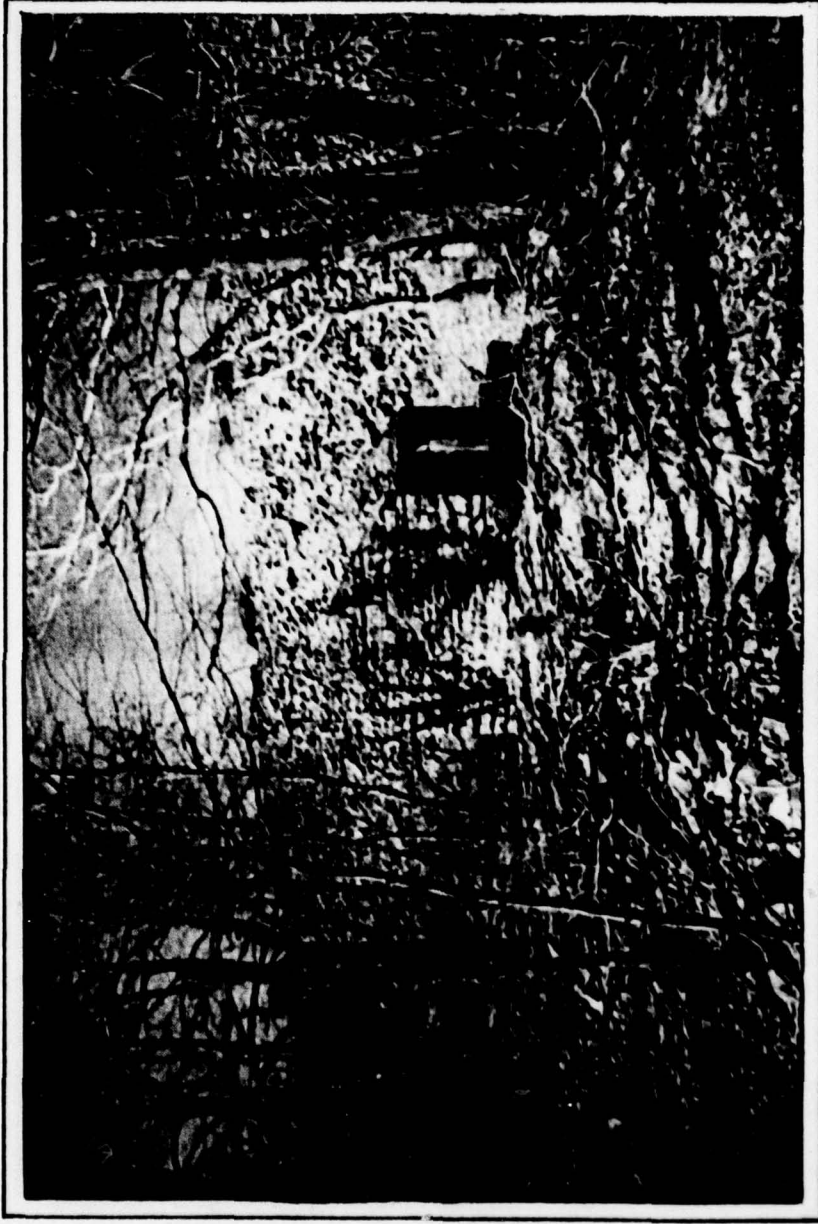
PHOTOGRAPH NO. 1

VALVE HOUSE AT DOWNSTREAM TOE OF
EMBANKMENT.

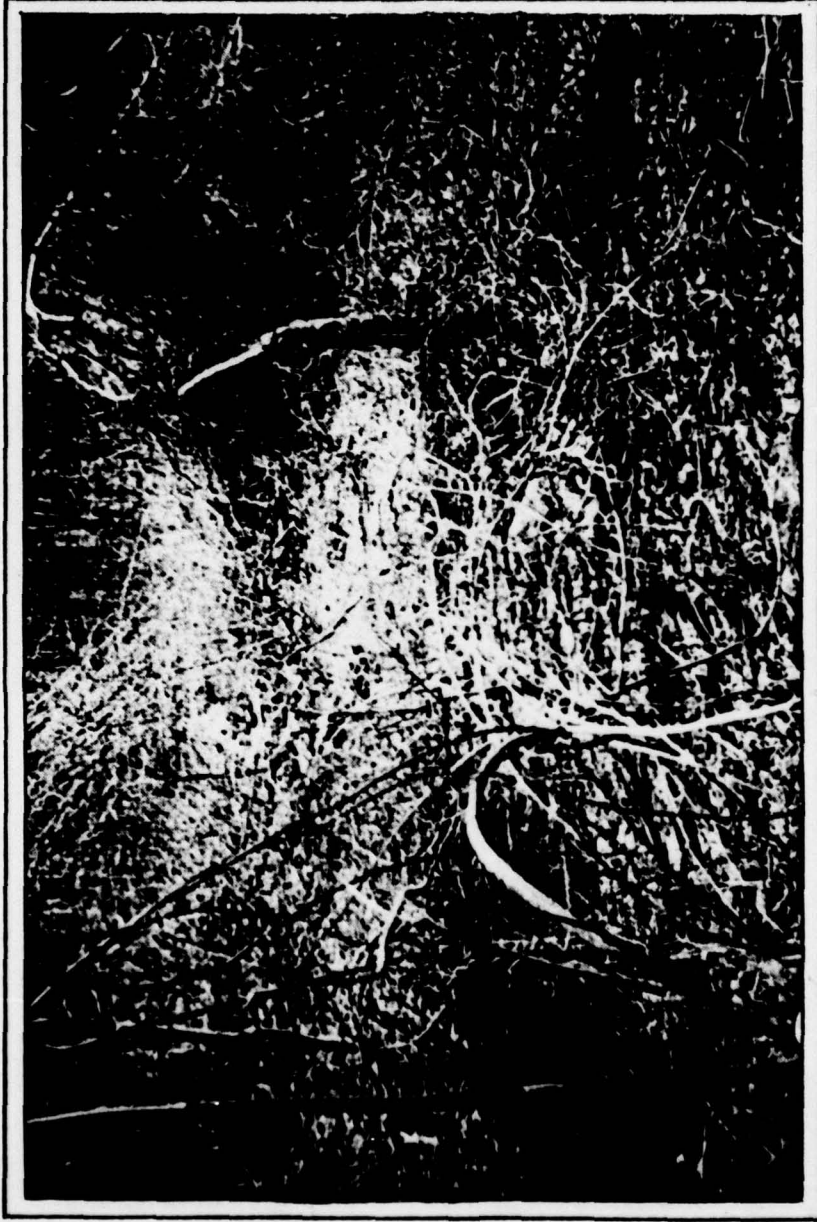
PHOTOGRAPH NO. 5

VIEW LOOKING DOWN CENTERLINE OF
SPILLWAY.

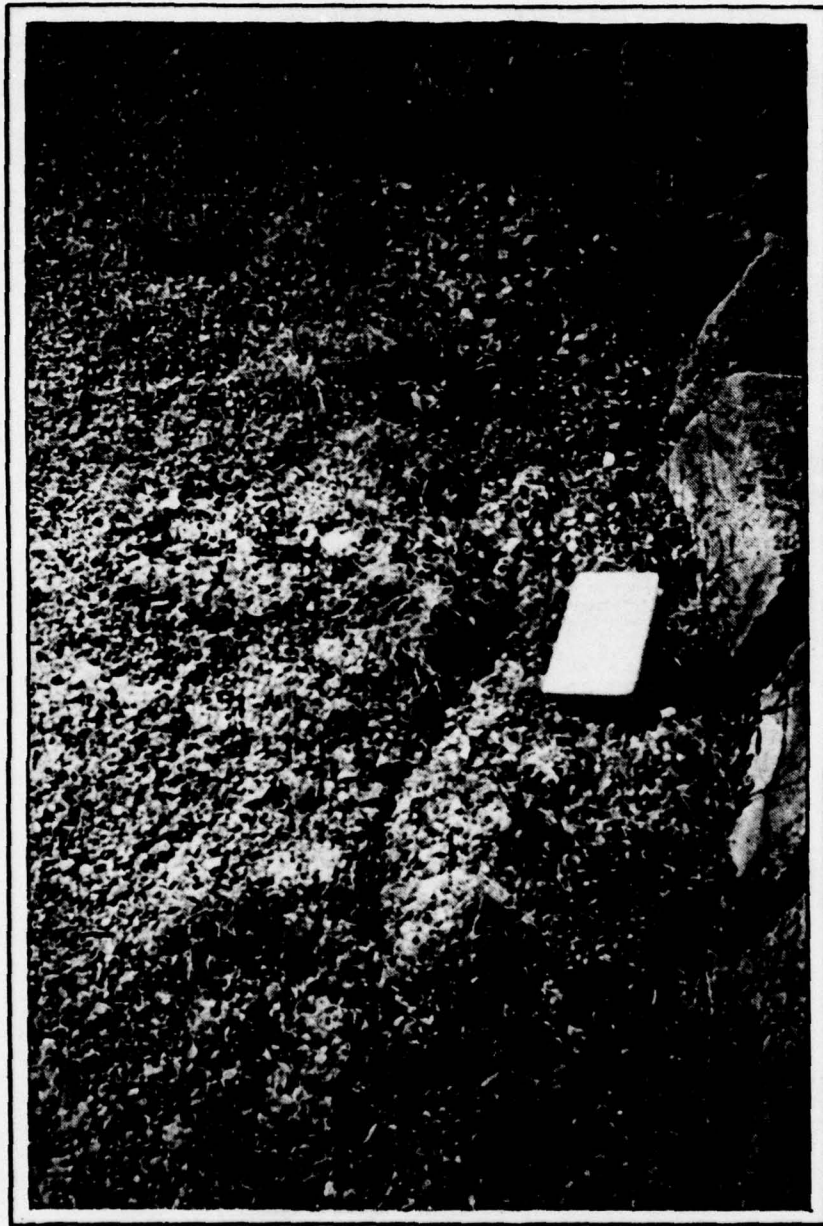
PHOTOGRAPH NO. 9

TYPICAL SURFICIAL LONGITUDINAL
CRACK ALONG CREST.
