**STEPHEN FOSTER DAM**

NDS ID NO. PA-906  
DER ID NO. 8-59

PHASE I INSPECTION REPORT  
NATIONAL DAM INSPECTION PROGRAM

JUNE, 1979

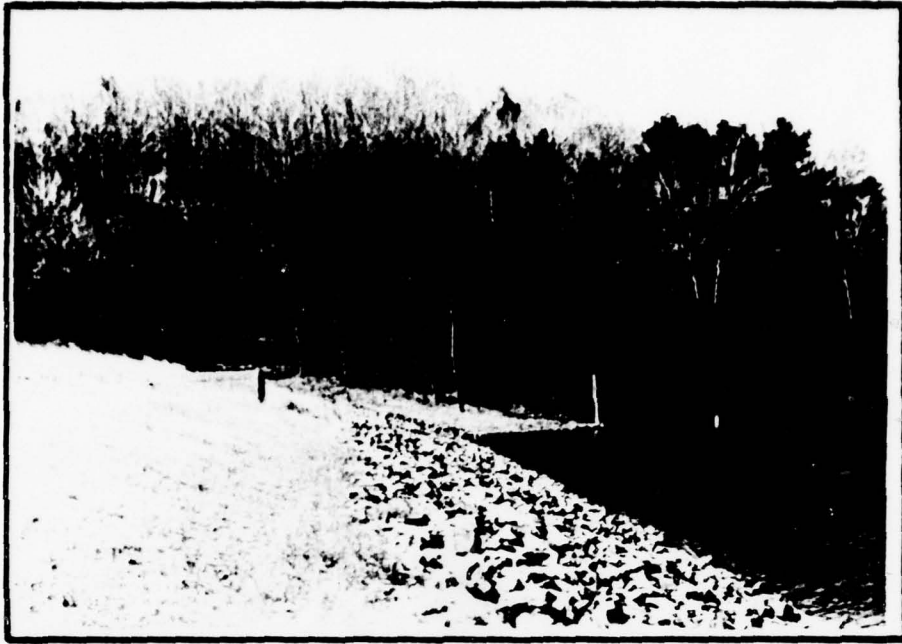
Upstream slope and drain control structure from left abutment.

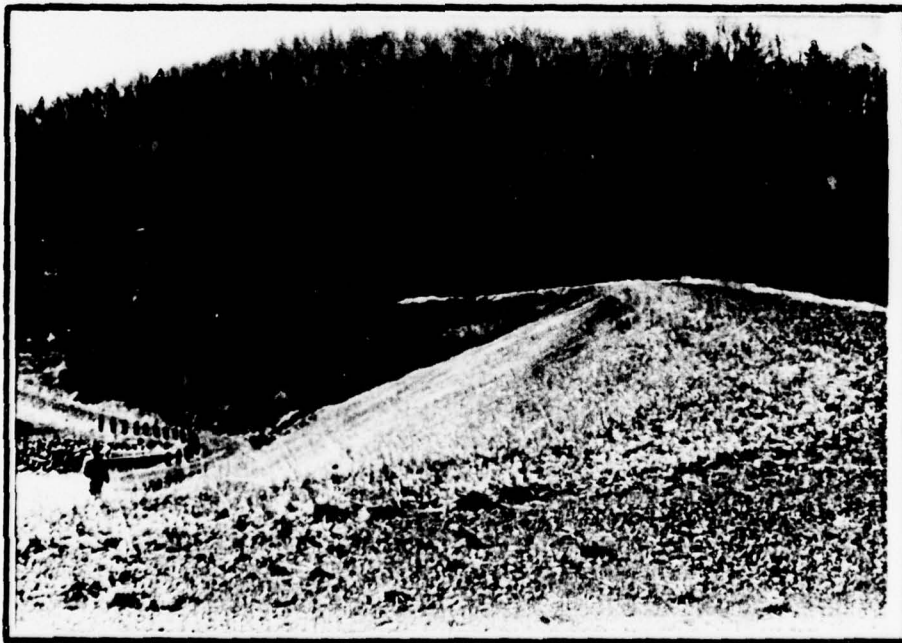
Downstream slope from spillway area.

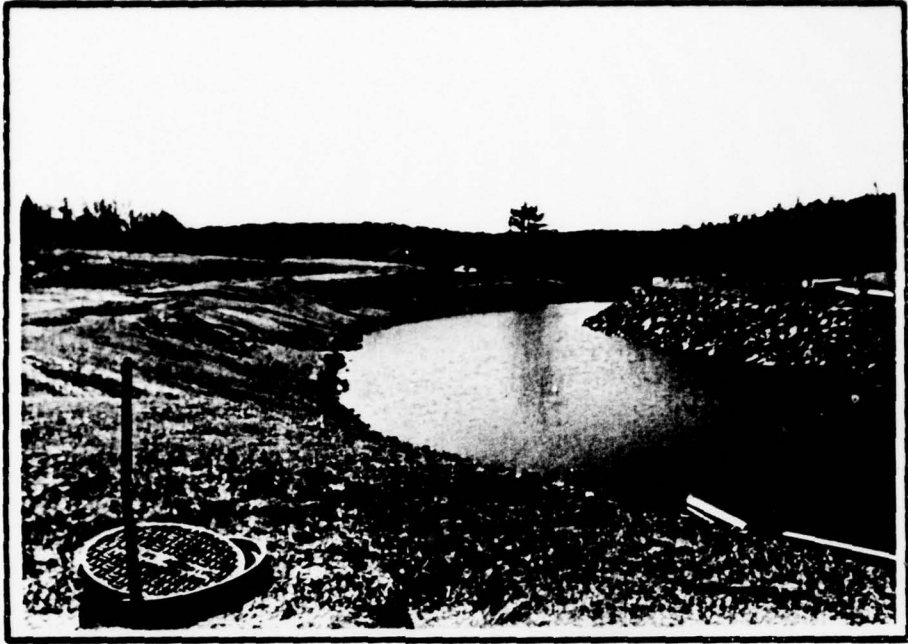
c. Visual Observations. The concrete in the spillway and spillway discharge channel is in good condition. The cut slope on the left spillway approach channel contains several active slides. These slides have approximately 1 to 3 feet vertical displacement and approximately 8 feet horizontal displacement. The slides are moving toward the spillway approach channel. A large slide in this area could partially block the spillway approach channel. Several slides have taken place to the left of the spillway discharge channel. The moving of this hillside has caused the left wingwall near the spillway weir to move and a joint has opened approximately 1.5 inches wide.

Spillway approach channel.  
Note: slides on left abutment.

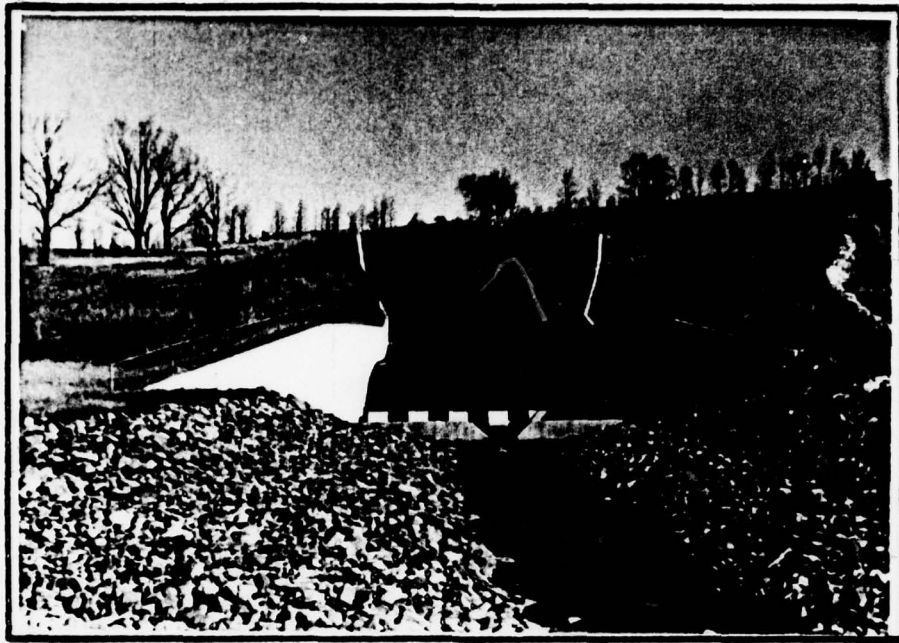
Spillway exit channel.

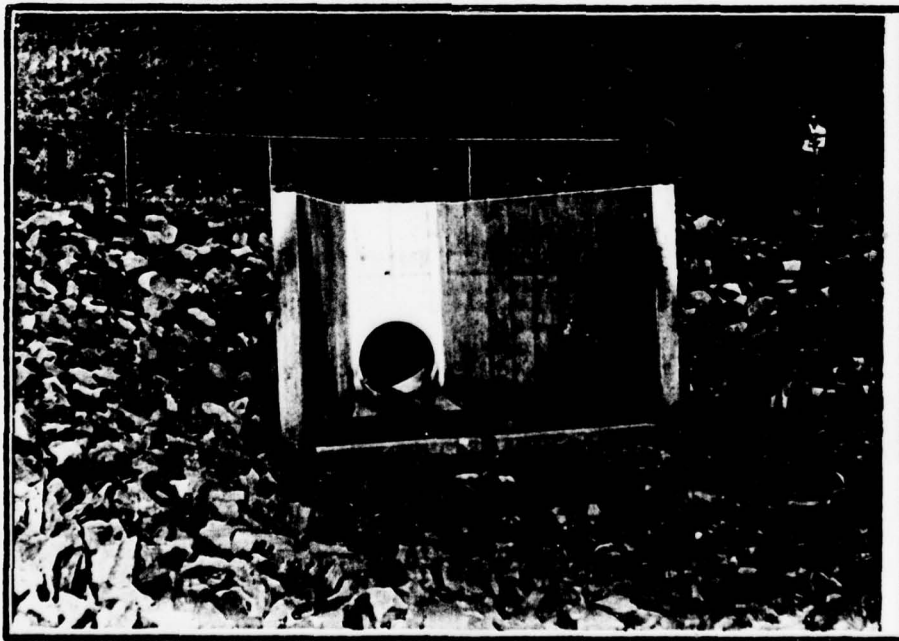
Endwall on reservoir drain.

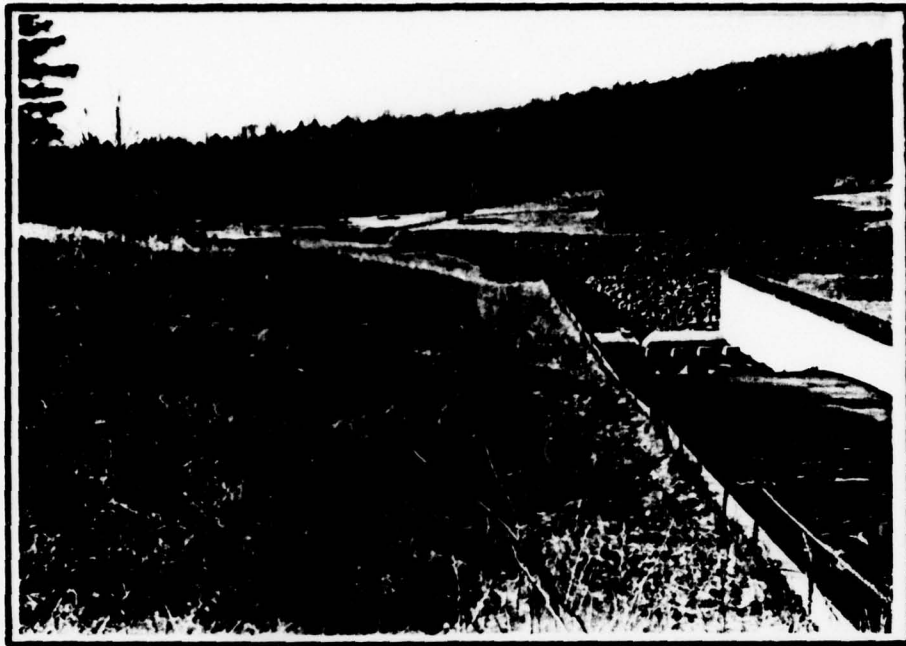
Immediate downstream view.  
Note: slides to left of spillway exit channel.

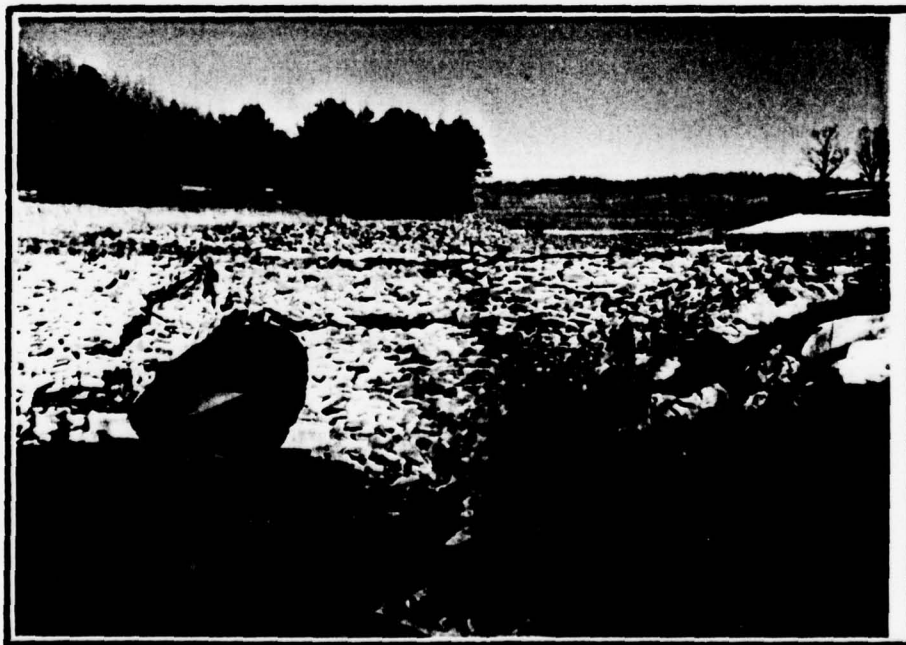
Damaged access road crossing.

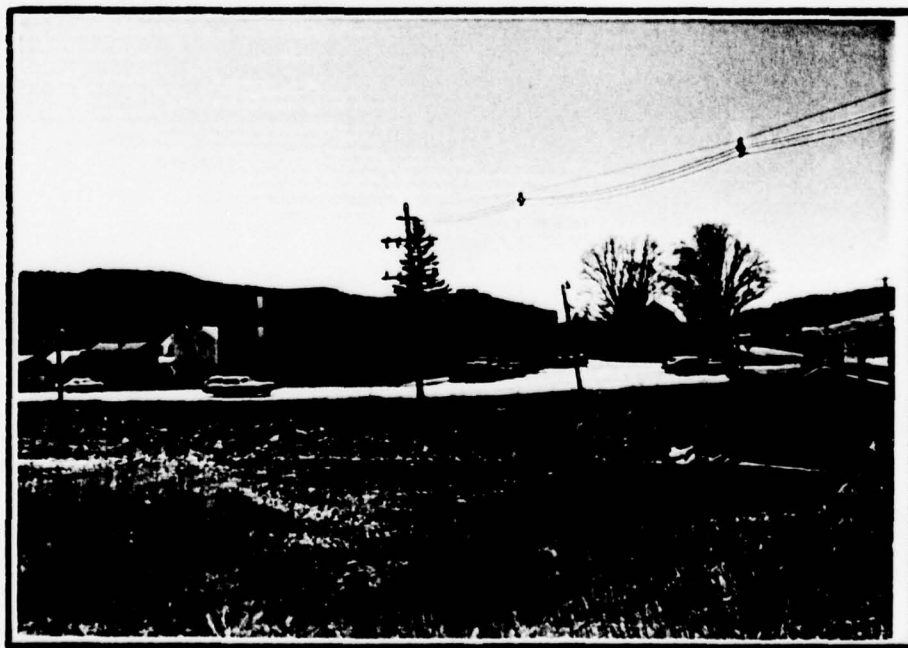
Homes and hospital downstream.
