HILLS CREEK DAM

NDS ID NO. PA-34

PHASE I INSPECTION REPORT
NATIONAL DAM INSPECTION PROGRAM

L. ROBERT KIMBALL & ASSOCIATES
CONSULTING ENGINEERS & ARCHITECTS
EBENSBURG, PENNSYLVANIA
15931

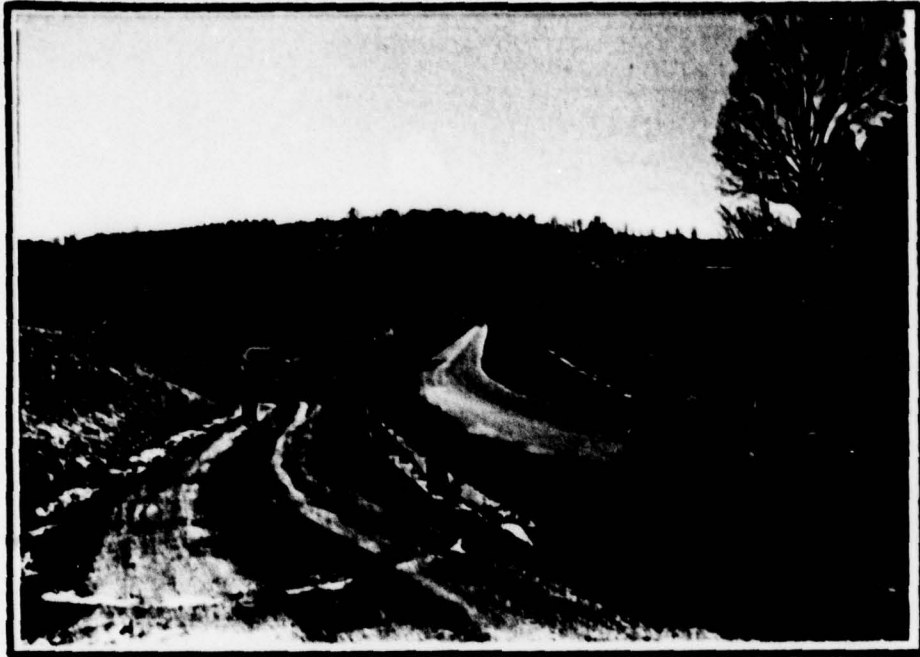
Overview of dam from left abutment.

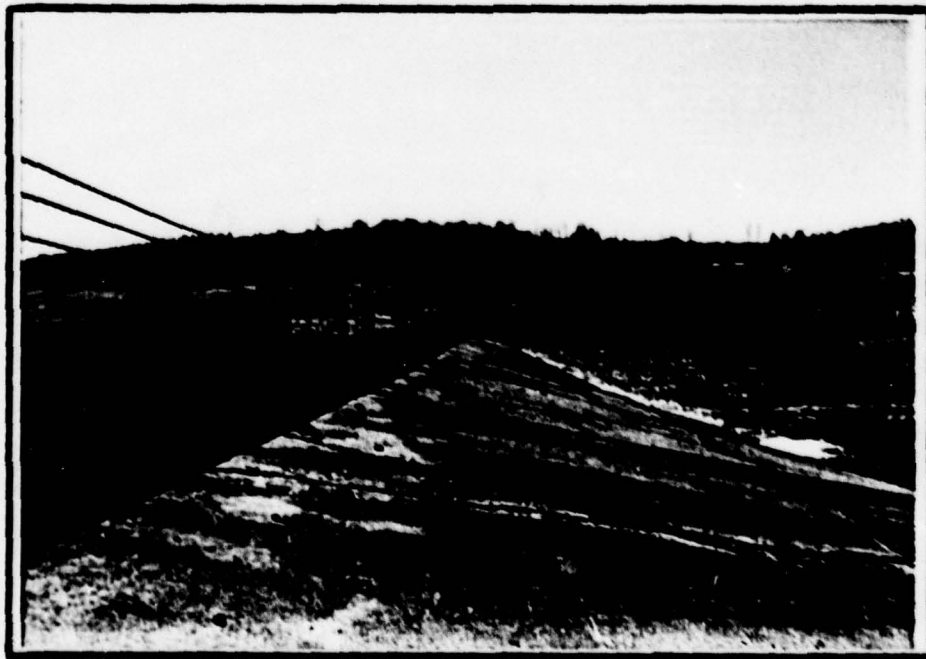
Upstream view of paved slope.

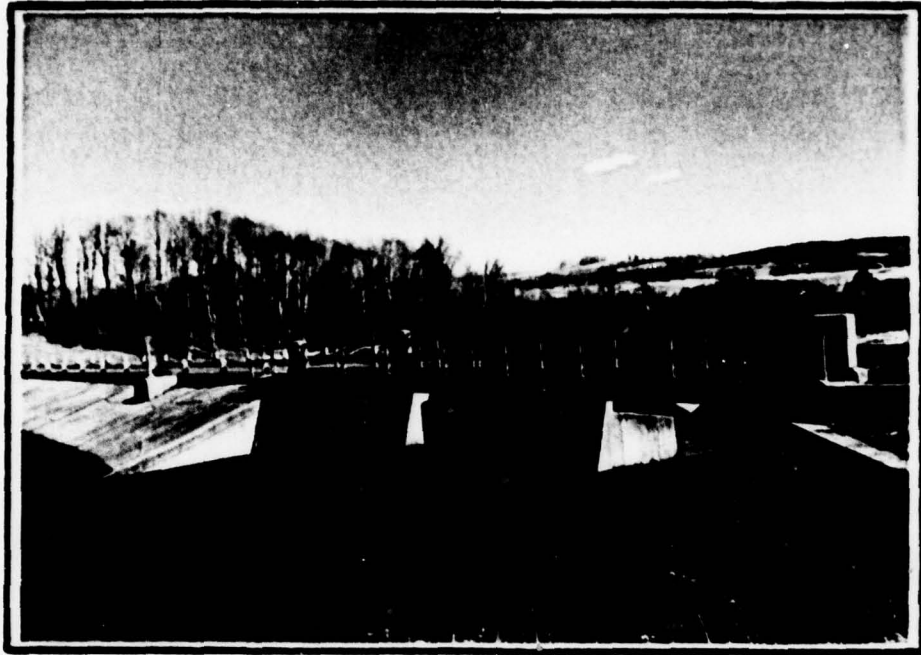
Roadway bridge over spillway.

2. Because of the bridge across the emergency spillway and the pier located in the middle of the spillway, a trash boom should be installed to prevent any debris from blocking the emergency spillway.

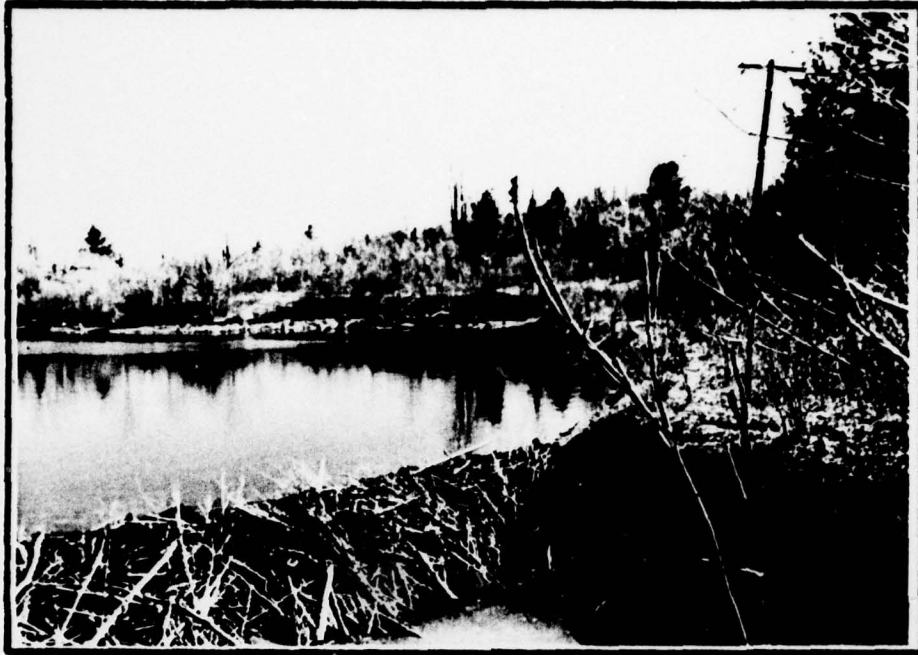
Note: Several small dams located upstream of Hills Creek Dam were constructed by beavers. These dams have failed in the past during heavy storms. These ponds are shallow and in the event of failure, the additional inflow should be insignificant.

Beaver dam upstream of Hills Creek Dam.

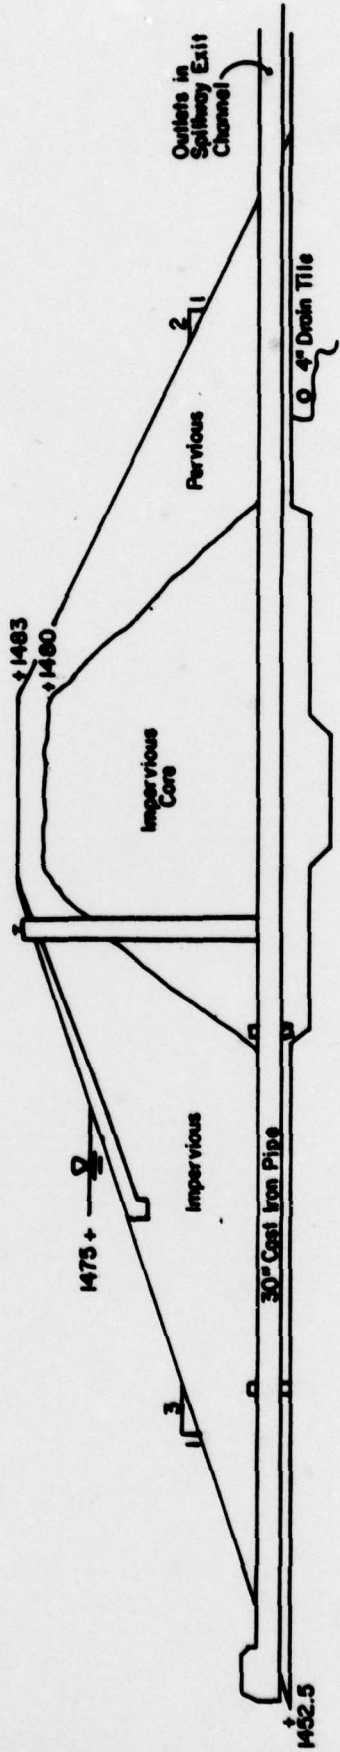
Note: Sketch Made from Construction Drawings. Discrepancy of 1' Vertically from Field Measurements.
