**LAKE MOUNT UNION DAM**

NDS ID NO. PA-473

PHASE I INSPECTION REPORT  
NATIONAL DAM INSPECTION PROGRAM

L. ROBERT KIMBALL & ASSOCIATES ✓  
CONSULTING ENGINEERS & ARCHITECTS  
EBENSBURG, PENNSYLVANIA  
15931

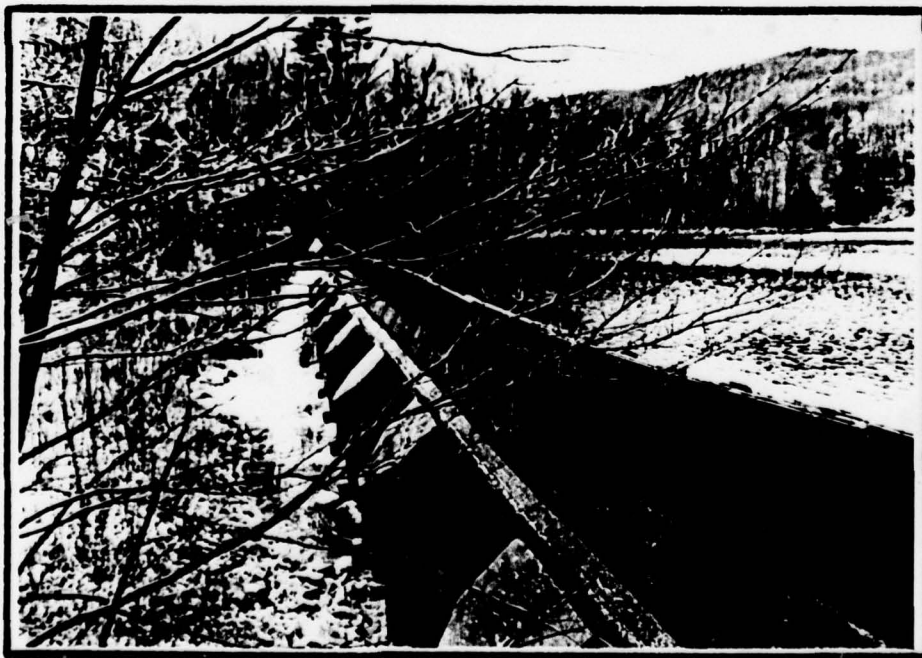
View of spillway crest from left abutment.

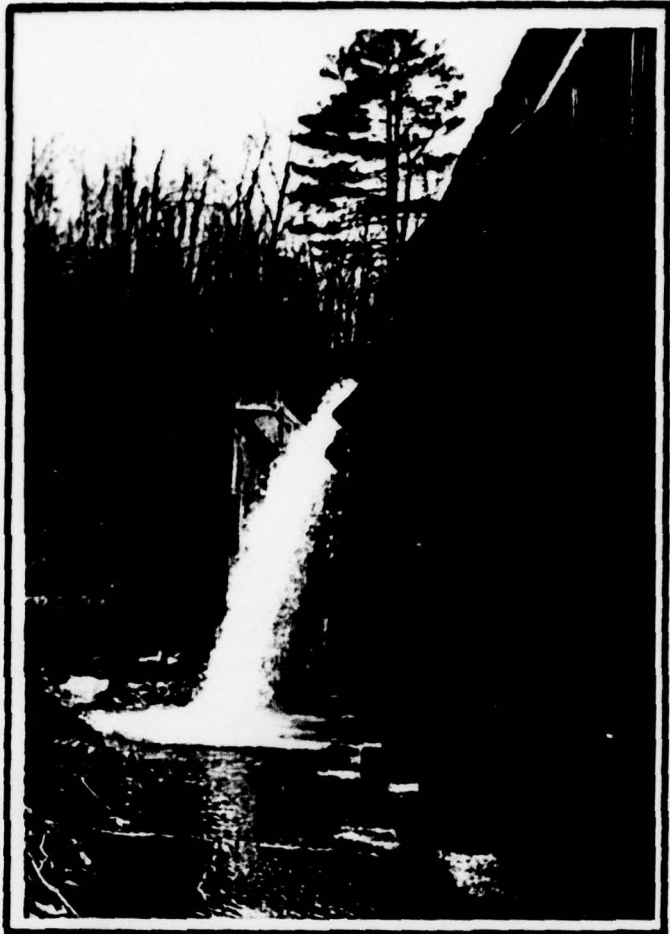
Downstream view of buttresses looking toward  
right abutment.

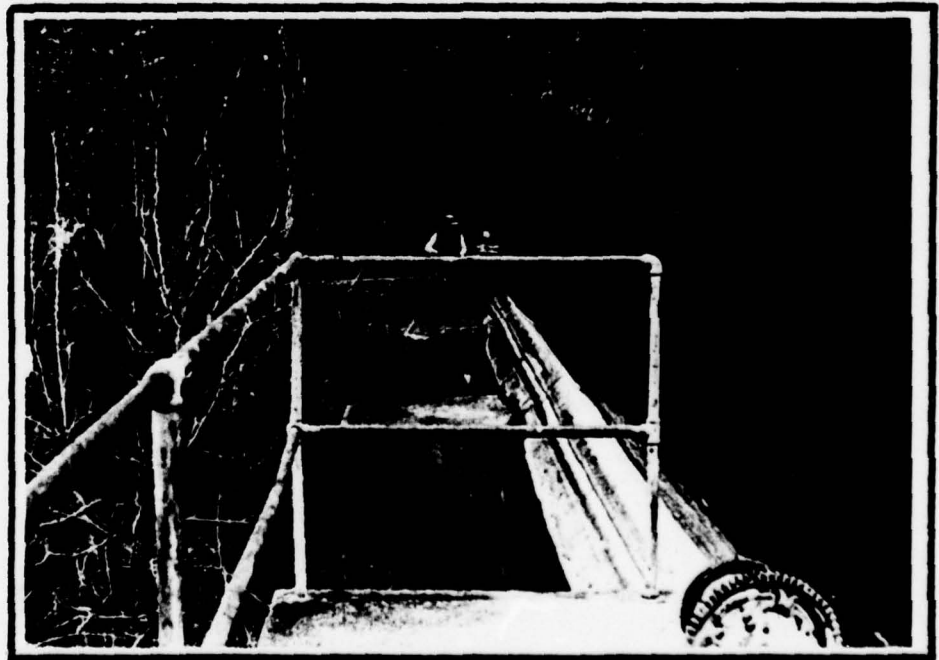
View of right abutment and non-overflow section.
