CLOE DAM

NDI I.D. NO: PA-421
DER I.D. NO: 33-2

PHASE I INSPECTION REPORT
NATIONAL DAM INSPECTION PROGRAM

D'APPOLONIA CONSULTING ENGINEERS
10 DUFF ROAD
PITTSBURGH, PA. 15235
JUNE 1979

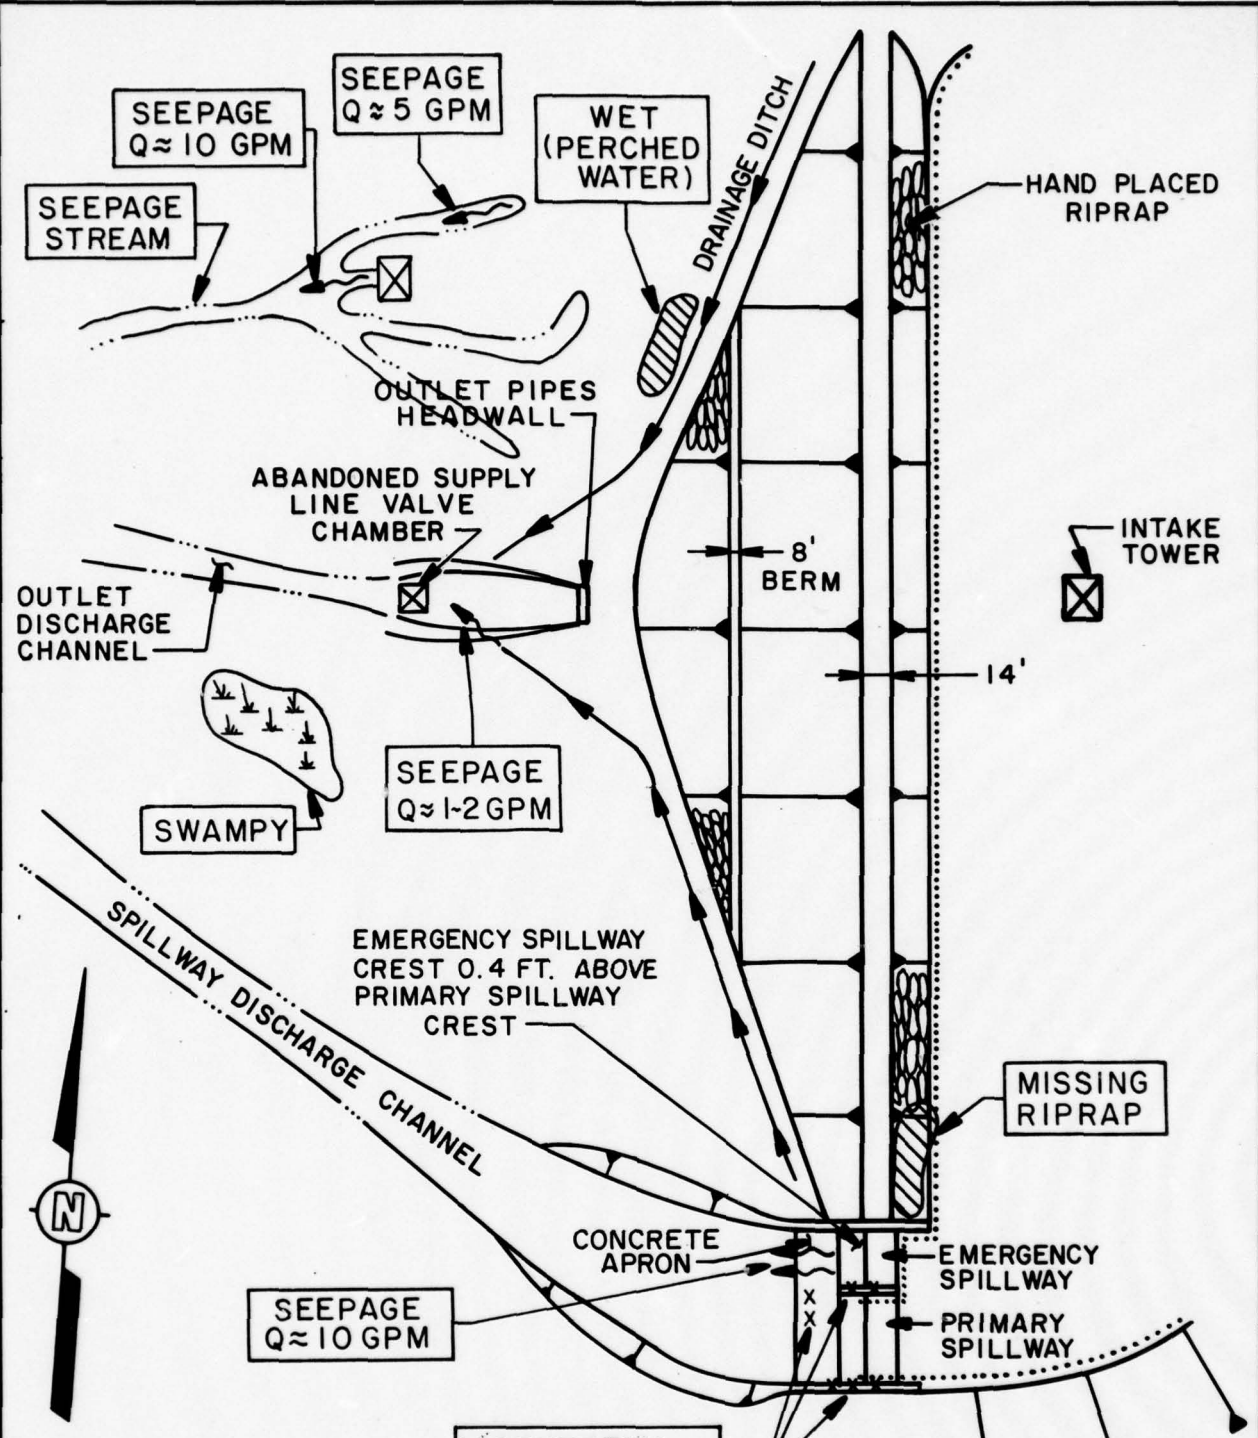
- NOTES:**
1. PRIMARY SPILLWAY FREEBOARD ≈ 5.0 FEET.
 2. POOL LEVEL DATE OF INSPECTION: 0.3 FEET ABOVE PRIMARY SPILLWAY CREST.

SEVERELY DETERIORATED CONCRETE

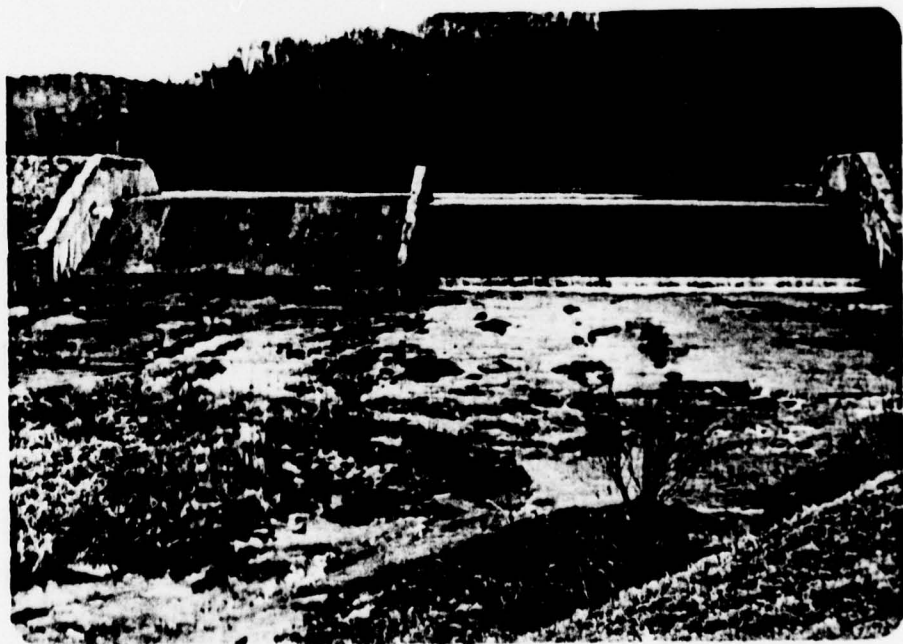
Photograph No. 2
Primary spillway (right) and emergency spillway (left).

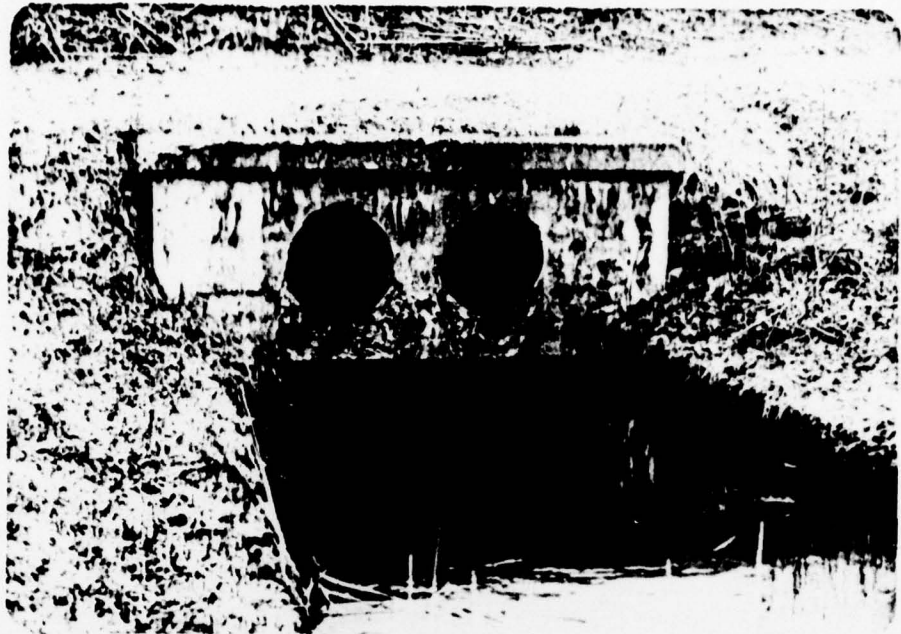
Photograph No. 5
Outlet pipes.

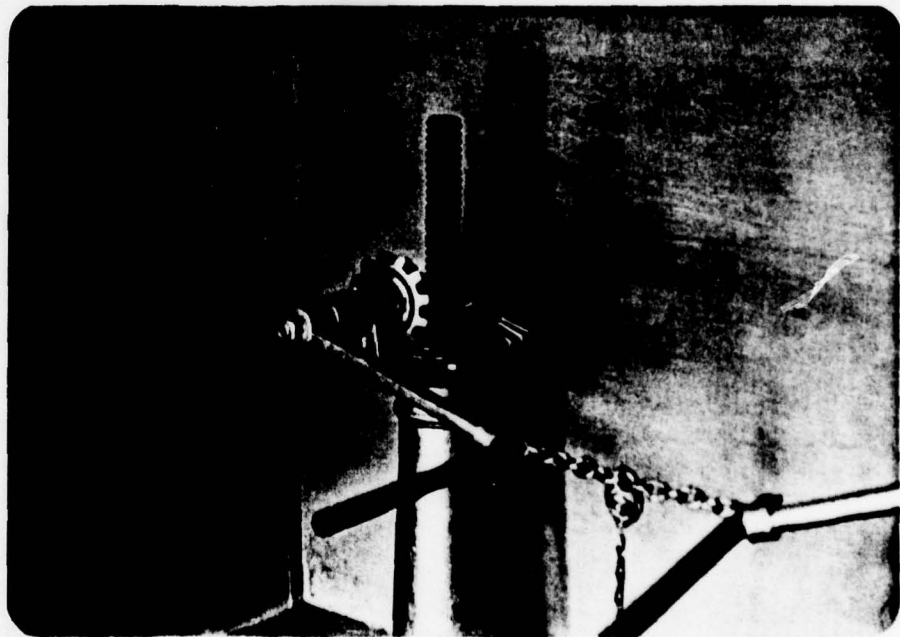
4.3 Maintenance of Operating Facilities. The maintenance condition of the operating facilities is considered to be good. However, Fish Commission personnel reported that the outlet conduit sluice gates have not been operated in the recent past. The operation of the sluice gates was not observed, because the operational condition of the gates was questionable.

Photograph No. 6
outlet pipe controls at intake tower.

It is reported that the outlet pipe sluice gates have not been operated in the recent past. It is therefore recommended that the operational condition of the outlet pipe gates be evaluated and necessary maintenance performed.
