GALION BAY DAM  
(LAKE RENE)  
NDI I.D. NO: PA-747  
DER I.D. NO: 17-107

PHASE I INSPECTION REPORT  
NATIONAL DAM INSPECTION PROGRAM

BY  
D'APPOLONIA CONSULTING ENGINEERS  
10 DUFF ROAD  
PITTSBURGH, PA. 15235  
JUNE 1979

NAME OF DAM: Galion Bay Dam  
STATE LOCATED: Pennsylvania  
COUNTY LOCATED: Clearfield  
STREAM: Gravel Lick, a tributary of Sandy Lick Creek  
DATE OF INSPECTION: April 4 and May 4, 1979

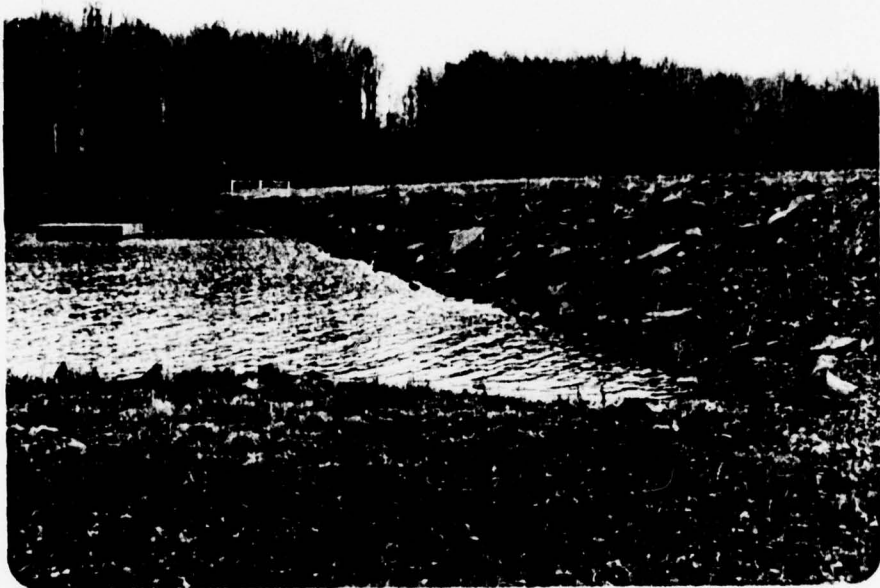
Upstream Face

In general, the condition of the dam is considered to be good. One wet area was found along the toe of the dam near the left abutment. No measurable seepage was found to be associated with this wet area. Riprap on the upstream face was found to be partially deteriorated; however, it is still providing adequate erosion protection.

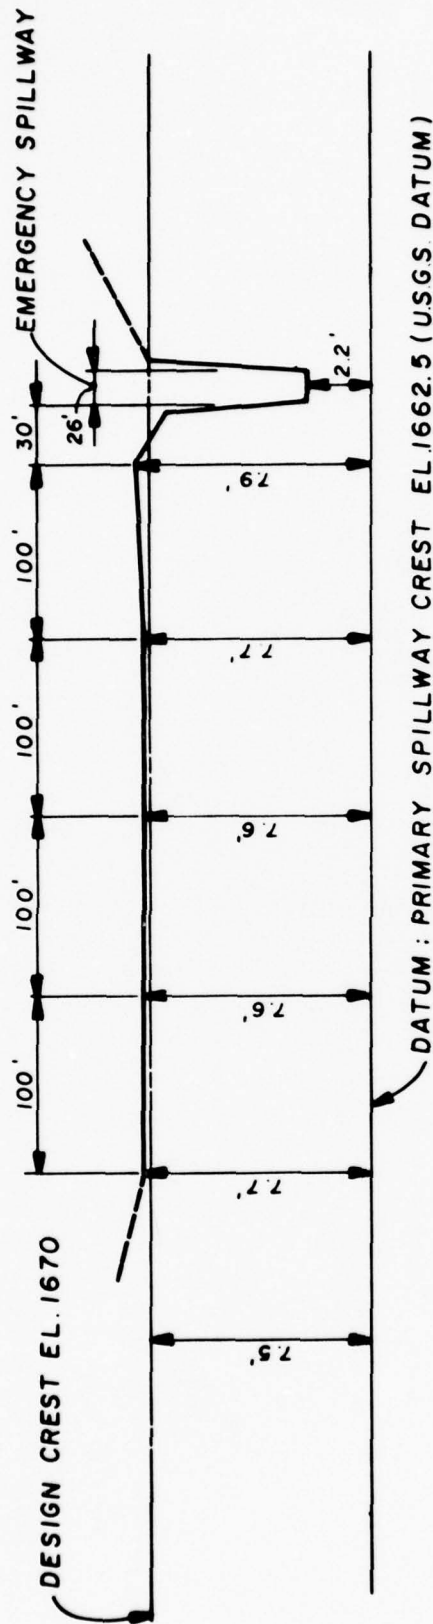
PLATE 9  
GALION BAY DAM  
DAM CREST SURVEY  
FIELD INSPECTION DATE: APR. 3, 79

The top of the embankment was surveyed relative to the pool level on the date of inspection, which was estimated at Elevation 1662.6 and the lowest area on the crest of the embankment was found to be within 0.1 foot above the design elevation of 1670. The dam crest profile is illustrated on Plate 9.

1. POOL LEVEL DATE OF INSPECTION:  
~0.2 FT. ABOVE PRIMARY SPILLWAY CREST
2. EMERGENCY SPILLWAY FREEBOARD =  
7.5 FT.

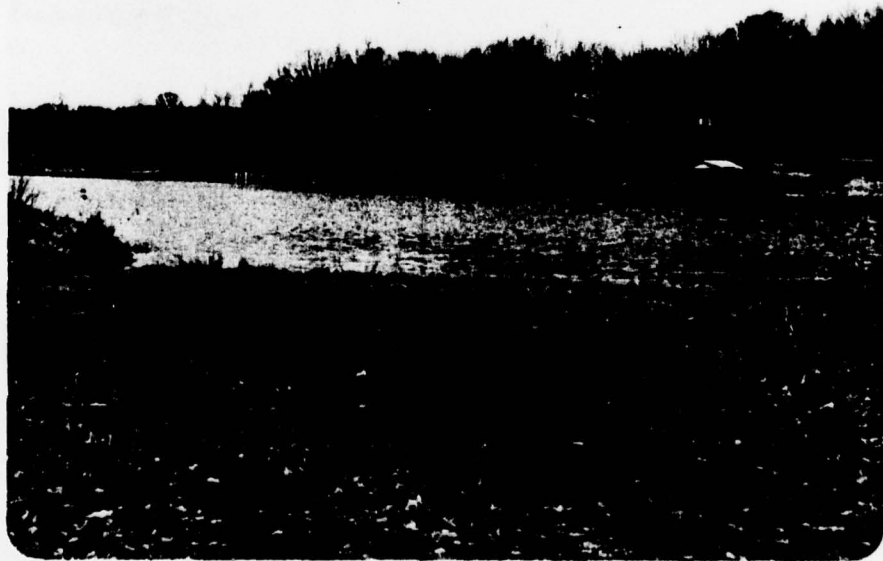
Photograph No. 2

Emergency spillway approach channel.

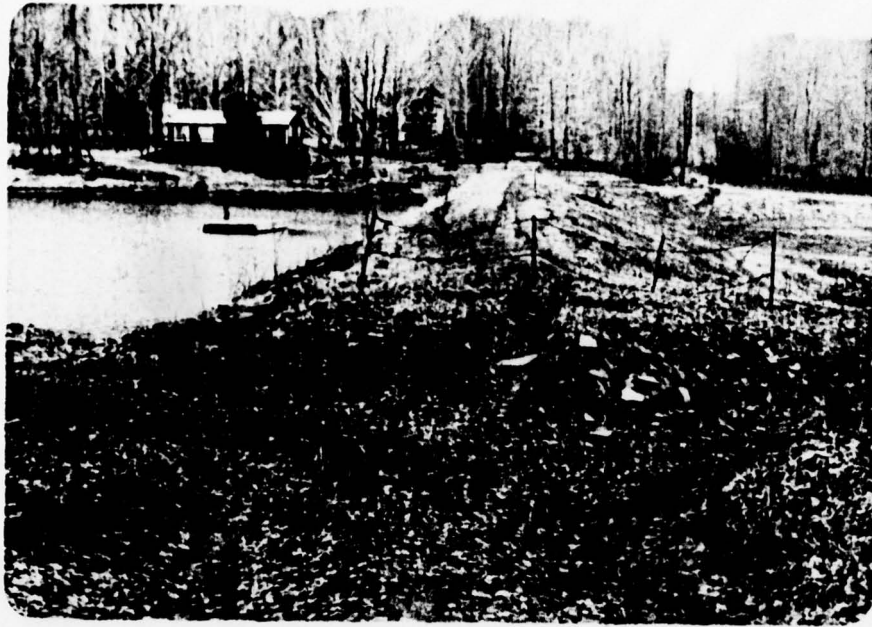
Photograph No. 3

c. Appurtenant Structures. The appurtenant structures were examined for deterioration or other signs of distress or obstructions that would limit flow. While the primary spillway structures were found to be in good condition, lack of adequate riprap on the embankment side of the emergency spillway discharge channel raised some concern about potential erosion of the embankment during large flows through the emergency spillway. Therefore, installation of adequate erosion protection in the emergency spillway channel is recommended.

(2) Appurtenant Structures. Lack of adequate riprap on the embankment (left) side of the emergency spillway discharge channel raises some concern as to the potential for erosion of the embankment during large flows through the emergency spillway. Therefore, installation of additional erosion protection on the embankment side of the emergency spillway discharge channel is recommended.

Inadequate riprap in emergency spillway against the embankment.

1. Adequate erosion protection should be provided on the embankment (left) side of the emergency spillway discharge channel to protect the embankment from eroding during flows through the emergency spillway.
2. Around-the-clock surveillance should be provided during unusually heavy runoff and a formal warning system should be developed to alert downstream residents in the event of emergencies.
3. The dam and appurtenant structures should be inspected regularly and necessary maintenance should be performed.

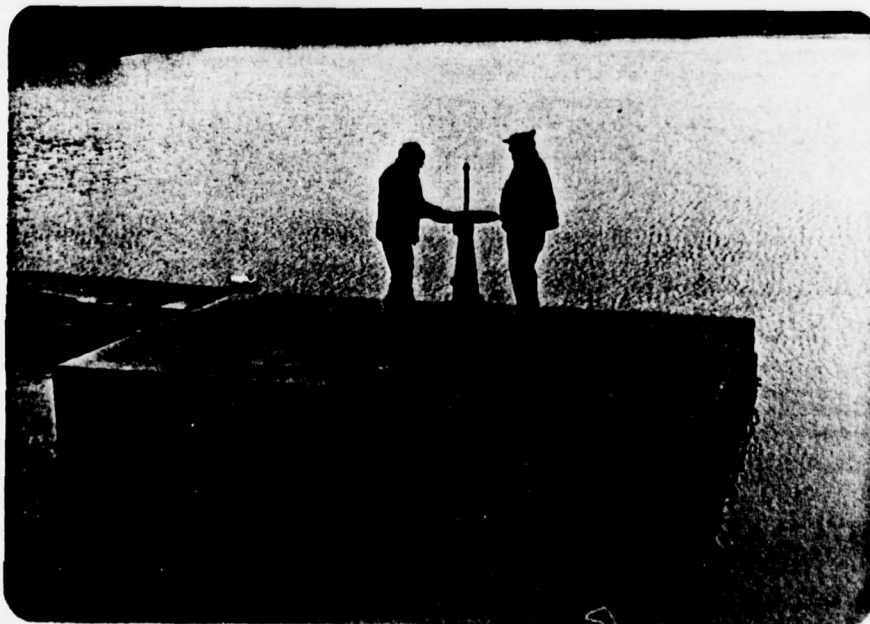
Photograph No. 4

4.3 Maintenance of Operating Facilities. The only operational feature of the dam is the reservoir outlet sluice gate which is operated by a hoist located on the drop inlet structure. The reservoir outlet pipe sluice gate was operated and observed to be functional.

Primary spillway intake structure and outlet pipe sluice gate control.

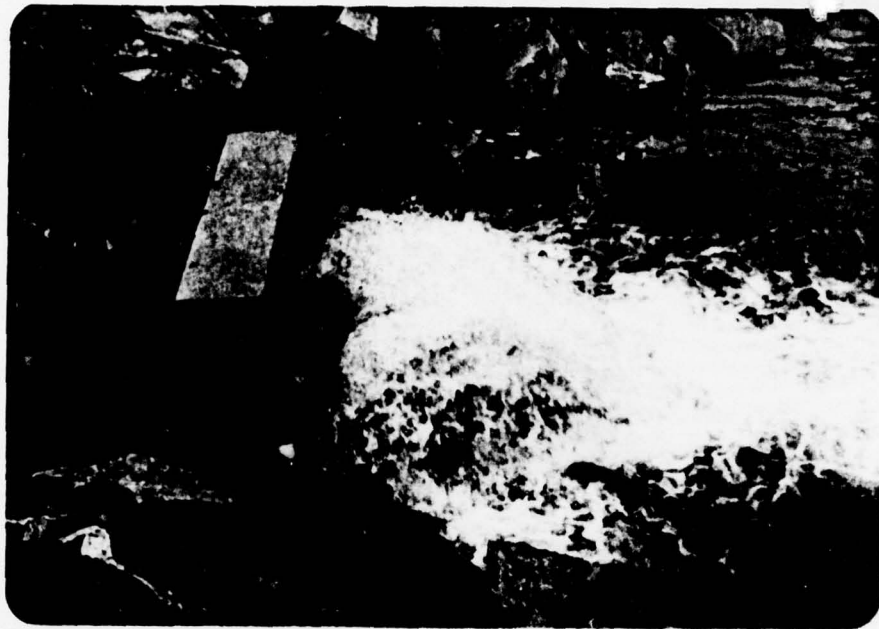
Photograph No. 5  
Primary spillway discharge pipe.

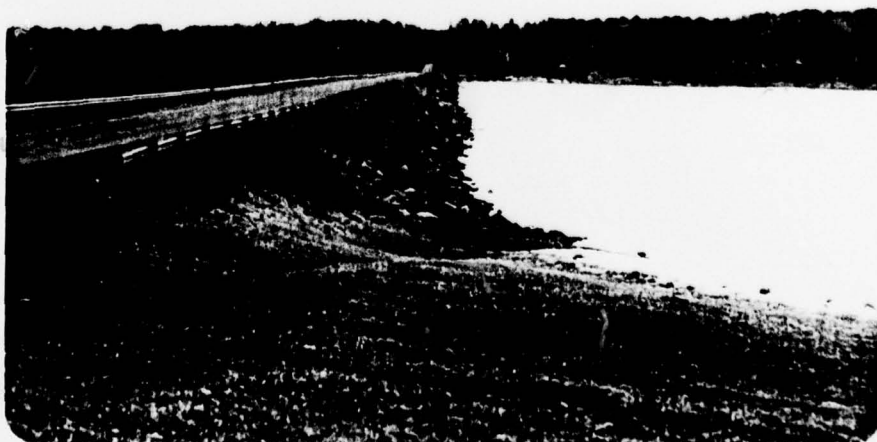
Photograph No. 6  
Downstream dam. Gravel Lick Dam two miles downstream.
