KYLE DAM

NDI I.D. NO: PA-417

PHASE I INSPECTION REPORT
NATIONAL DAM INSPECTION PROGRAM

JUNE 1979

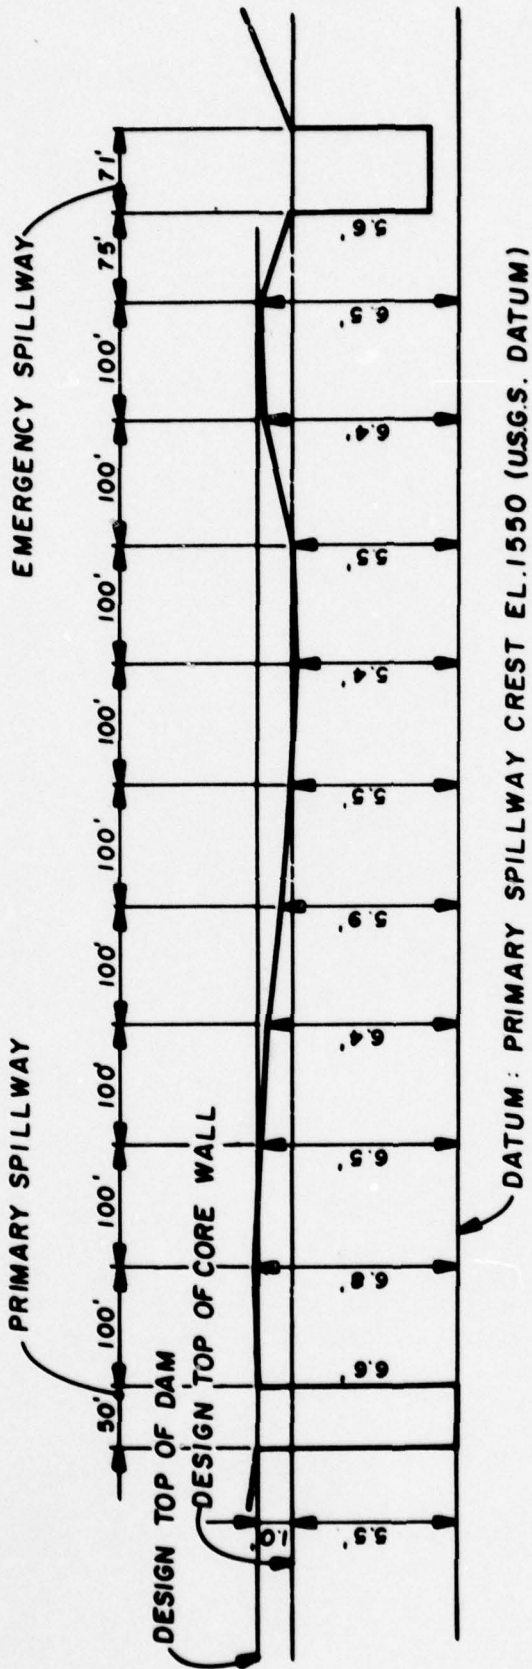
DAM CREST PROFILE
(LOOKING DOWNSTREAM)

The crest of the dam was surveyed, relative to the primary crest elevation, and it was found that the middle one-third of the embankment has settled by approximately one foot relative to the abutments. The low spot on the crest was found to be approximately 5.4 feet above the primary spillway crest elevation. The dam crest profile is illustrated on Plate 7.

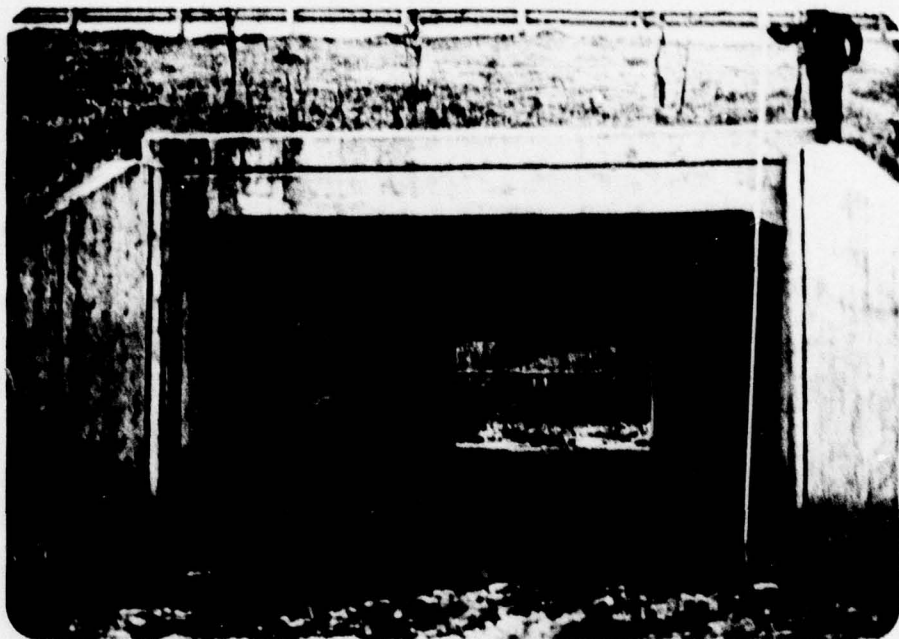
Photograph No. 7

Interstate Route 80 underpass (1000 feet downstream).
