LITTLE YOUGHIOGHENY RIVER SITE NO. 5

NDI ID NO. MD 55

PHASE I INSPECTION REPORT

JUNE 1979

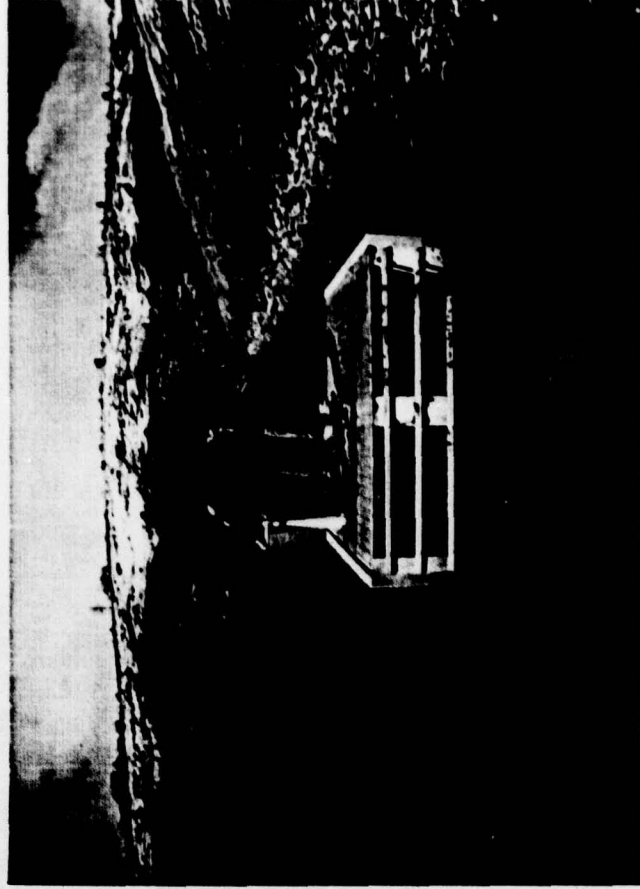
PHOTOGRAPH 4 View of principal spillway riser.
