LITTLE YOUGHIOGHENY RIVER SITE NO. 7

NDI ID NO. MD 32

PHASE I INSPECTION REPORT

PHASE 1 REPORT
NATIONAL DAM INSPECTION PROGRAM

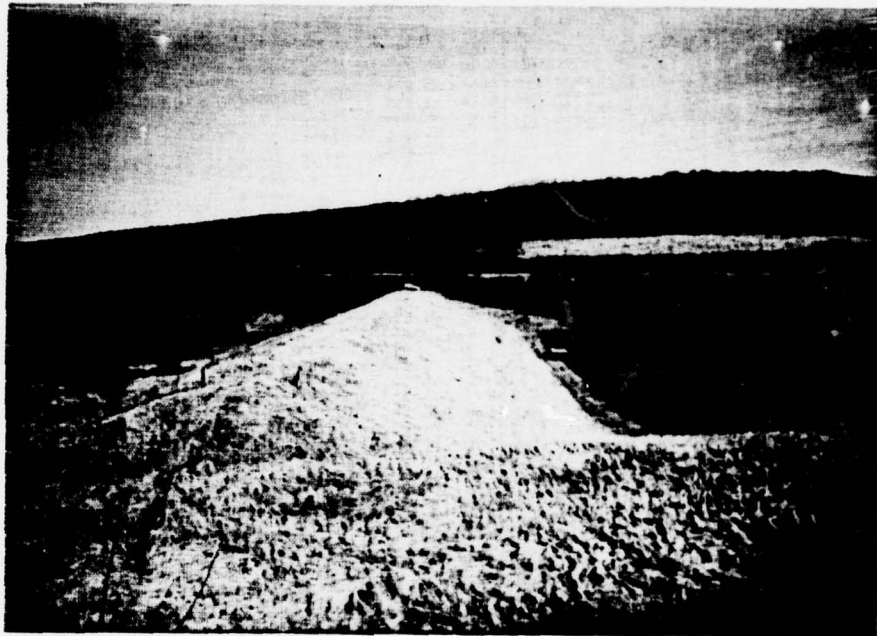
Overview of Dam

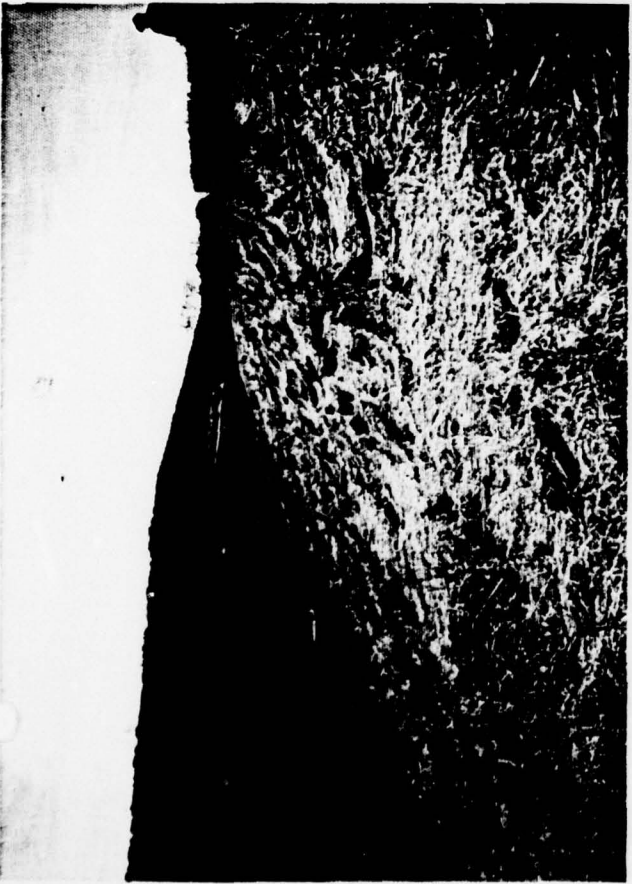
PHOTOGRAPH 1 View of upstream embankment slope and emergency spillway inlet in background.

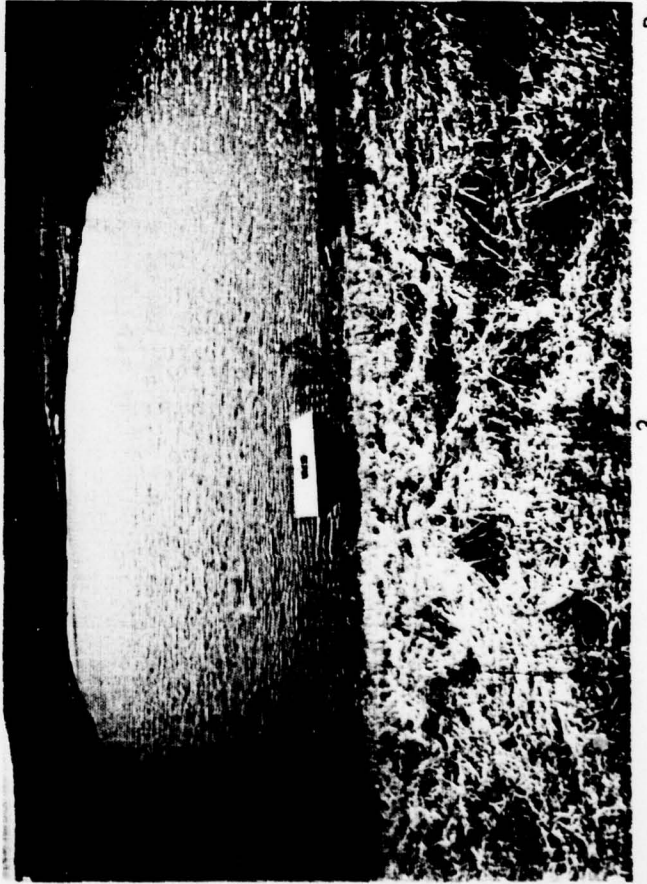
PHOTOGRAPH 3 Overview of principal spillway riser and reservoir.

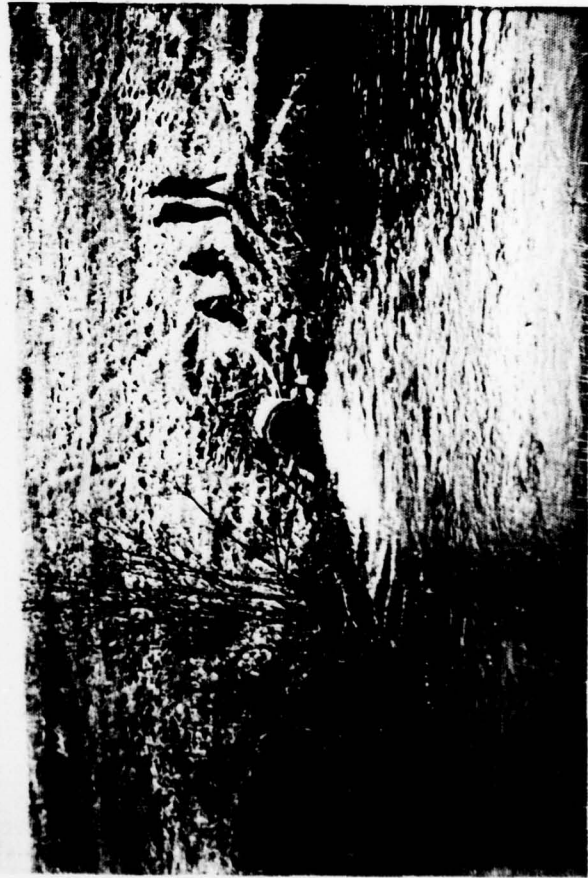
Seepage outlet drain pipes are subject to inundation by plunge pool tailwater. Should the outlet drains become submerged, the downstream embankment phreatic surface could rise and result in reduced slope stability.

On the date of the field reconnaissance review, the outlet drain pipes were observed inundated by tailwater. The exposed bottom of the south outlet toe drain was observed rusted through. This outlet toe drain was reportedly accidentally damaged by Soil Conservation Service inspection personnel about two weeks later.

PHOTOGRAPH 7 View of seepage toe drains and outlet discharge pipe..

2) Remove damaged end section of seepage outlet drain pipe. Replace with new pipe end section and connecting band or install a perforated plastic pipe inside remaining outlet pipe sections.
