**BOG BROOK DAM NO. 1  
AND DAM NO. 2**

**PHASE I INSPECTION REPORT**

**DAM NO. 1 - NY 00068  
DAM NO. 2 - NY 00069**

Prepared by: O'Brien and Gere Engineers, Inc.

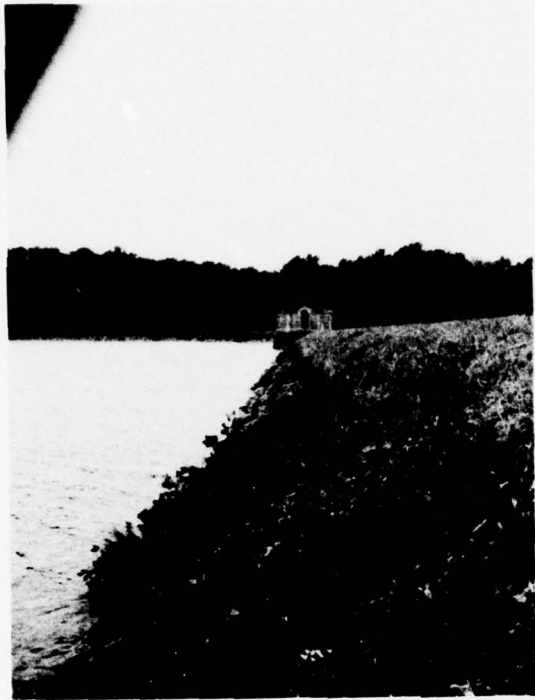
UPSTREAM SLOPE AND  
CENTER GATEHOUSE DAM NO. 1

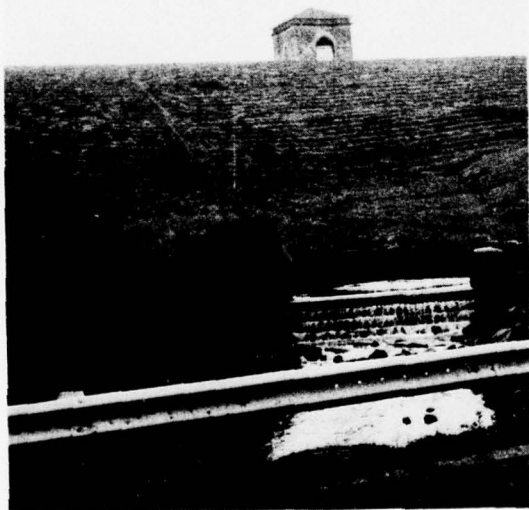
DOWNSTREAM SLOPE AND  
STILLING BASIN DAM NO. 1

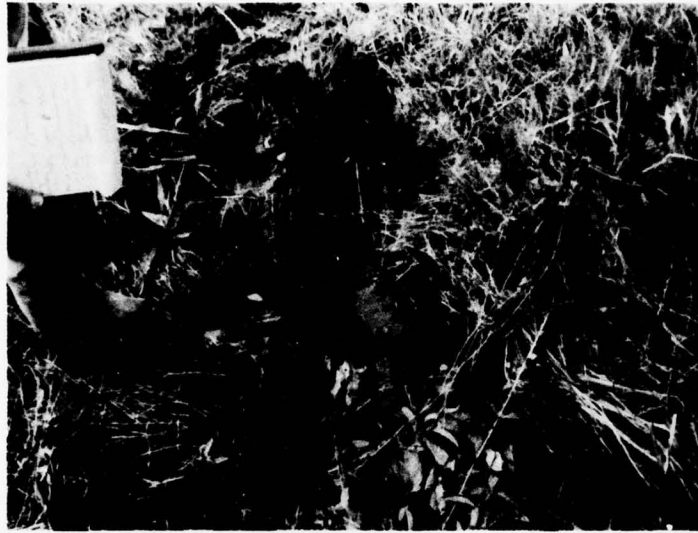
According to Mr. Birrell, Section Engineer, the seepage and saturated ground at the north abutment of Dam No. 1 has existed for a number of years except during extended periods of dry weather. Fine-grained soil is not in evidence either in the seepage or as accumulated deposits on the dam and valley slopes. The "Report to the Aqueduct Commissioners, 1895-1907" states, sic "notwithstanding that precaution (extending the corewall into what was considered competent bedrock), a slight infiltration occurs, which has been collected in a system of drains and led finally through small pipes, where its volume can be constantly observed." The location of these pipes is unknown and it is possible that the observed seepage is a result of a clogged drain system.

SATURATED GROUND NEAR RIGHT ABUTMENT  
OF DAM NO. 1

Seepage noted at the north abutment  
of Dam No. 1. Ground surface was  
moist and saturated in some  
locations.

A study should be undertaken to  
determine the cause and source  
of seepage and it should be  
monitored continuously to  
detect turbidity or increased  
flow.
