# CITY OF UTICA RESERVOIR # 4

## PHASE I INSPECTION REPORT

NY 00198

Name of Dam: Utica Reservoir No. 4 Dam  
 State Located: New York  
 County Located: Oneida  
 Stream: Ballou Creek  
 Date of Inspection: June 5, 1978

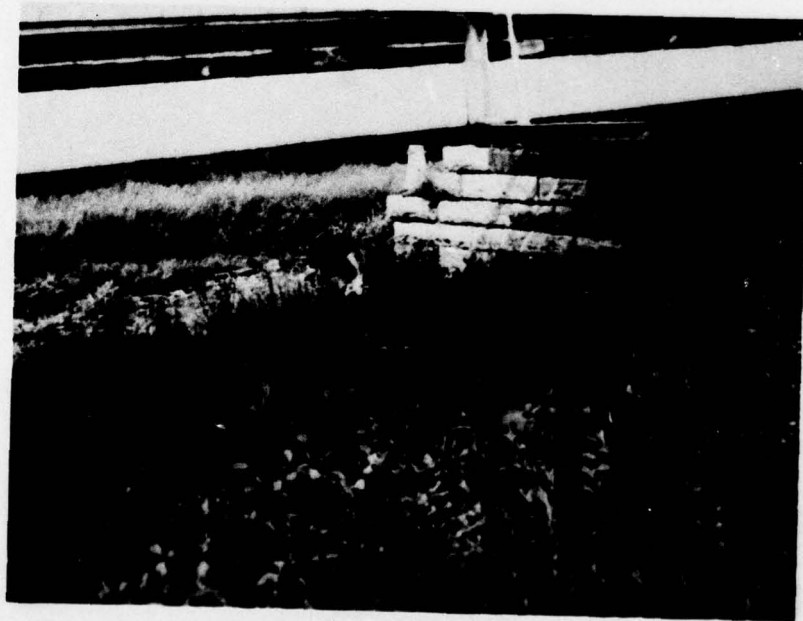
c. Spillway - Clear water was observed boiling (approximately 4 GPM) through two small holes, each approximately 1 inch in diameter, in the masonry apron about 25 feet downstream of the weir crest. Seepage was noted at the base of the downstream face of the east spillway wingwall. There was no flow over the spillway at time of inspection.

Water was seen boiling through the downstream spillway apron and under the eastern wingwall. Although the water was clear at the time, a continuance of this seepage could cause piping.

SPILLWAY CREST
