**BROOKSIDE RESERVOIR
MONTGOMERY COUNTY
INVENTORY NO 168**

**PHASE I INSPECTION REPORT
NATIONAL DAM SAFETY PROGRAM**

Name of Dam Brookside, City of Amsterdam NY163

State Located New York
County Located Montgomery
Stream Bunn Creek
Date of Inspection June 16, 1978

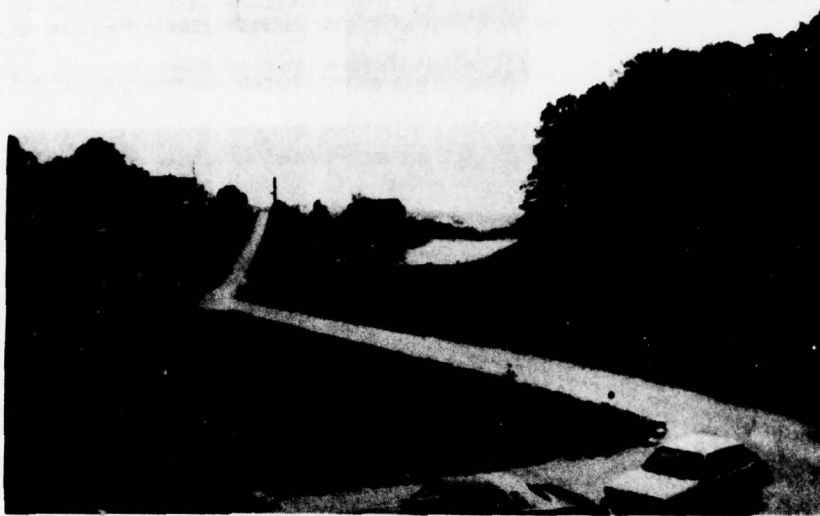
7. View of reservoir and access road from filtration plant.
