TRW DEFENSE AND SPACE SYSTEMS GROUP REDONDO BEACH CA
9433 DESIGN POINTING ANOMALY. VOLUME I. TECHNICAL REPORT. (U)

0433 DESPIN POINTING ANOMALY

VOLUME I
TECHNICAL REPORT

REPORT NO. 28600-AR-010-01 ✓

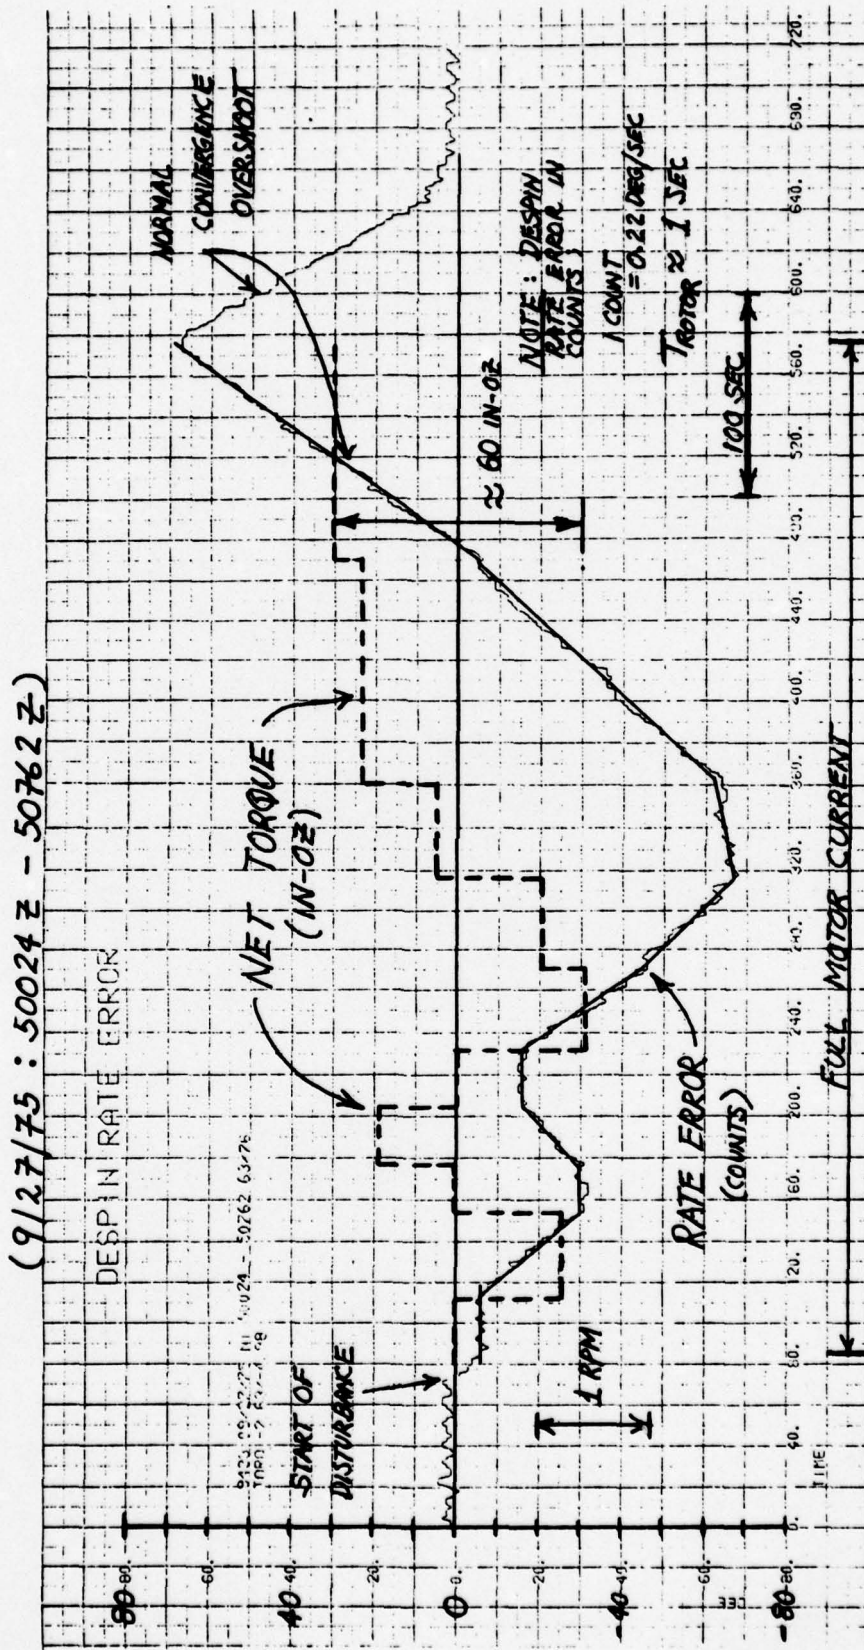
Figure 3.3-3. Analysis of Rate Mode Torque Transient

(this was the case between 90 and 580 seconds), friction torque variations can be deduced. An analysis of the data in Figure 3.3-3 shows that a sequence of torque pulses with amplitudes as large as 30 in-oz of varying duration disturbed the system. These results are consistent with those deduced from an analyses of recent Normal Mode pointing error data. Unlike the small pointing transients observed shortly after launch, the pointing error transients of recent months are being generated by torque pulses which are significantly larger than the 5 in-oz that has been heretofore attributed to retainer instability.

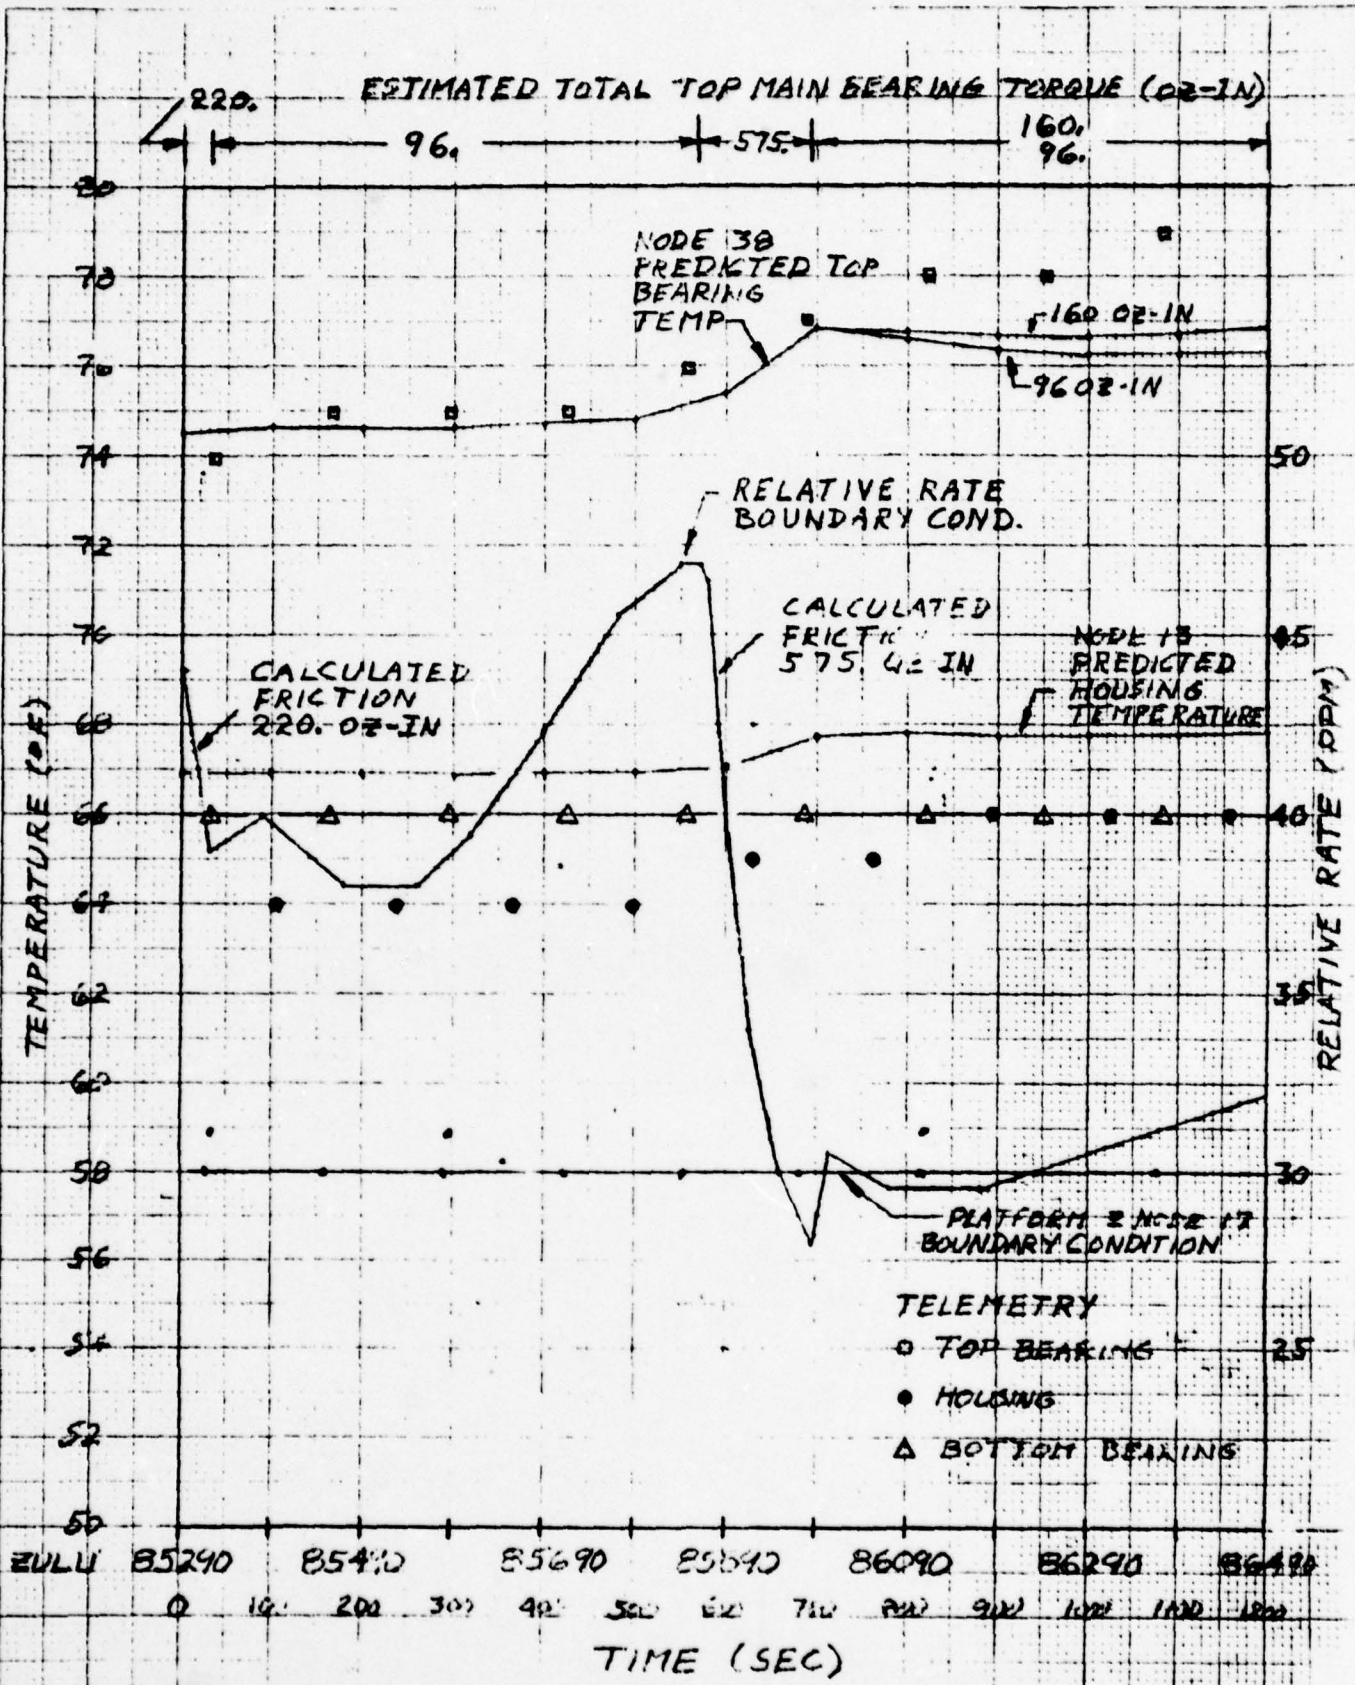
Figure 5.1-6. Temperature Simulation Major Dropout, 13 October 1975

- The major friction transient occurring on 13 October was also simulated, and the comparative data was plotted in Figure 5.1-6. The key temperature gradients are recorded in Figure 5.1-7. The predicted temperatures are all within the tolerance range of telemetry data; note, however, that the simulation again predicted housing temperatures higher than observed in orbital data.

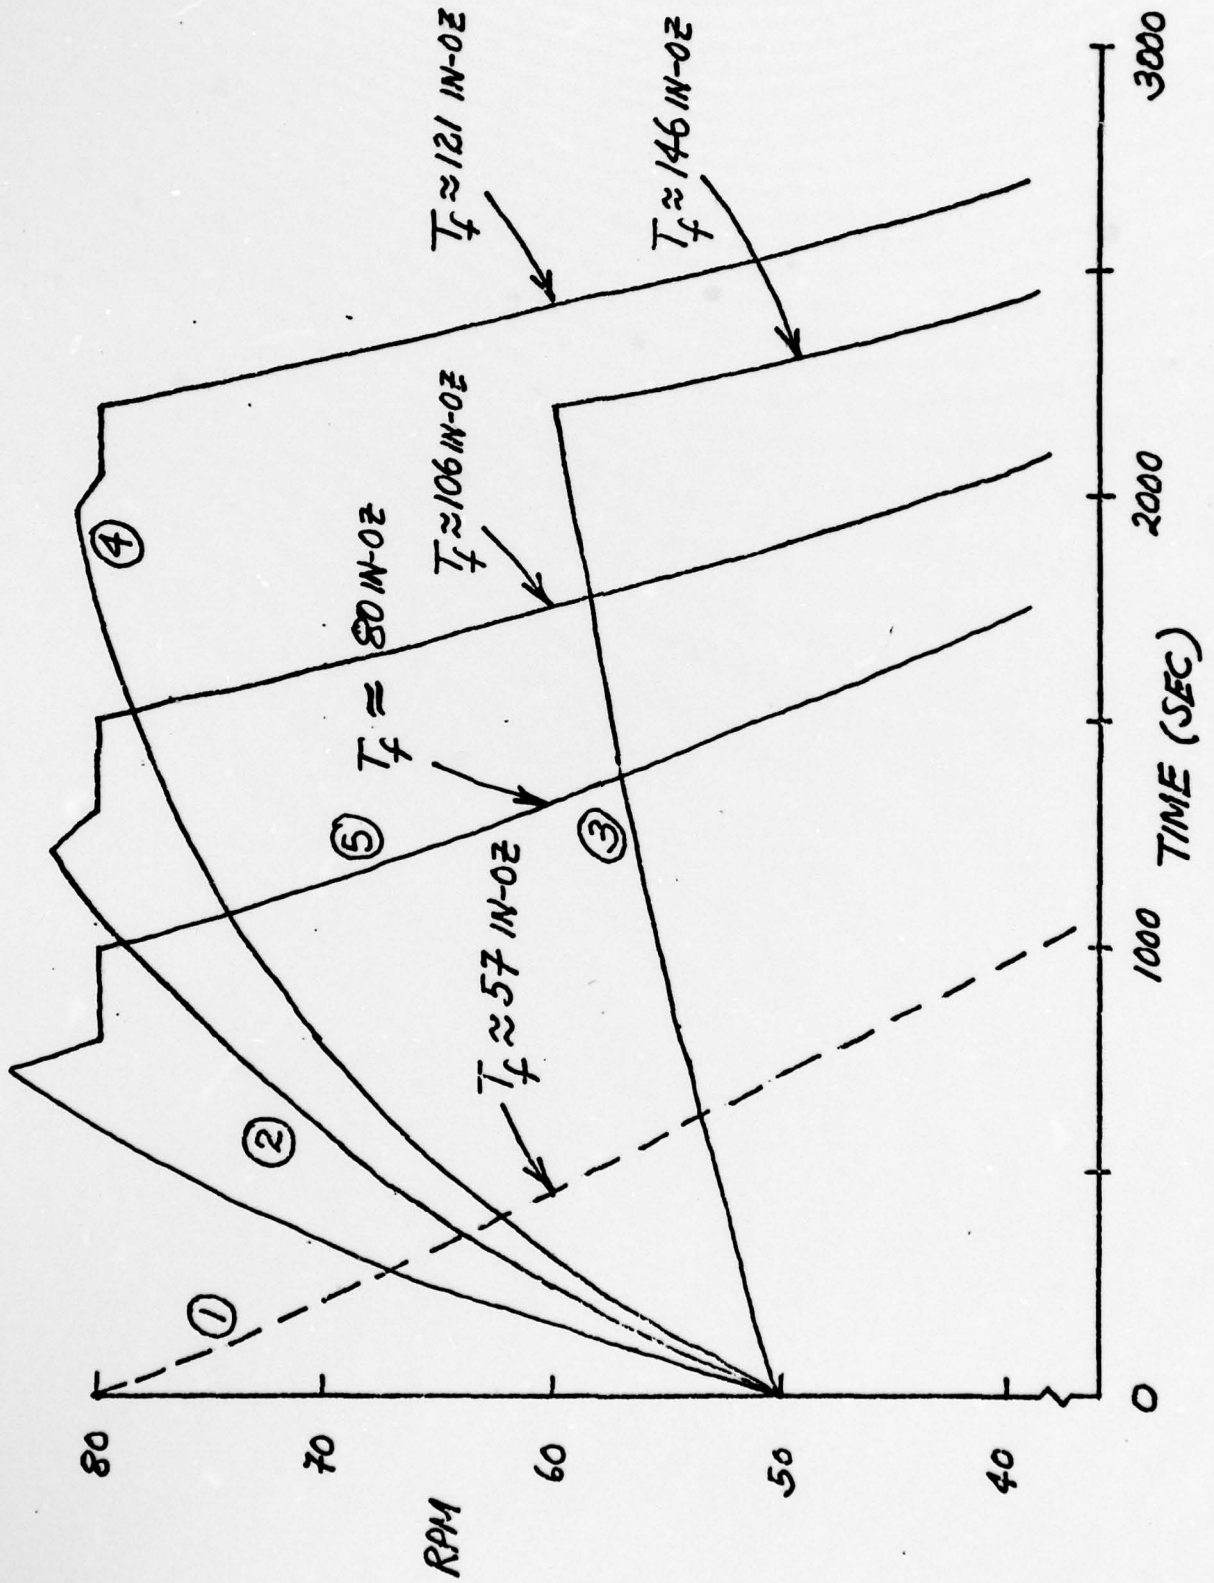
Figure 6.1-1. Laboratory System Test Results (9 October 1975)

Runs ② through ④ represent performance with varying levels of friction applied via the Teflon rod mentioned above. In Run ⑤, the friction load was removed and the redundant motor winding was fully shorted to evaluate the braking effect thus produced. These runs showed a definite reduction in motor torque capability with increased speed (later verified by motor tests), but did not exhibit the apparent increase in DMA friction torque seen during the 9433 on-orbit friction tests.

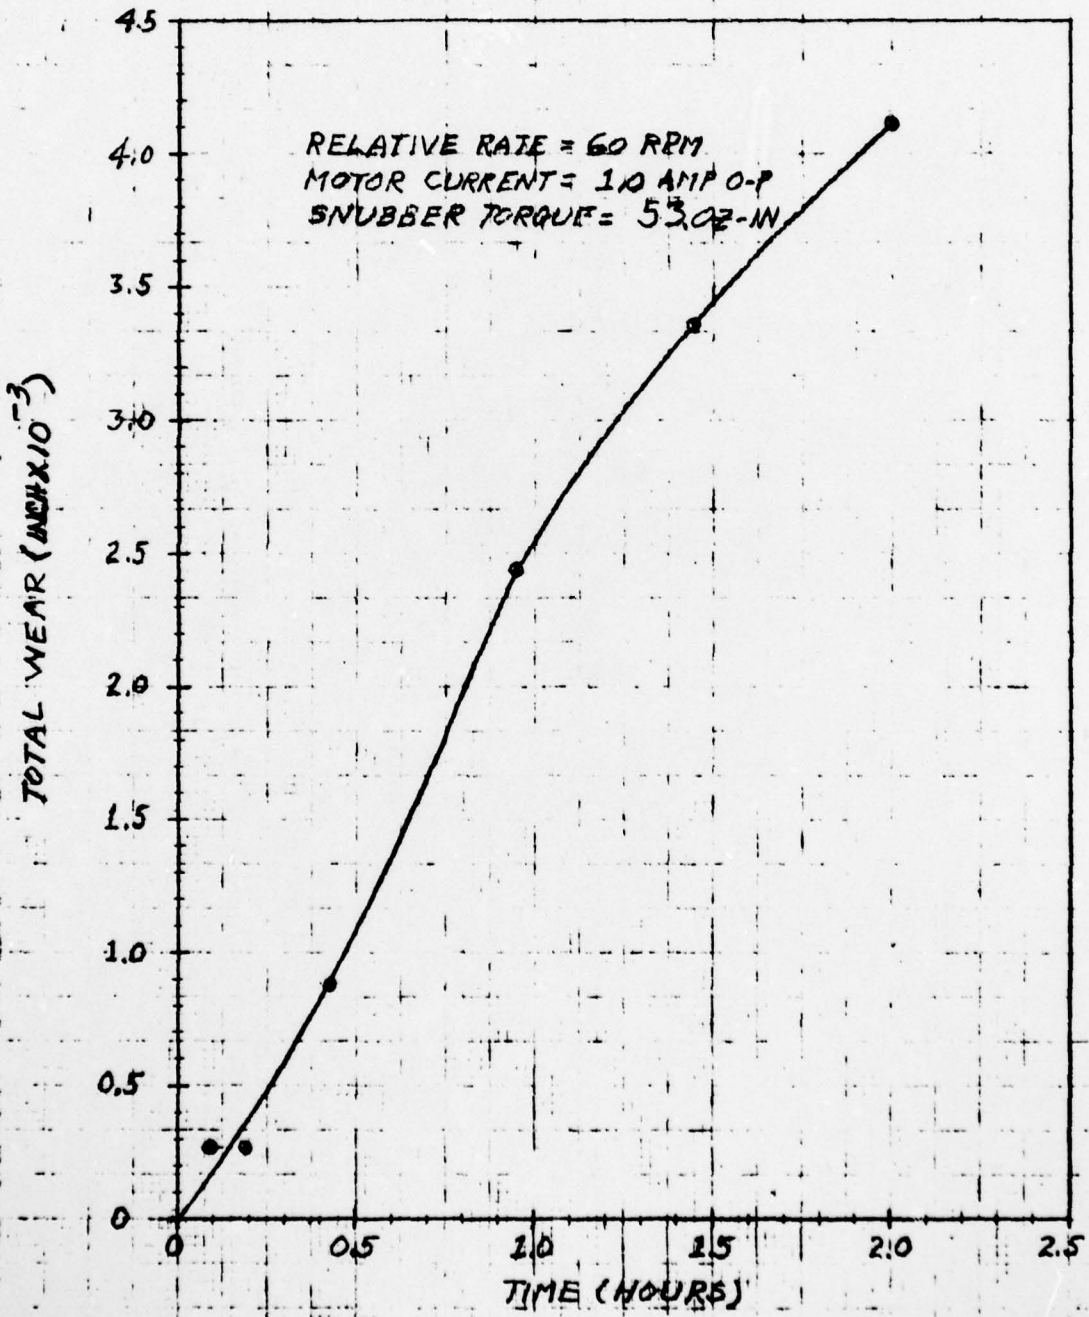
Figure 6.4-2. Snubber Wear Test Data

The test procedure was to run for a period of time and then to shut down and measure the total decrease (wear) or increase in dimensions along the contact radius. Figure 6.4-2 shows the radial wear resulting from a two hour test in which a constant snubber friction of approximately 50 in-oz has been maintained. The normal force was initially 5.9 lbs and was steadily reduced during the first 11 minutes to 3 pounds. During this period, the snubber was producing a black debris as the anodize coating was being worn
