HINCKLEY DAM

PHASE I INSPECTION REPORT NATIONAL DAM SAFETY PROGRAM

NY 00181

Date: July 6, 1978

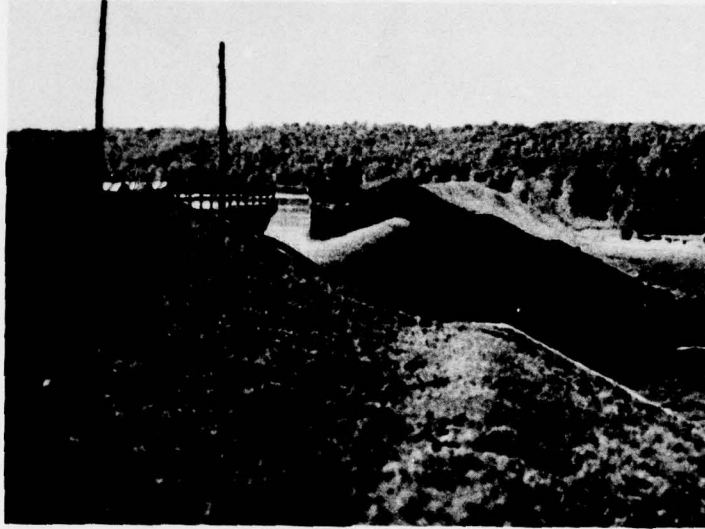
OVERALL VIEW OF DAM LOOKING SOUTH
FROM NORTH ABUTMENT

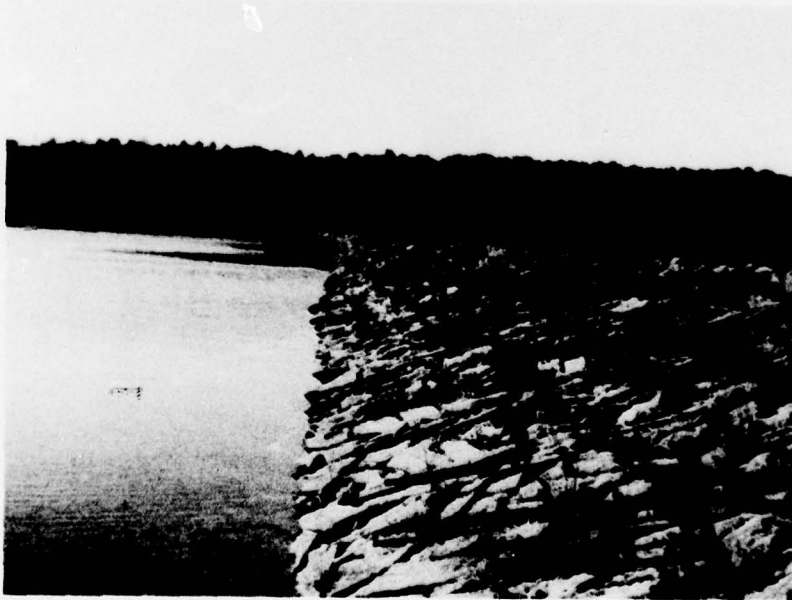
VIEW OF UPSTREAM FACE OF DAM

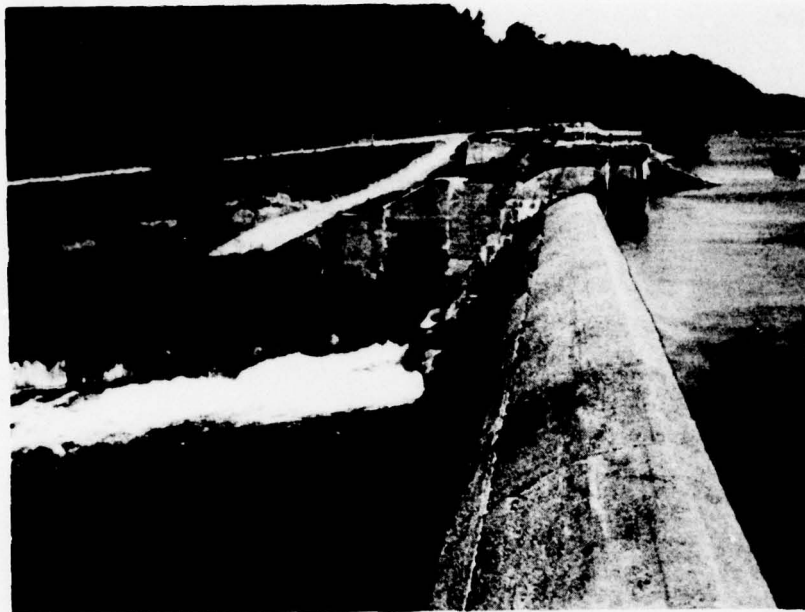
NORTH ABUTMENT, OUTLET WORKS, AND SPILLWAY

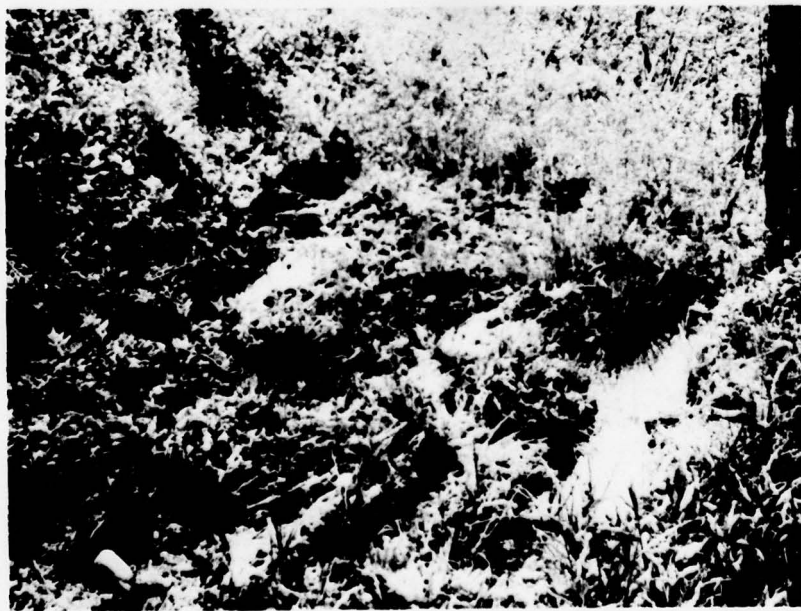
Drainage of the downstream slope is accomplished by backsloping the two benches to form swales parallel to the crest. Cobblestone lined ditches, constructed at right angles to the benches, are provided at 300 foot intervals for drainage down the slope. A ditch parallel to the embankment is provided at the toe. Standing water was observed in the toe ditch, and in many areas standing water was widespread, creating swampy conditions. The standing water was brown or rust colored. The vegetation in these areas is indicative of a prevailing moist or saturated condition (See the bottom photograph on page A1).

The remedial work completed in November, 1977, the high flow from the weep holes in the downstream wingwall, and the areas of saturation and standing water on the embankments and at the downstream toe, indicate that excessive seepage is occurring. The seepage may be occurring from the embankment or the foundation. Discoloration of standing water, evident at several locations, could be indicative of fines migration or precipitation of ferrous impurities in the embankment or foundation. In addition, the observed depression on the upstream slope of the north abutment may be the result of fines migration through the embankment.

SATURATED AREA WITH STANDING WATER AT TOE OF EMBANKMENT

A boring program should be initiated immediately at several selected sections of the embankment to include, but not be limited to, determination of the composition and in situ properties of the embankment and foundation materials, to establish if they are satisfactory for the embankment core wall and foundation as designed and constructed, and to detect possible fines migration. Piezometers should be installed in the boreholes to evaluate pore pressure development throughout the embankment. The results of these investigations should be used to perform seepage and stability analyses for the embankments.

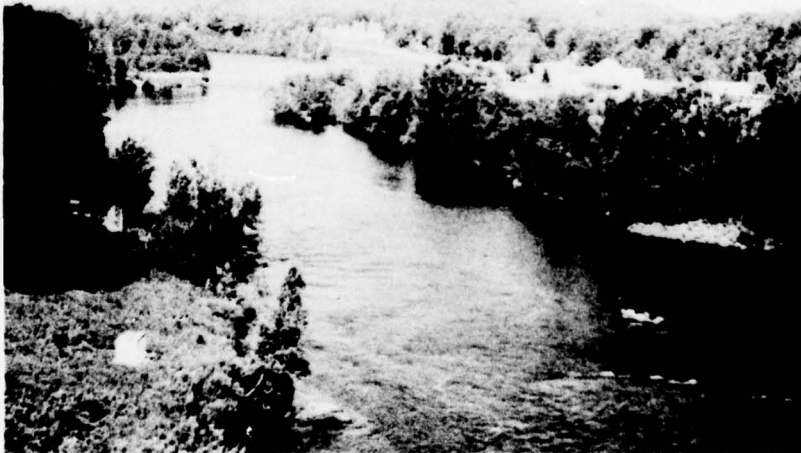
VIEW OF DOWNSTREAM CHANNEL
