Name Of Dam: UPPER NORTH RIVER NO. 76 (ELKHORN LAKE)

Location: AUGUSTA COUNTY, VIRGINIA

Inventory Number: VA. NO. 01506

PHASE I INSPECTION REPORT NATIONAL DAM SAFETY PROGRAM

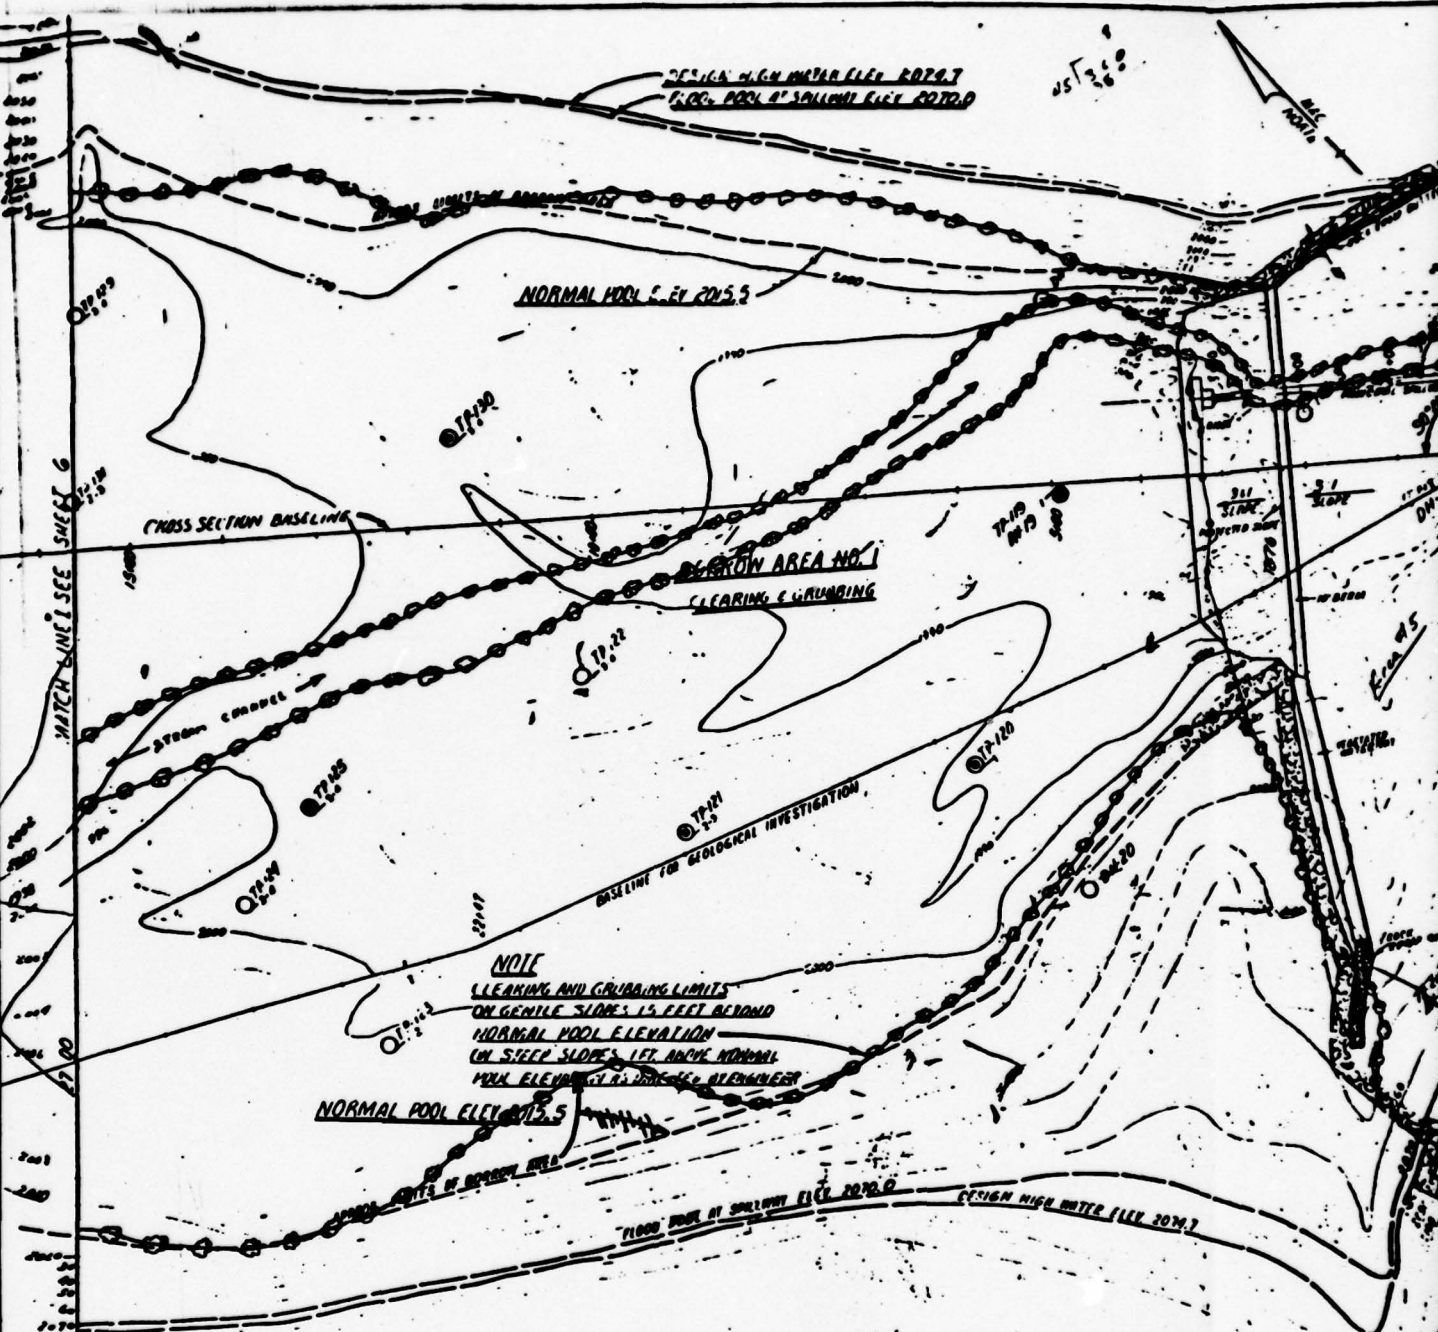
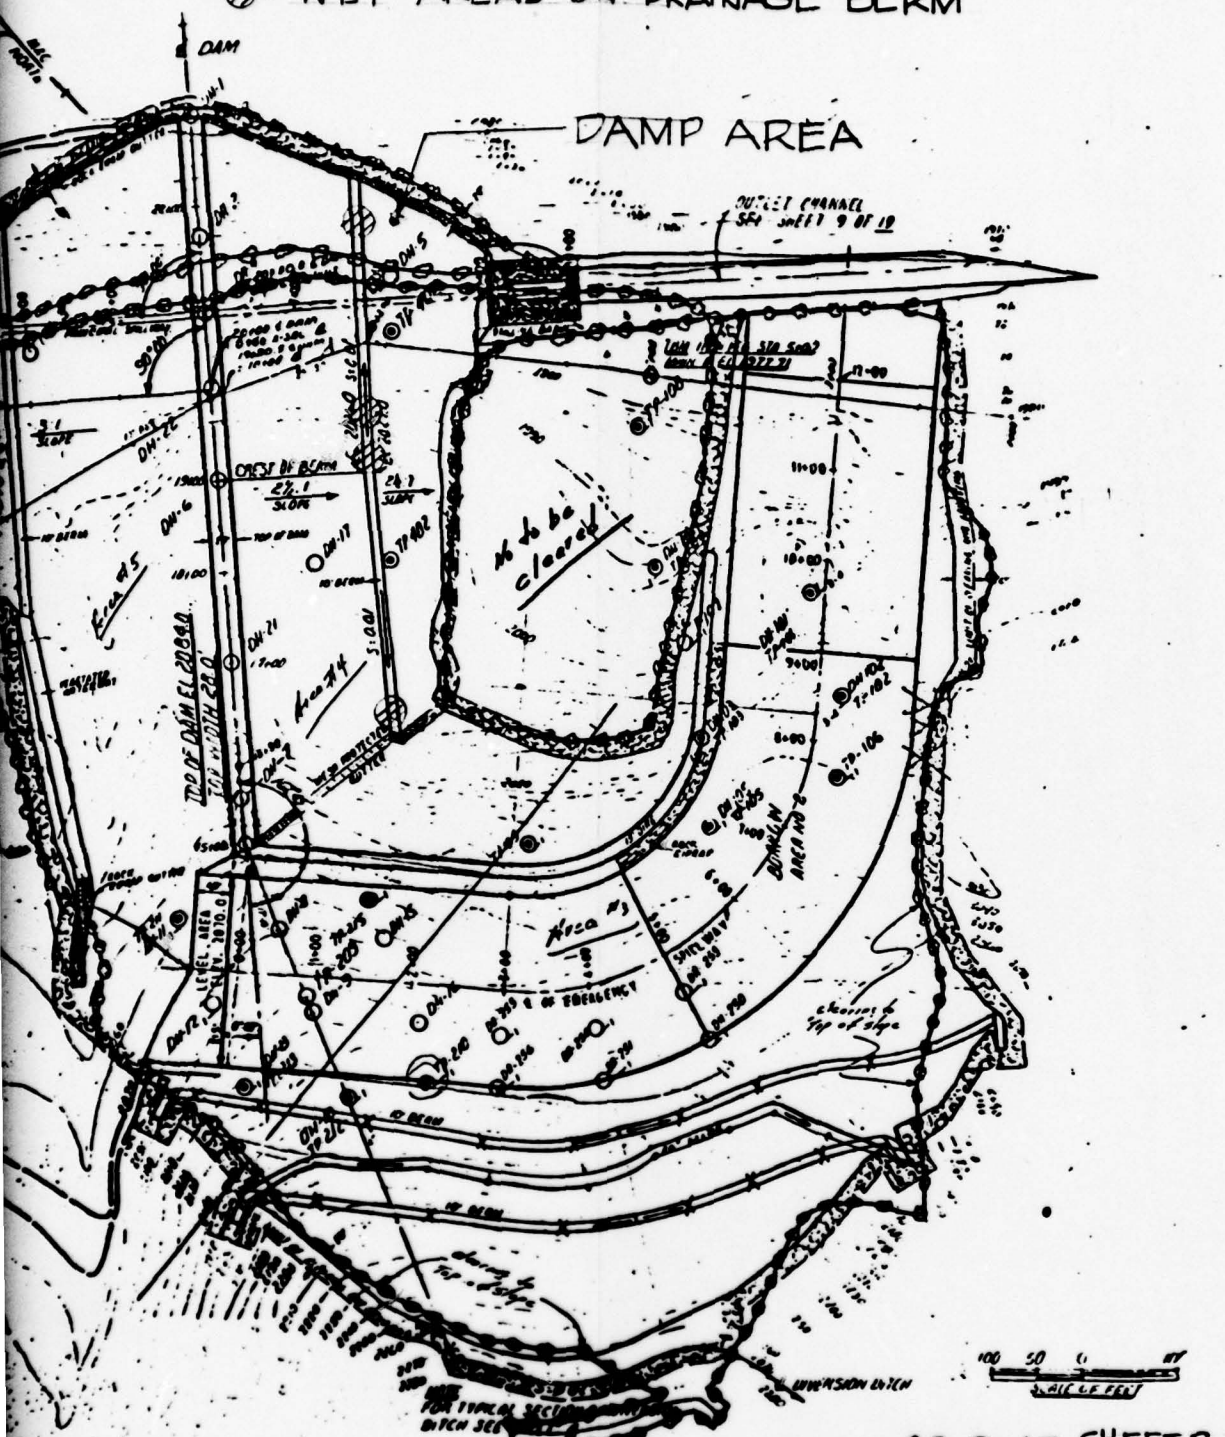
AS BUILT SHEET 2

Wet spots observed along the drainage berm on the downstream slope are probably the result of recent ponding from precipitation, and runoff along low areas in the berm. The general location of these wet spots is illustrated on Sheet 2 in Appendix I. These wet spots occur at El 2026+, while normal pool is at El 2015.5, therefore, they are not the result of seepage. The downstream berm slopes toward both abutments to the riprap gutters, thus providing an adequate drainage system for collecting runoff. If increased ponding continues in the future, local grading may be required to allow better drainage of this berm.

The area of damp soil illustrated on Sheet 2, Appendix I, is believed to occur because of seepage of the water ponded above in the drainage berm. This condition is not believed to be related to seepage through the dam.

⊙ WET AREAS ON DRAINAGE BERM

1.7 Seepage: One damp spot was noted about 20 ft right of the left abutment and about 50 ft downstream of the midslope drainage berm. We believe this wet area at about EL 2005 is the result of surface water seeping from the drainage berm above.

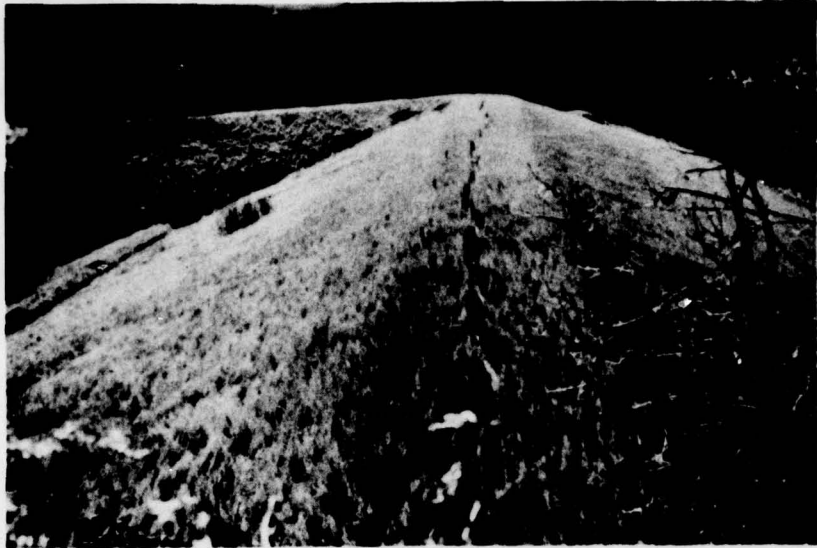
TOP OF EARTHEN BERM
VIEW FROM NORTHEAST
Photo #1

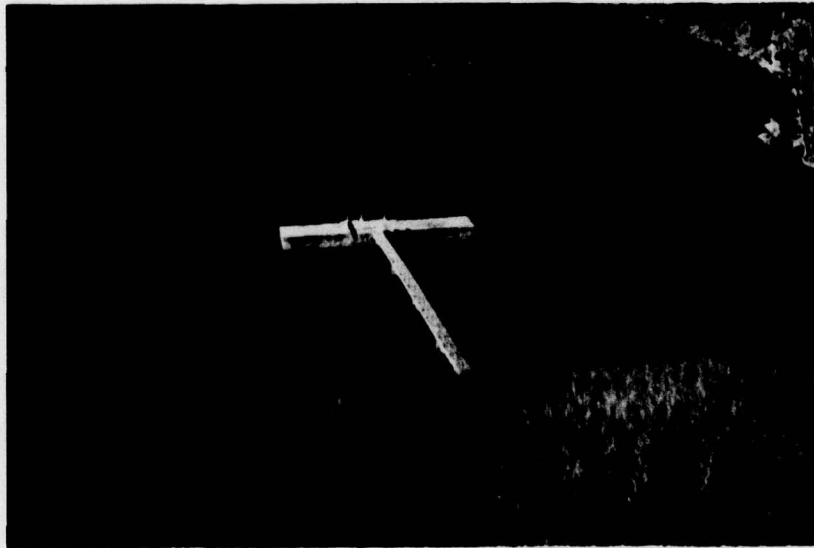
PRINCIPAL SPILLWAY STRUCTURE
(GOOD CONDITION)
Photo #2

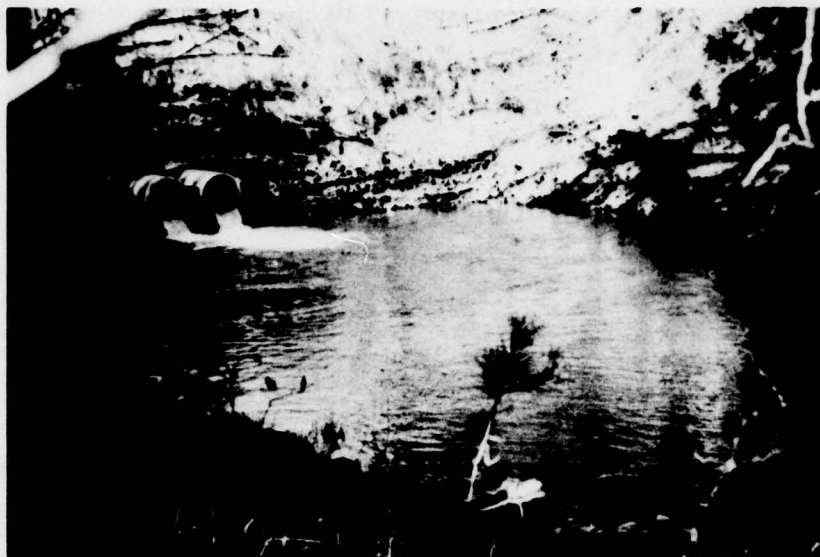
STILLING BASIN AND OUTLET PIPE
(NOTE RIP RAP AND STILL WATER SURFACE)
Photo #3

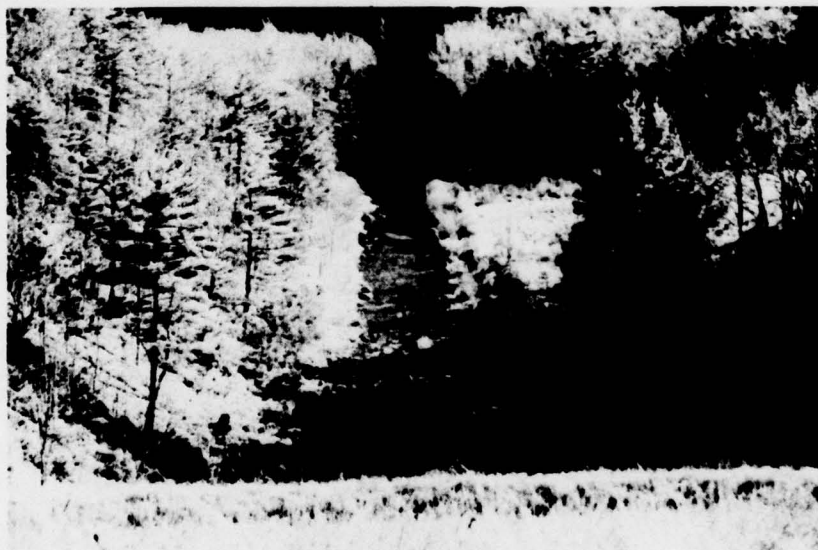
DOWNSTREAM CHANNEL
(GOOD CONDITION)
Photo #4
