Name Of Dam: STAUNTON DAM  
Location: AUGUSTA COUNTY, VIRGINIA  
Inventory Number: VA. NO. 01518

# PHASE I INSPECTION REPORT NATIONAL DAM SAFETY PROGRAM

Name of Dam: Staunton Dam, Va. No. 1518

Date of Inspection: December 13, 1978

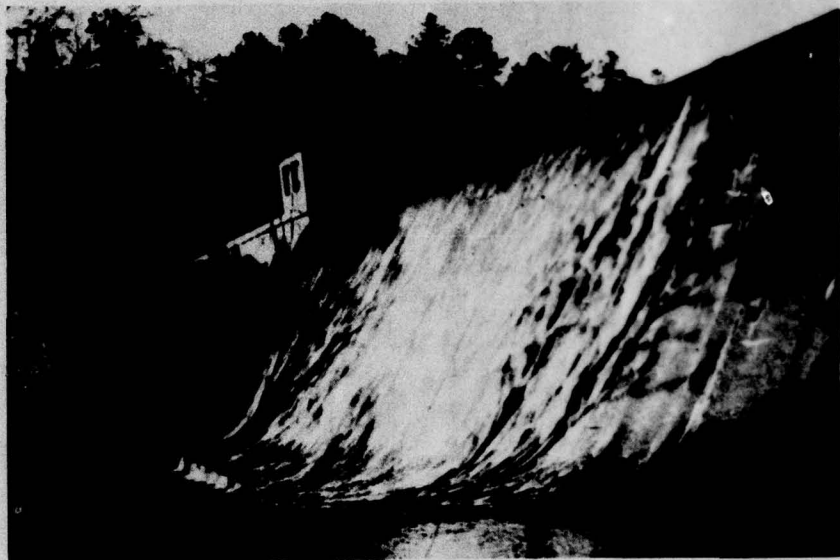
The gunited surface of the spillway was sounded and found to have voids in several locations. The valve chamber for the 36 inch drawdown inlet was found to have calcium deposits coating the walls. The valves for the water supply inlet were inoperable. It could not be determined if construction joints in the spillway were leaking.

**VIEW OF WESTERN SECTION OF  
DOWNSTREAM SIDE OF SPILLWAY  
Photo #1**

1.6 Surface Cracks, Concrete Surfaces: Various surface cracks on spillway. Spillway was sealed with Gunitite in 1971, but appears to be bleeding lime from concrete. Observation by owner indicates no visible wet spots when water below spillway.

The gunited surface does not present an immediate problem. However, it is recommended that the owner evaluate the gunited surface and construction joints.

The gunited surfaces should be sounded and the expansion joints on spillway checked for leakage at a period of no flow over the spillway surface.

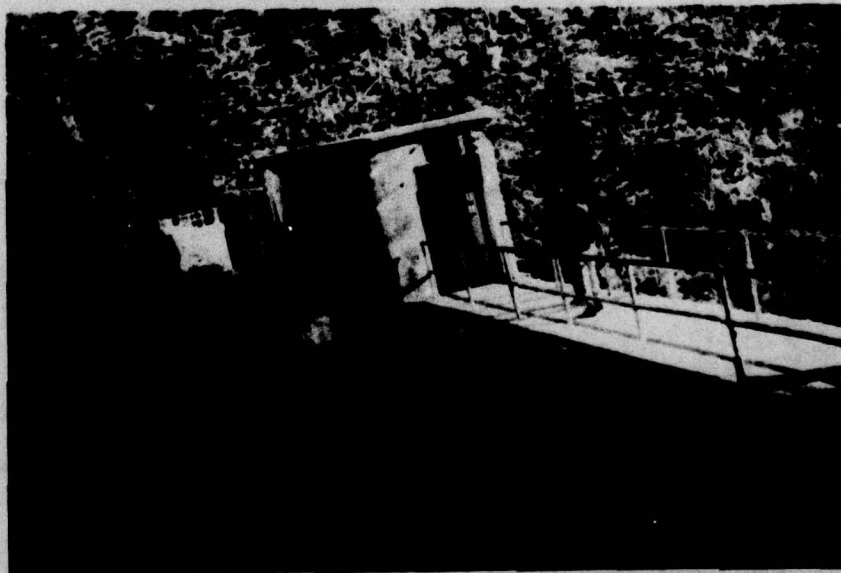
**VIEW OF GATE HOUSE STRUCTURE**  
Photo #4

1.4 Water Passages: Passages are clear of debris. A 36" cast iron drain is used to lower lake and is operable. A 16" cast iron intake is used for water supply to the City of Staunton. No visible leaks were observed at the lower control station. Valves in dam not operable.

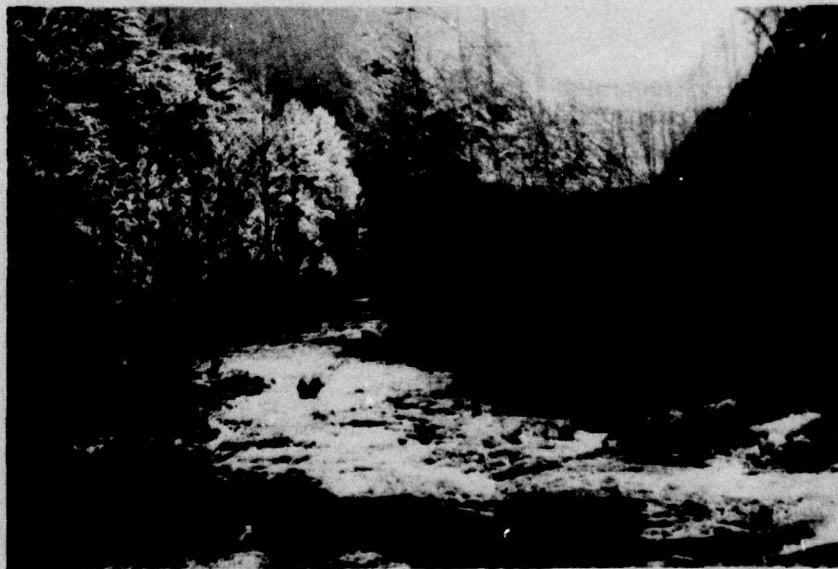
**VIEW OF DOWNSTREAM OUTLET CHANNEL**  
Photo #6

2.4 Outlet Channel: Good condition. No debris, some heavy shrubs.

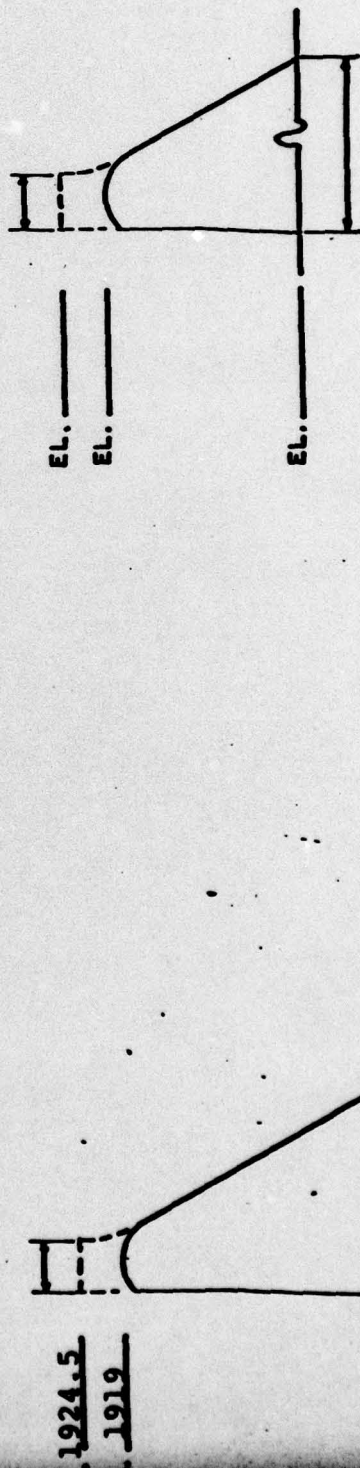
passes within the middle third of the base. Under surcharged conditions caused by the PMF, the resultant of all forces will cause overturning. Without direct evidence that the dam is keyed into the bedrock, and assuming only a surface of bedrock foundation, the dam would be subject to overturning failure under the PMF loading without regard to end restraint.

LOADING CASE	ELEV. HEAD WATER	ELEV. TAIL WATER	Σ V.	Σ H	Σ H / Σ V	LOCATION RESULTANT FROM TOE	% BASE IN COMPRESSION	FACTOR SAFETY SLIDING	FOUNDATION PRESSURE	
									TOE	HEEL
NORMAL POOL	1919	1878.5	49.3 K	55.0 K	1.11	15.6'	100%	1.35	4.11ksf	0.84 ksf
PROBABLE MAXIMUM FLOOD	1933.5	1913	33.3 k	47.5 k	1.42	4.1'	31%	1.32	5.4 ksf	0 ksf

NOTE: ANALYSIS DOES NOT CONSIDER ABUTMENT END RESTRAINT.

7.3 Investigation by Owner: This investigation should include sufficient subsurface exploration to define the depth of embedment of the structure. The stability of the dam should then be assessed with respect to sliding and overturning utilizing the estimated foundation geometry and estimated strength of the foundation rock and friction resistance of the concrete-rock interface using the methods defined in Reference I, Appendix V.
