COUNTRY LAKES DAM

NO. 1

NJ 00050

**PHASE 1 INSPECTION REPORT
NATIONAL DAM SAFETY PROGRAM**

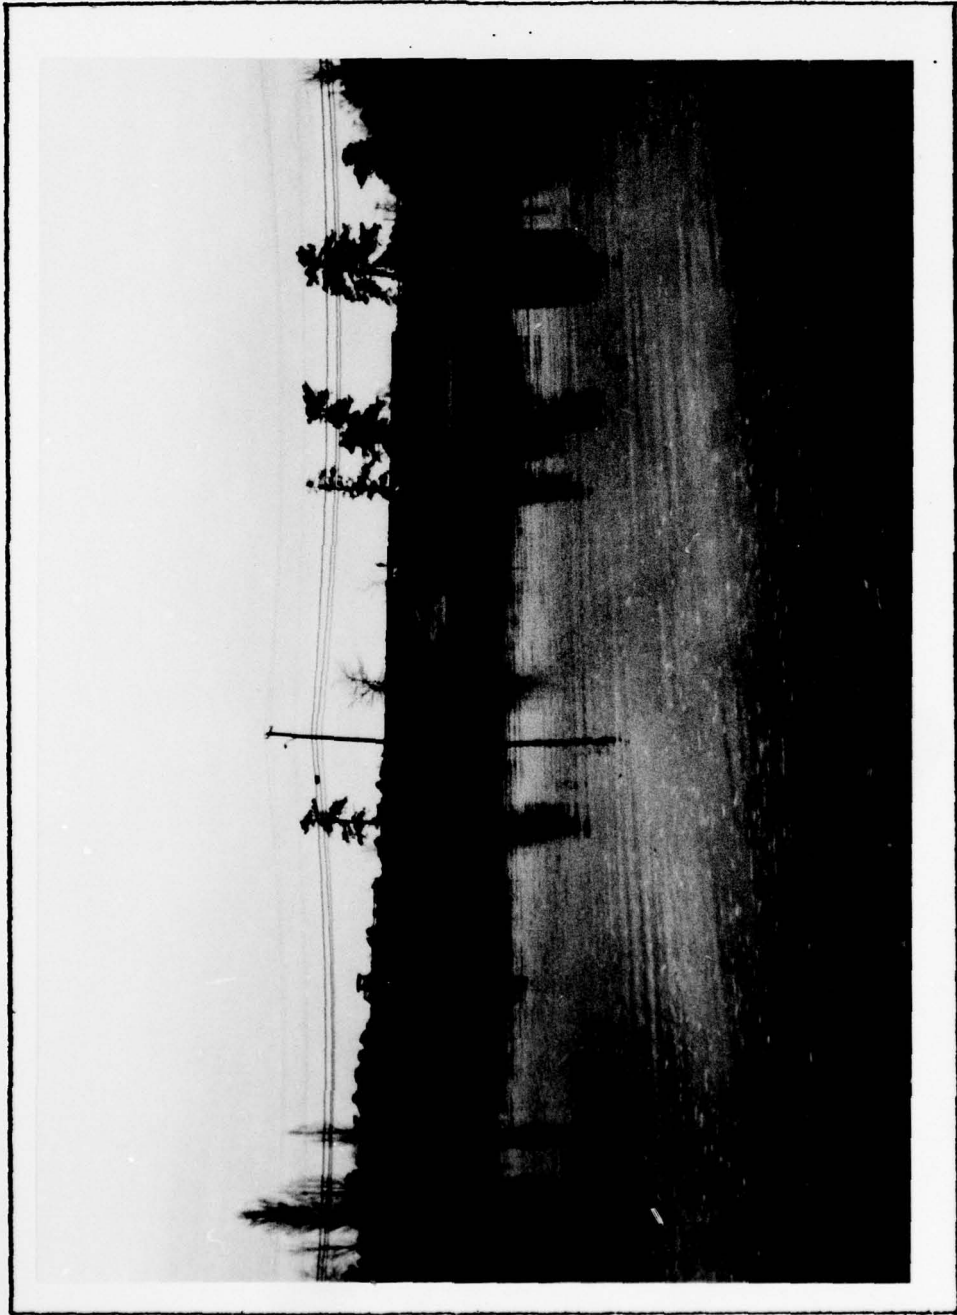
*OVERVIEW OF THE EMBANKMENT AND SPILLWAY LOOKING UPSTREAM
COUNTRY LAKES DAM NUMBER ONE, BURLINGTON COUNTY, NEW JERSEY*

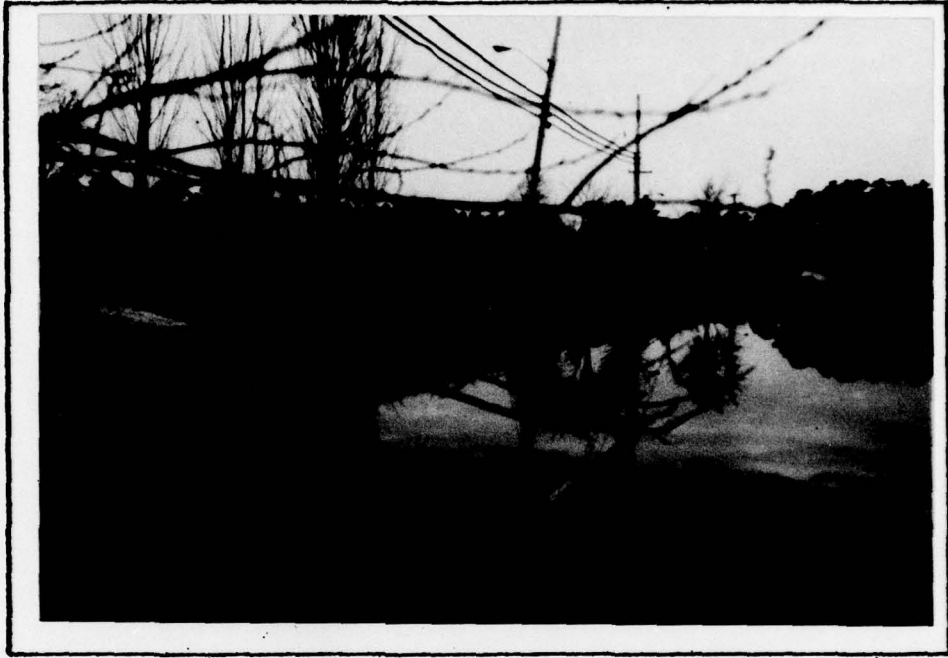
*UPSTREAM FACE OF THE DAM
FROM THE LEFT ABUTMENT 4/12/79*

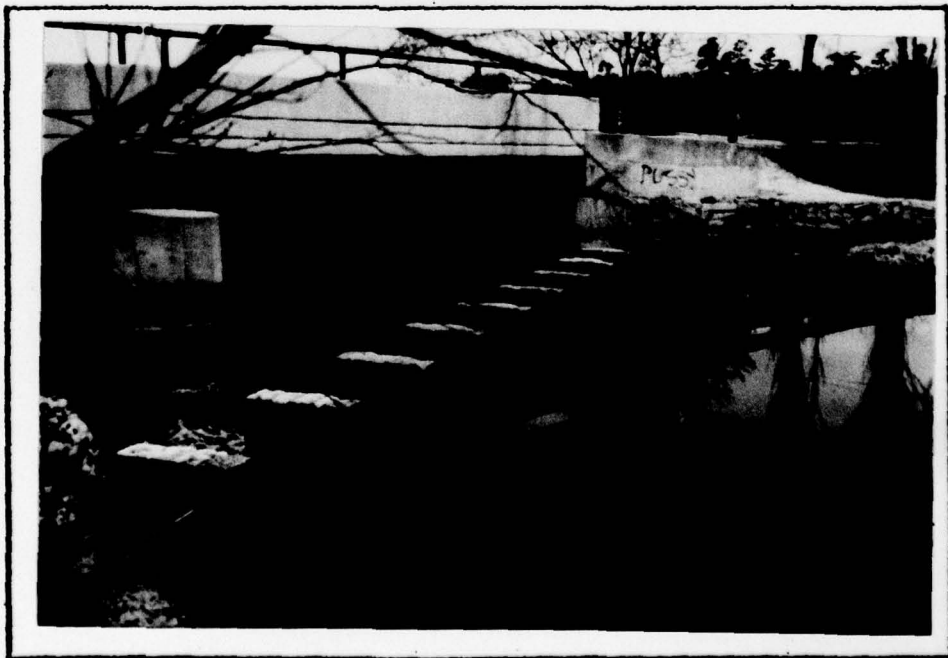
c. Visual Observations. The bridge and the concrete portion of the spillway appeared to be in good condition. However, if a large flood occurs, the full spillway capacity may be difficult to attain due to the laborious process involved in removing the stop logs. This operation would also be impeded due to the lack of a service bridge over spillway piers.

*SPILLWAY STOPLOG PIERS
AND THE BRIDGE OPENING 4/12/79*

(1) A service bridge should be provided to facilitate the removal of stop logs.

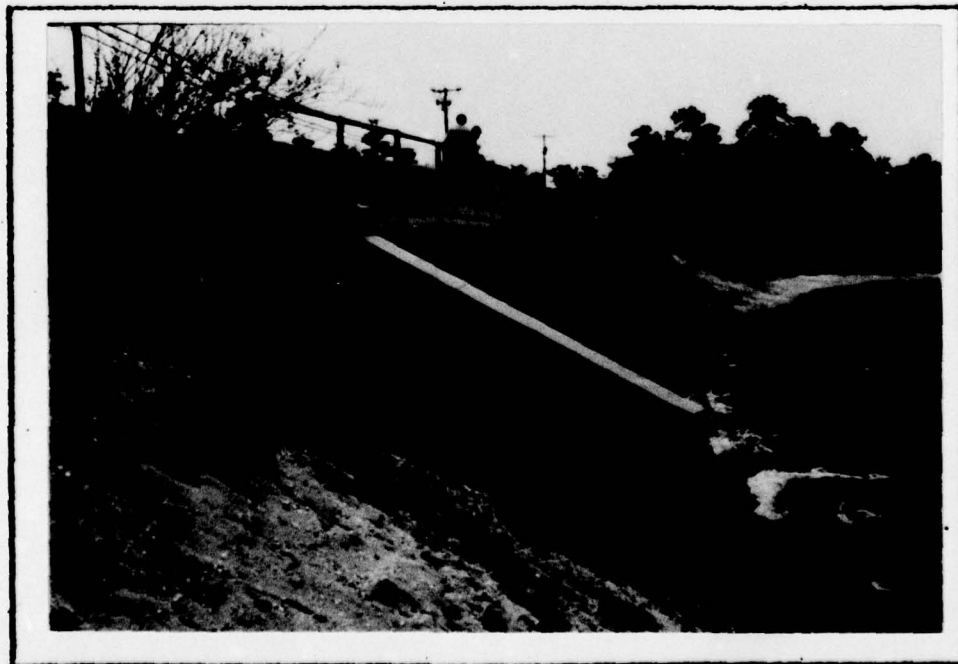
*DOWNSTREAM FACE OF THE
EMBANKMENT AND BRIDGE 4/12/79*

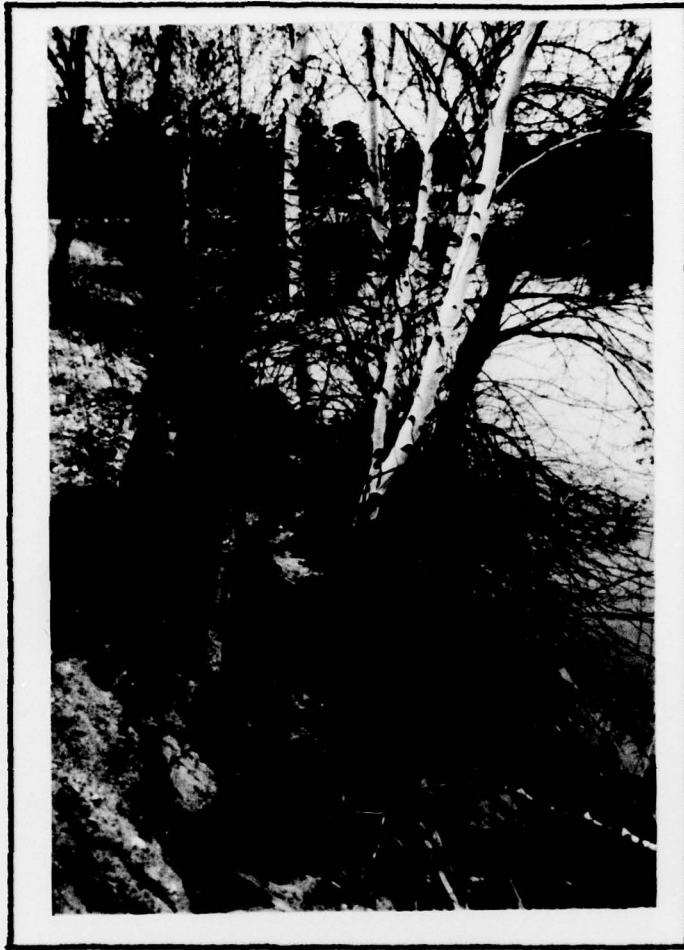
*DOWNSTREAM FACE OF
THE EMBANKMENT
SHOWING DEBRIS
AND TREES
4/12/79*

(4) Trees and brush should be removed from the embankment and the areas where trees have been removed should be backfilled and regraded.

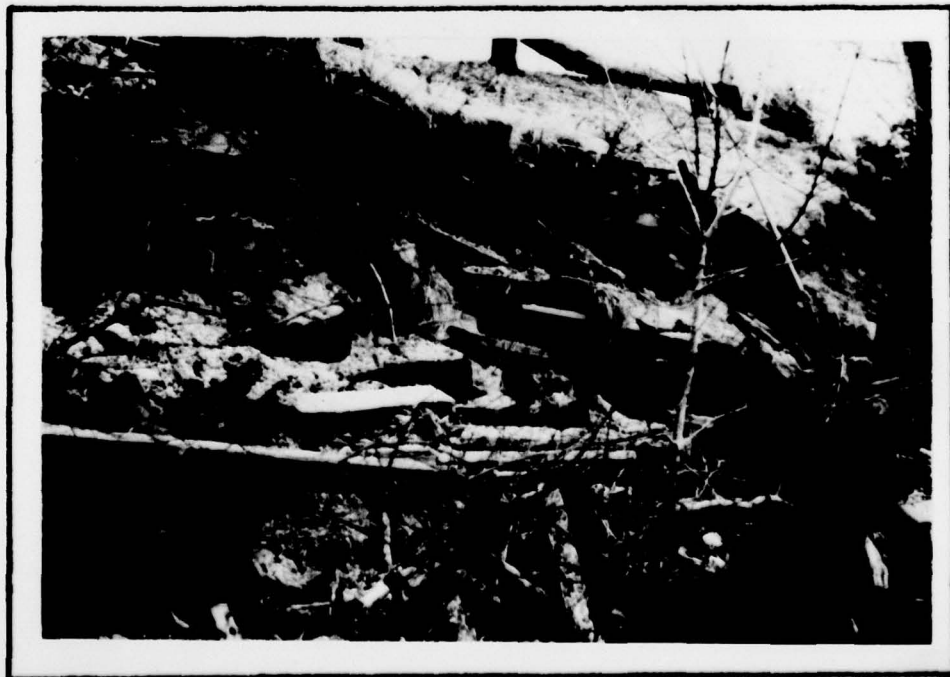
*DOWNSTREAM FACE OF THE EMBANKMENT
SHOWING EXTENSIVE DEBRIS 4/12/79*

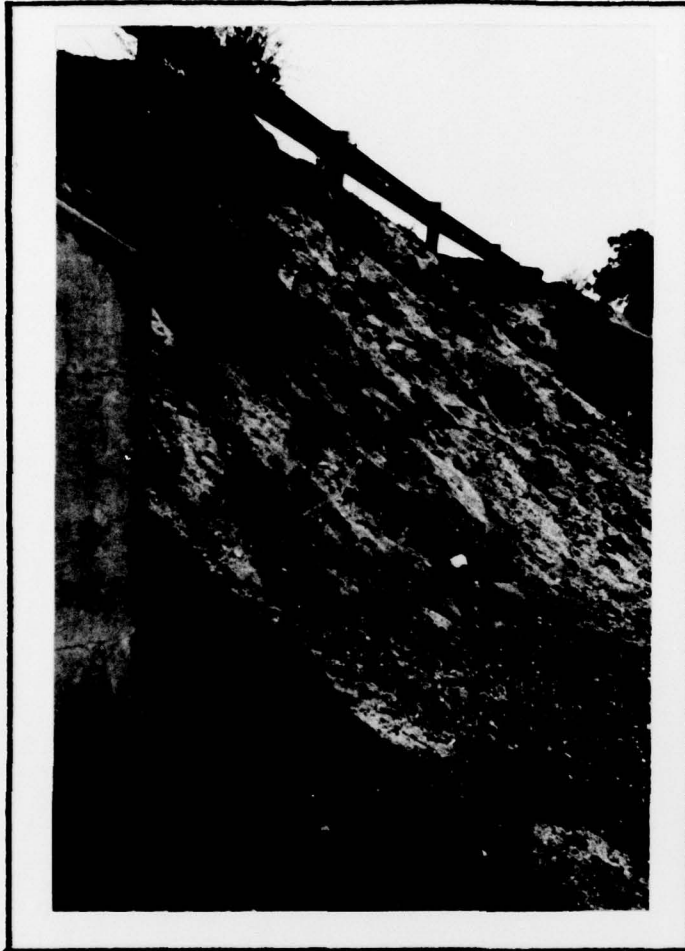
a. Visual Observations. On the date of the inspection, the embankment appeared to be in fair condition. The depression of the road adjacent to the bridge may be due to poor compaction during construction. Both the upstream and the downstream slopes do not have adequate slope protection. The downstream slope has no protection and is subject to an intensive erosive process from surface runoff. There are a number of areas where surface runoff has deeply eroded the downstream slope. The variation of the slopes of the embankment appears to be largely a result of erosion by surface runoff.

*DOWNSTREAM FACE OF
THE EMBANKMENT
SHOWING EROSION
AND LACK OF COVER
4/12/79*

(3) Areas below design elevation should be filled and compacted to restore the embankment to design elevations and slopes. The embankment slopes should be protected with vegetative cover or riprap.

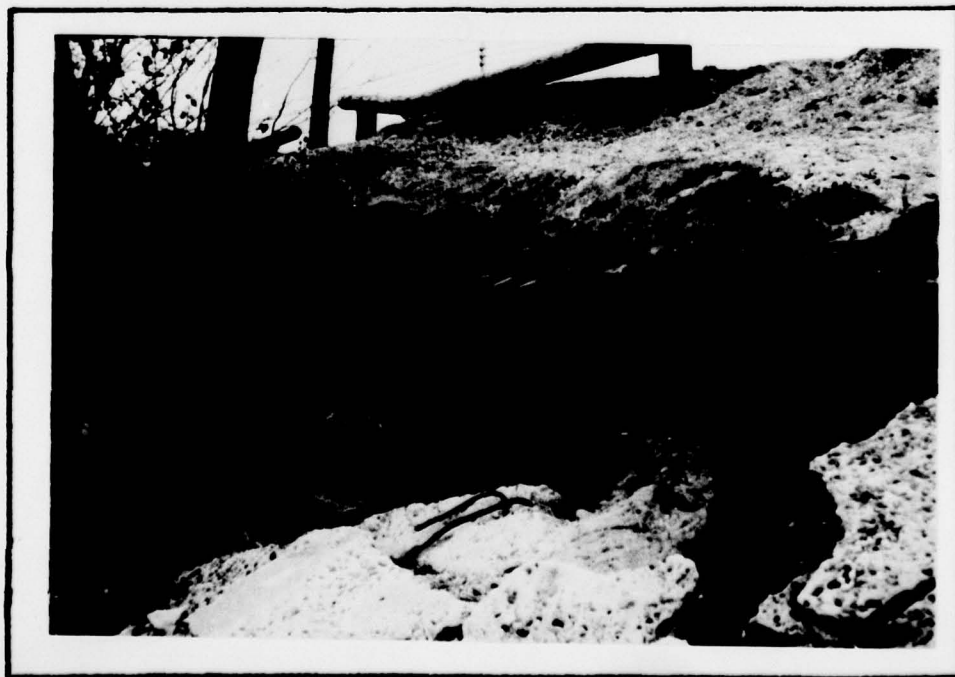
*DOWNSTREAM FACE OF THE EMBANKMENT SHOWING
EROSION AND MATERIALS INCLUDED IN THE EMBANKMENT D-4*

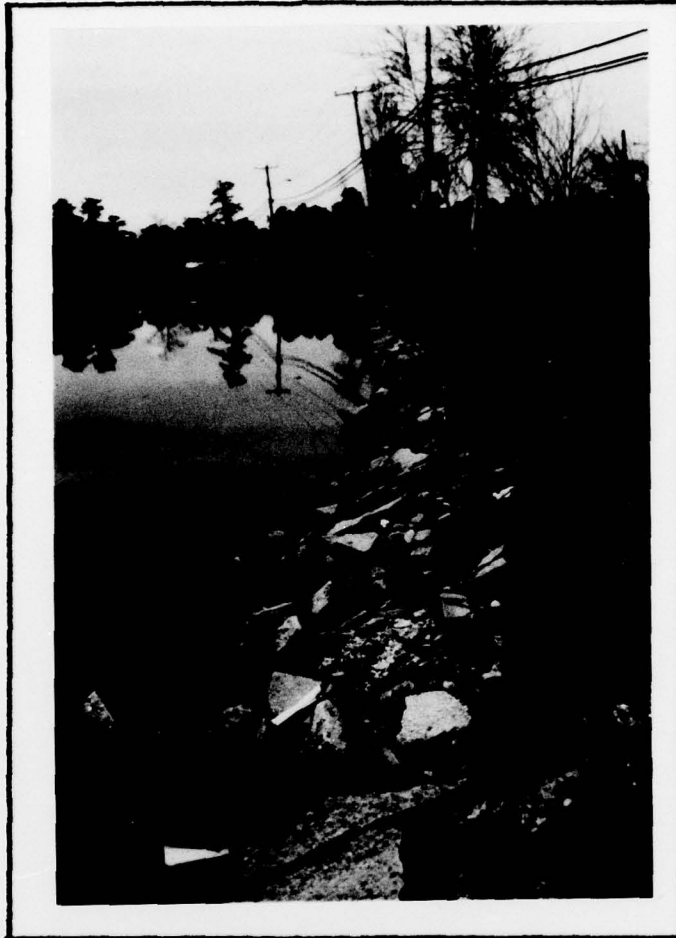
**UPSTREAM FACE OF
THE DAM FROM THE
RIGHT ABUTMENT**

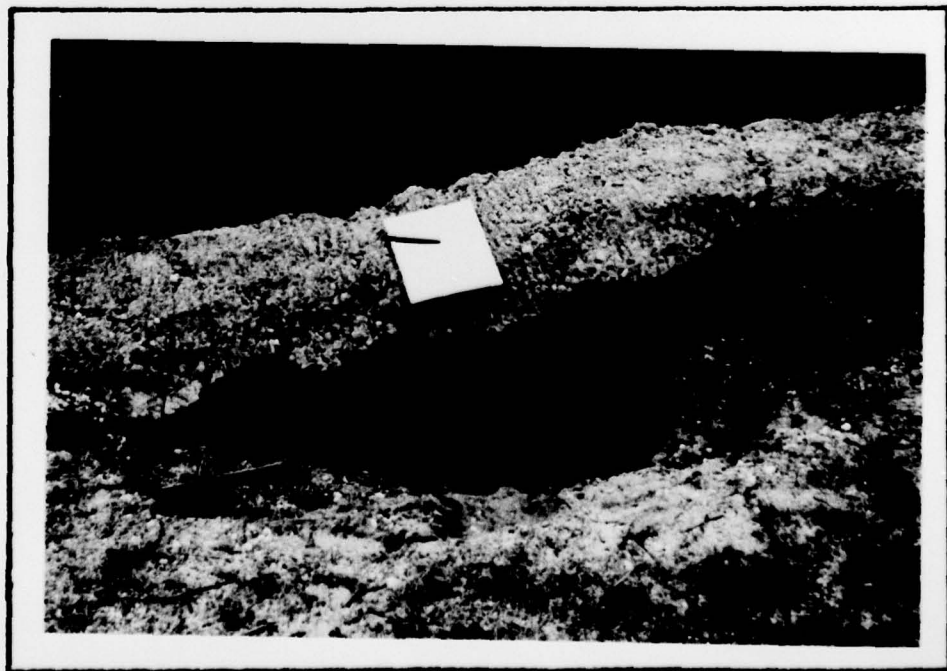
Some slight undermining was
observed at the junction of
embankment and upstream and
downstream retaining walls.

**UNDERMINING OF THE BLOCK WALL ALONG
THE UPSTREAM EMBANKMENT SLOPE 4/12/79**

(2) In several areas erosion of the embankment is taking place behind the upstream and downstream retaining walls. These areas should be backfilled and compacted with suitable material.
