LAKE PARSIPPANY DYKE

NO 1

NJ 00356

PHASE 1 INSPECTION REPORT
NATIONAL DAM SAFETY PROGRAM

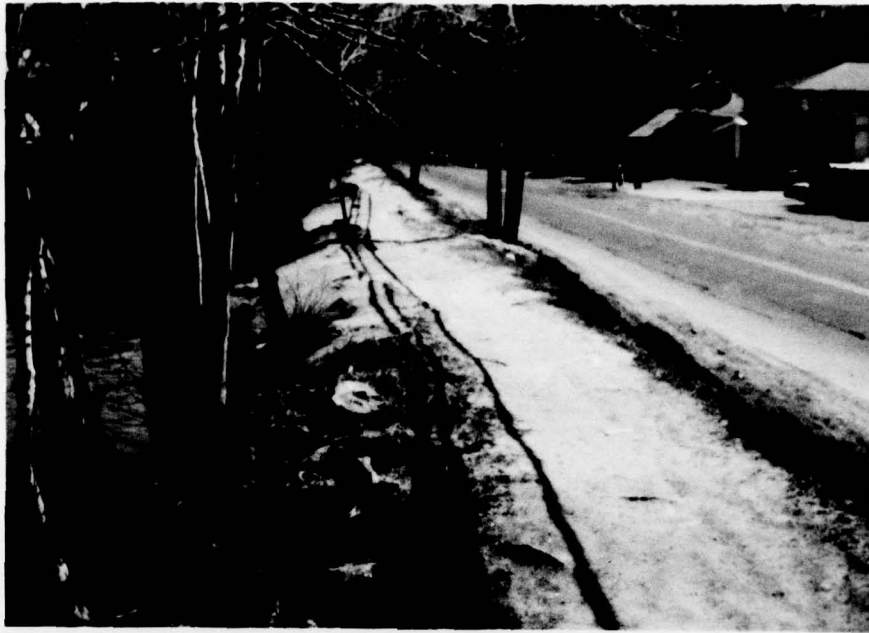
PHOTO 1
CREST OF DYKE

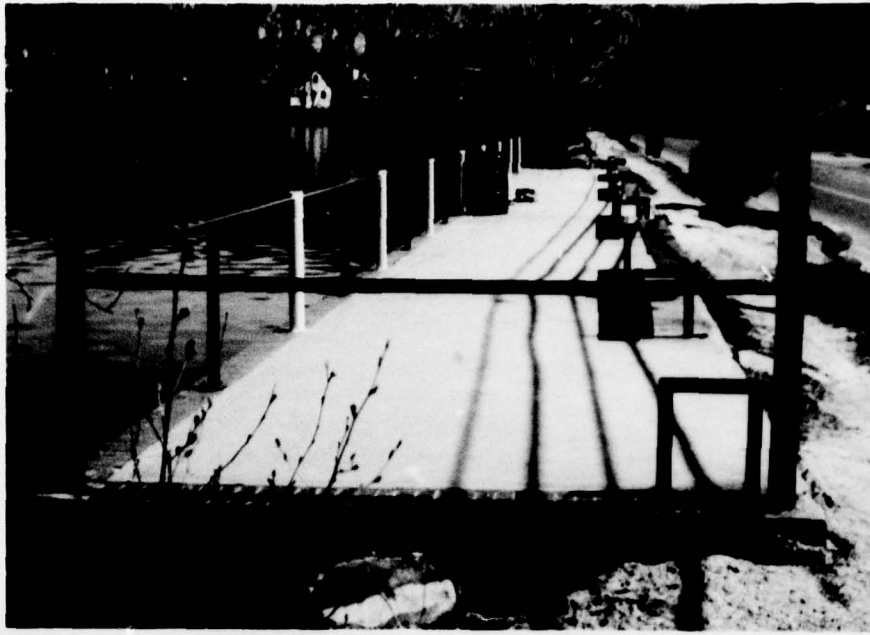
PHOTO 3
CONCRETE DOCK

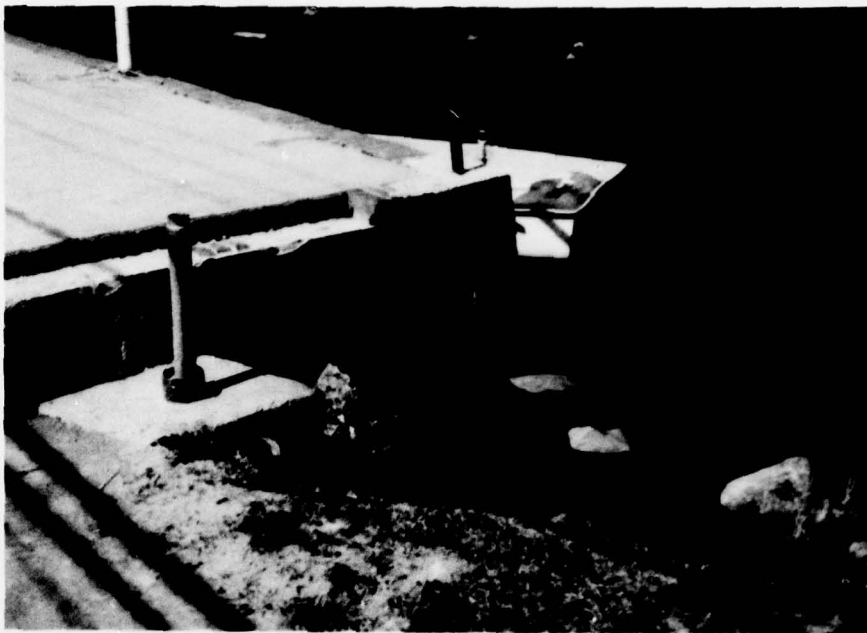
PHOTO 5

DETERIORATION OF SOUTH END OF CONCRETE DOCK

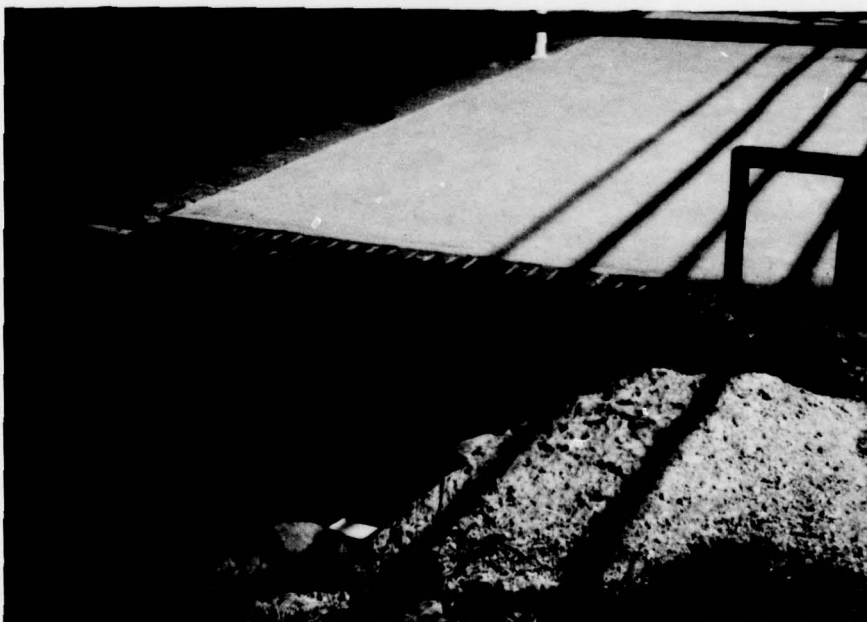
PHOTO 6

DETERIORATION OF NORTH END OF CONCRETE DOCK

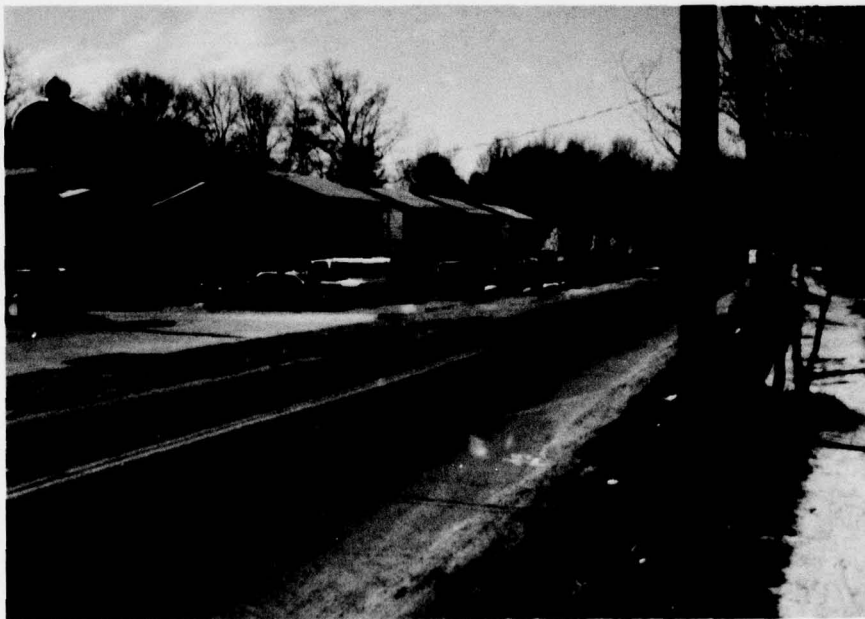
PHOTO 8
DOWNSTREAM FACE OF DYKE

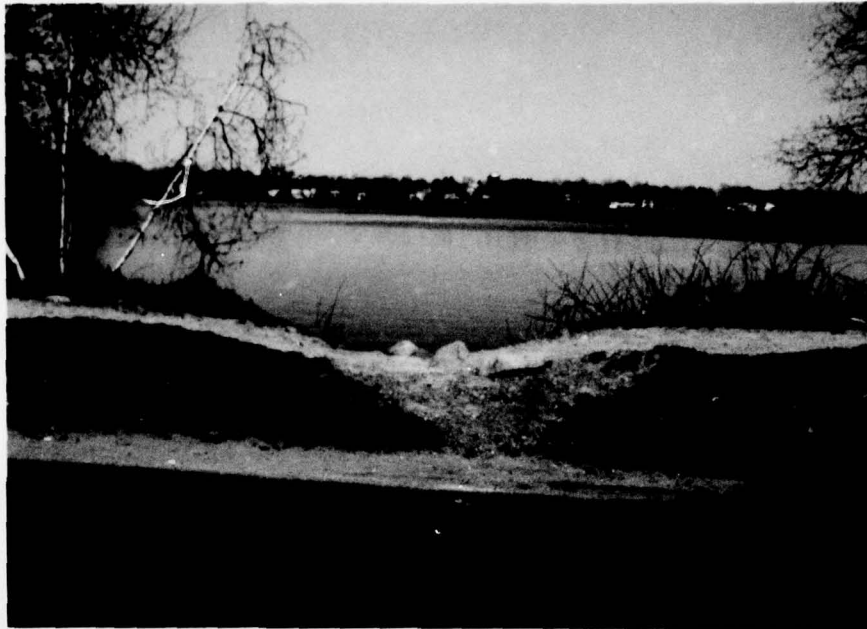
In general, the dyke appeared, at the time of inspection, to be outwardly structurally stable. Low points along the crest of embankment appear to be a result of erosion and not differential settlement. The condition of the timber corewall cannot be observed. The cause of the slope of the concrete dock as described in paragraph 3.1.b is not outwardly apparent.

PHOTO 9
EROSION OF CREST OF DYKE

(3) The dyke crest should be protected from pedestrian traffic by an appropriate pavement.

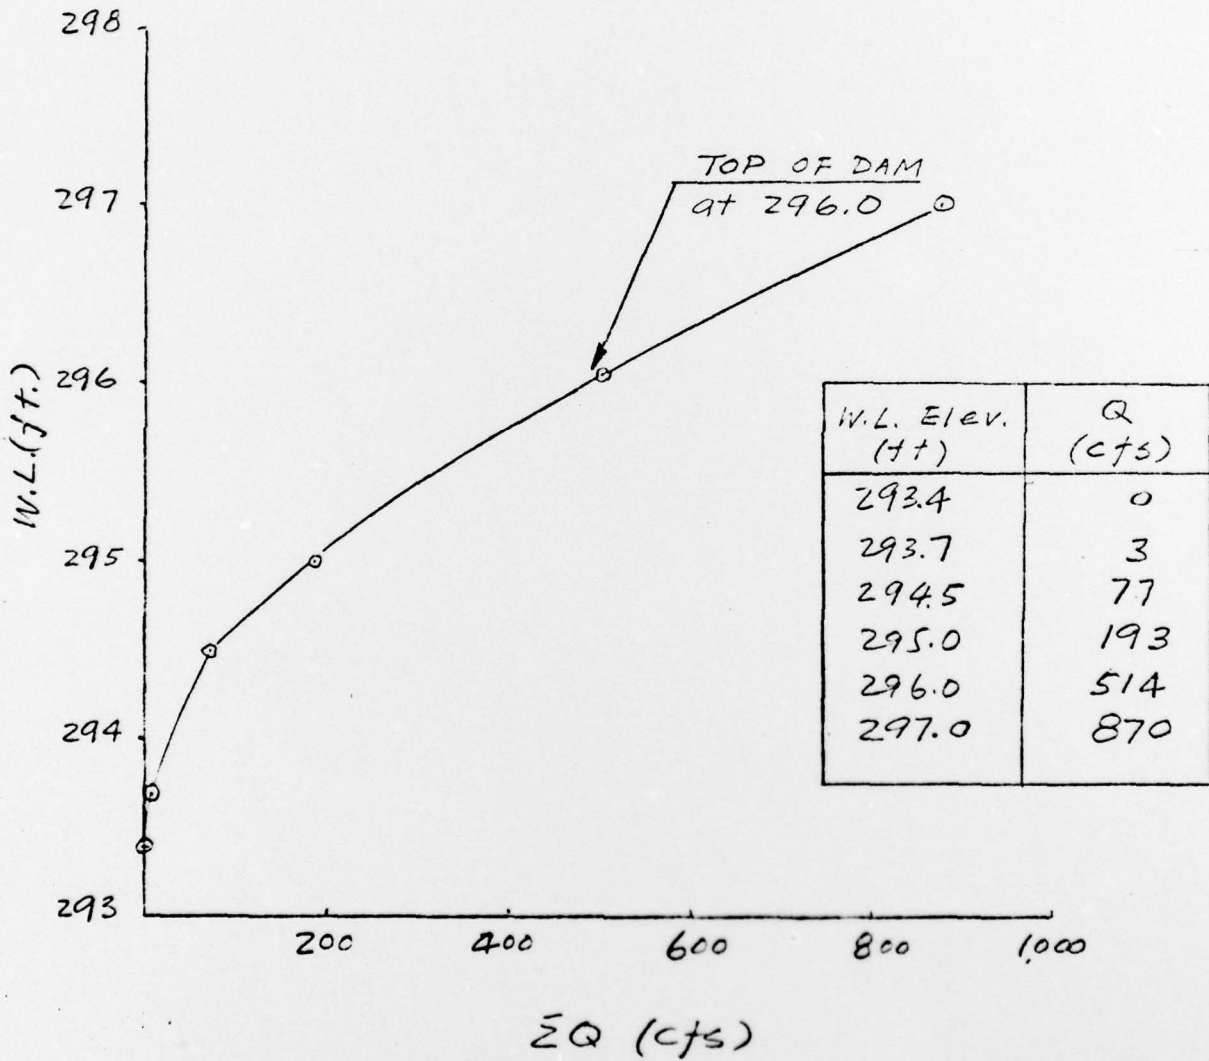
Stage-Discharge Curve
for spillway

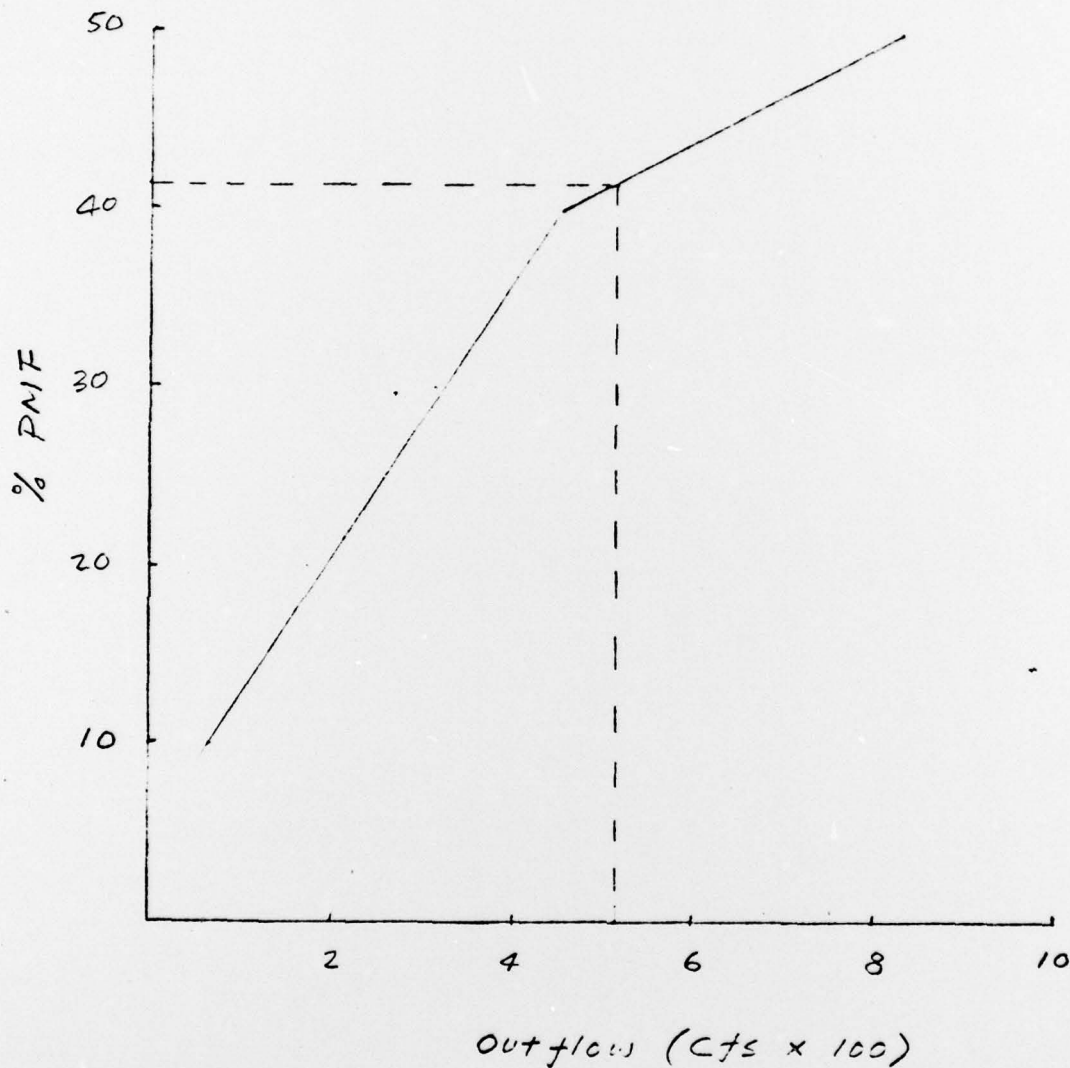
Overtopping Potential

Overtopping occurs at elev. 296 with $Q = 514$ cfs

\therefore Combination of dam and two dykes can pass approx. 41.5 % PMF.
