PASSAIC RIVER BASIN
TROY BROOK, MORRIS COUNTY
NEW JERSEY

LEVEL II CRYSTAL LAKE DAM

NJ 00169

PHASE 1 INSPECTION REPORT NATIONAL DAM SAFETY PROGRAM

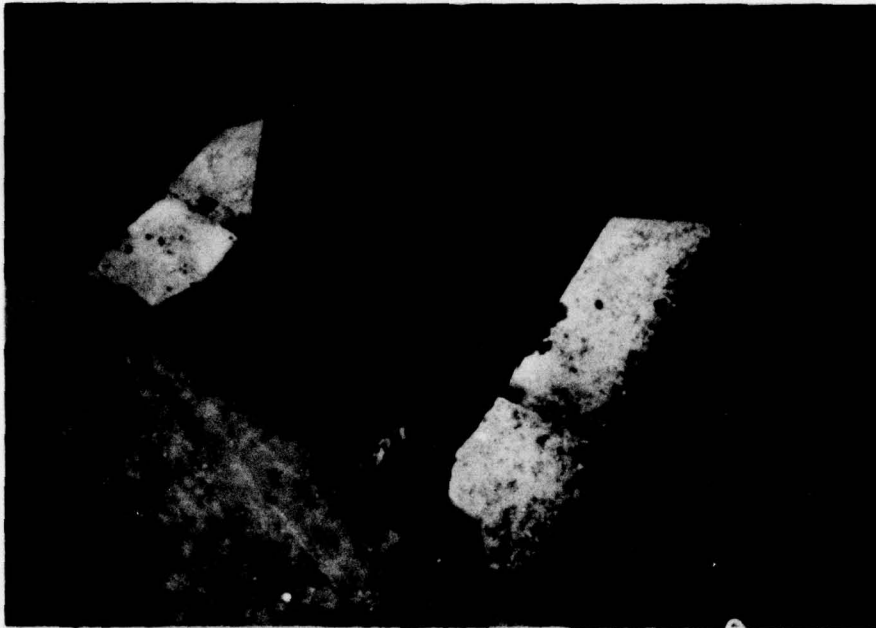
VIEW INSIDE DROP BOX OF SPILLWAY STRUCTURE

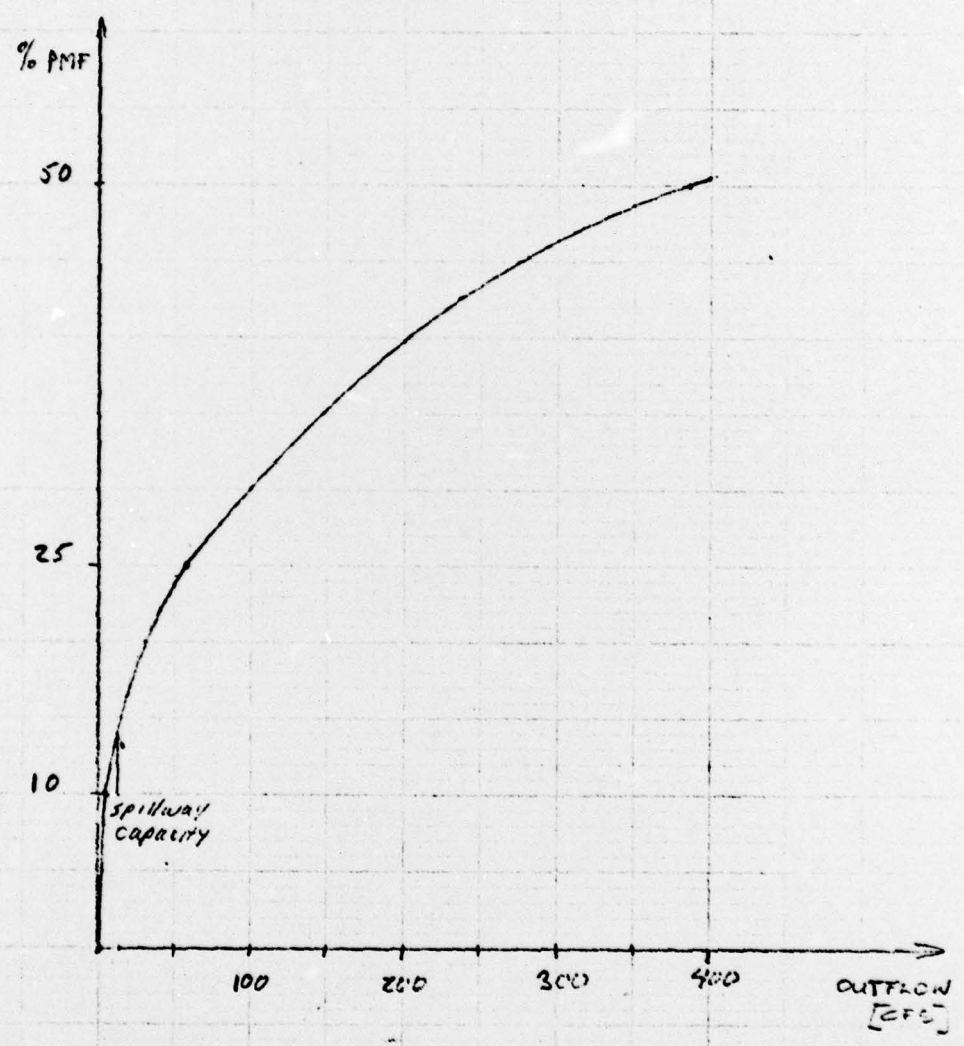
DAM OVERTOPS AT APPROX. ELEVATION 536, FEET MSL
WITH Q - 7 CFS
∴ SPILLWAY CAN PASS ~ 14% of PMF
