PASSAIC RIVER BASIN
PRIMROSE BROOK - MORRIS COUNTY
NEW JERSEY

MT. KEMBLE LAKE DAM

NJ 00363

PHASE 1 INSPECTION REPORT
NATIONAL DAM SAFETY PROGRAM

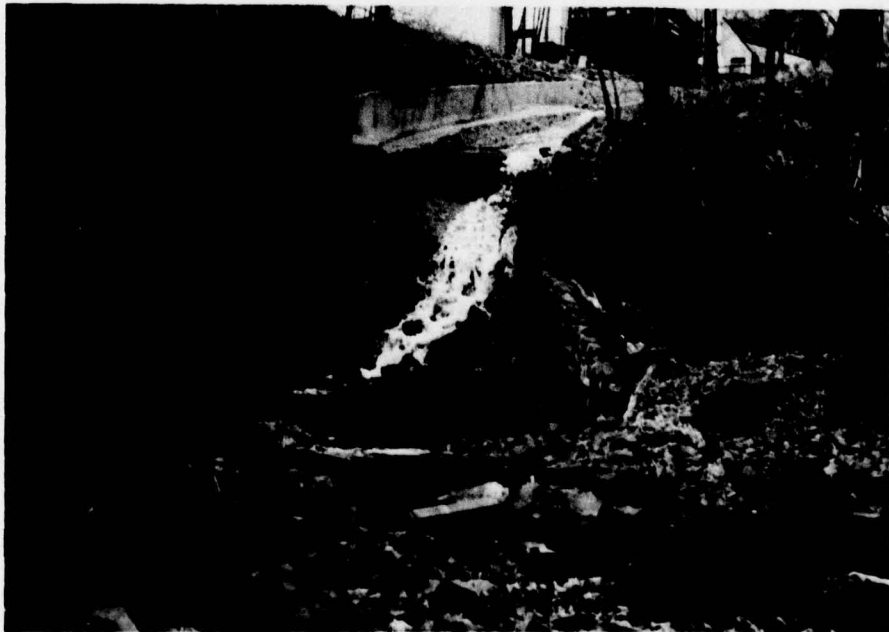
The stone masonry training wall along the east side of the lower section of the spillway discharge channel is in generally satisfactory condition. Water was observed flowing along the east side of the wall for a portion of its length. It could not be determined whether this flow is due to seepage through the dam or to leakage of discharge out of the spillway discharge channel.

PHOTO 2
SPILLWAY OUTLET

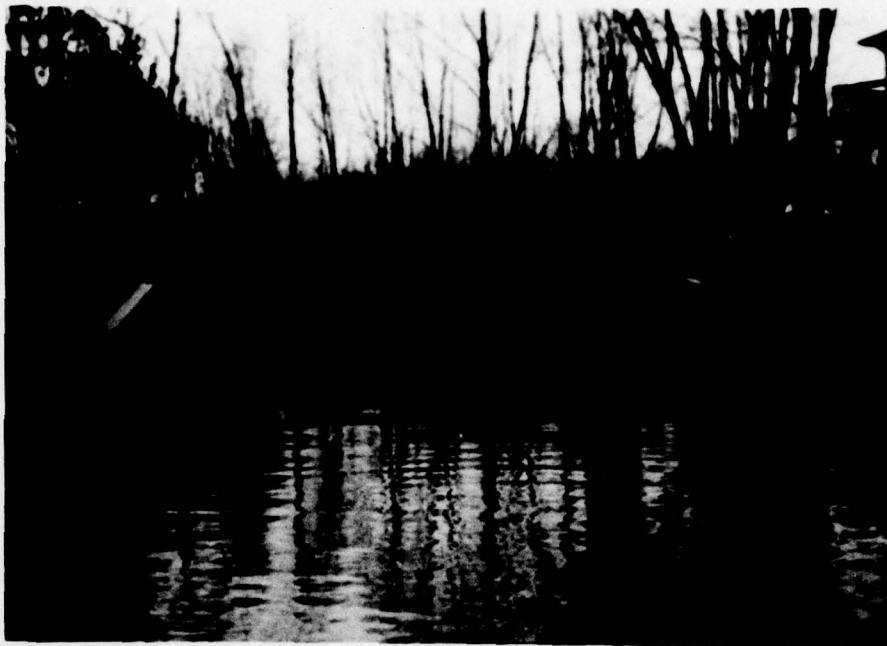
The concrete comprising the east and west training walls is in generally good condition. Three vertical cracks were observed near the point of intersection of the east training wall and the corewall. One crack was observed in each of the three branches of the intersection. These cracks could be indications of settlement of the training wall.

PHOTO 3
UPSTREAM VIEW OF SPILLWAY

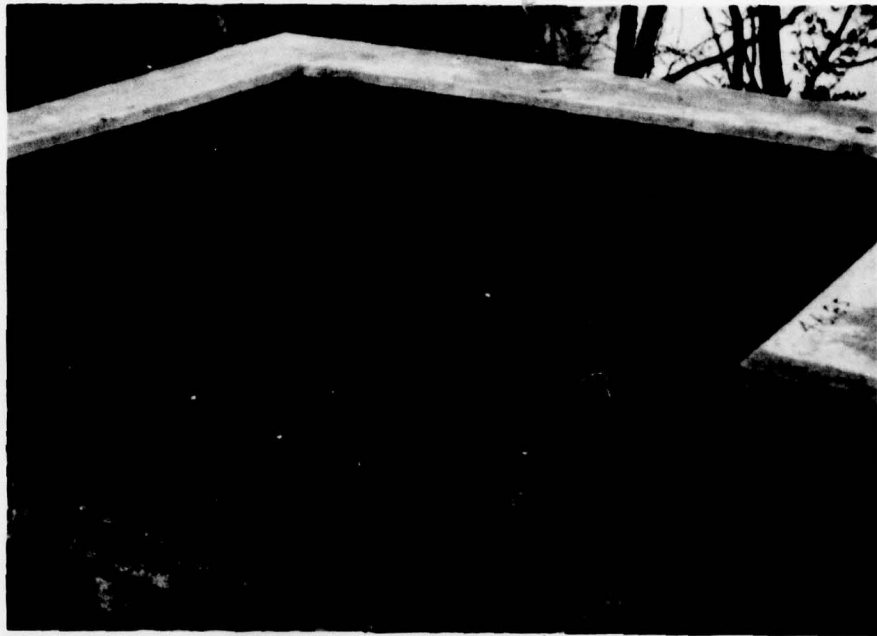
The gate operating stems, cast iron cover and metal steps of the outlet works manhole appeared to be in generally good condition. However, vertical cracks with widths of one-eighth inch each were observed in the east and west walls of the manhole. The discharge ends of the outlet pipes could not be clearly observed because they were submerged by the tailwater of the outlet works discharge channel.

PHOTO 7
OUTLET WORKS OPERATING MECHANISM
