PASSAIC RIVER BASIN
EASTMANS BROOK, MORRIS COUNTY
NEW JERSEY

LAKE PARSIPPANY DAM
NJ 00355

PHASE 1 INSPECTION REPORT
NATIONAL DAM SAFETY PROGRAM

Lake Parsippany Dam (NJ-00355)
Passaic River Basin. Eastmans Brook,
Morris County, New Jersey. Phase 1
Inspection Report.

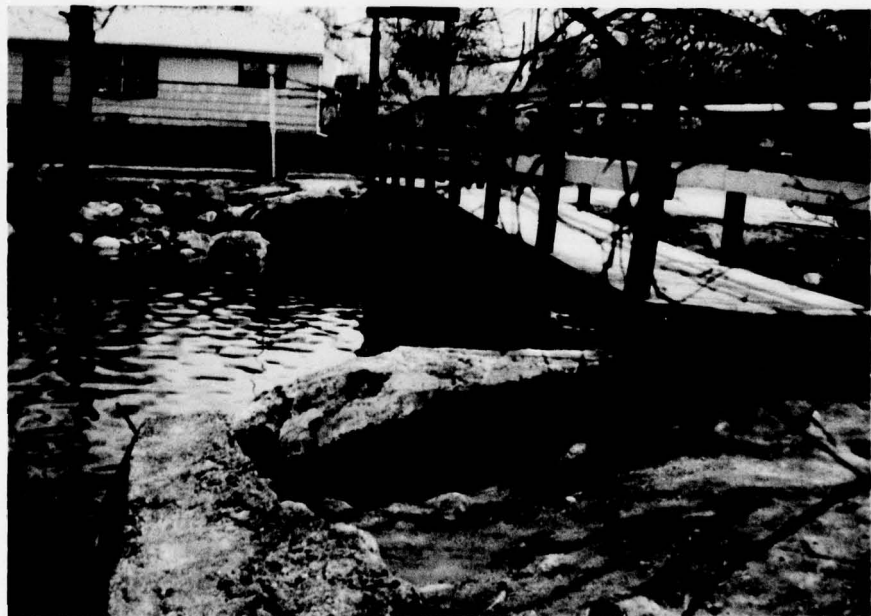
The apron appears to be in structurally sound condition with little or no settlement observed. However, significant spalling was observed on its surface. The timber walkway over the spillway is structurally sound; however, one railing is loose and is considered hazardous. The step-down from the west end of the walkway to the embankment surface is greater than 1 foot and is considered hazardous.

The east wingwall of the spillway is severely spalled over its entire surface and there is evidence of previous patching which now has become deteriorated. The west wingwall is spalled on its downstream end and cracked near the center. The upstream portion of the wingwall is broken off completely and reinforcing rods are protruding. The center pier is spalled on its upstream side from the waterline upward for approximately 1.5 feet. The downstream side of the pier has been patched extensively.

PHOTO 2
DETERIORATION OF CONCRETE AT SPILLWAY

The spillway, wingwalls and apron surface are in deteriorated condition. In the near future they should be thoroughly inspected and renovated by sand blasting, patching, grouting and coating with epoxy.

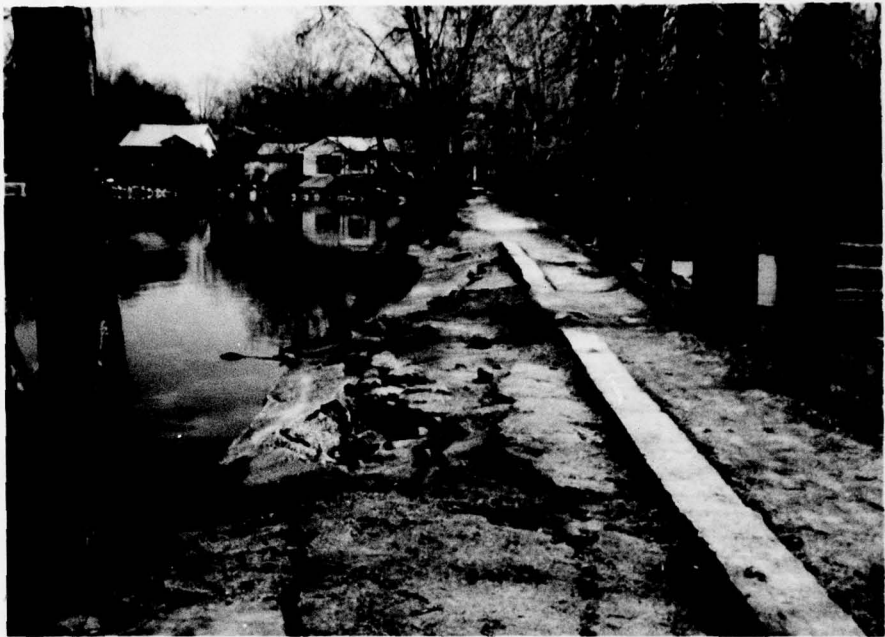
PHOTO 3

The dam embankment appears to be uniformly aligned horizontally with a bend point near the center as shown on the construction drawings. The vertical alignment is irregular with significant depressions noted throughout, most noticeably near the east (spillway) end. The concrete corewall is exposed for about half the length of the dam due to pedestrian traffic and erosion and possibly settlement. The exposed part of the wall does not show any sign of disintegration or spalling. The crest of embankment is bare for most of its length due to pedestrian traffic.

CREST OF DAM - EAST END

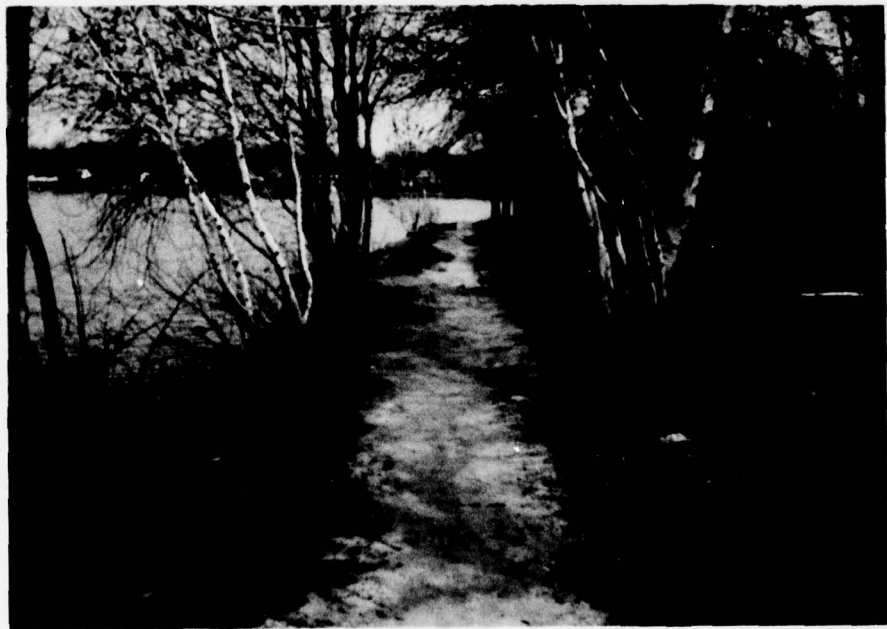
PHOTO 4

CREST OF DAM - WEST END

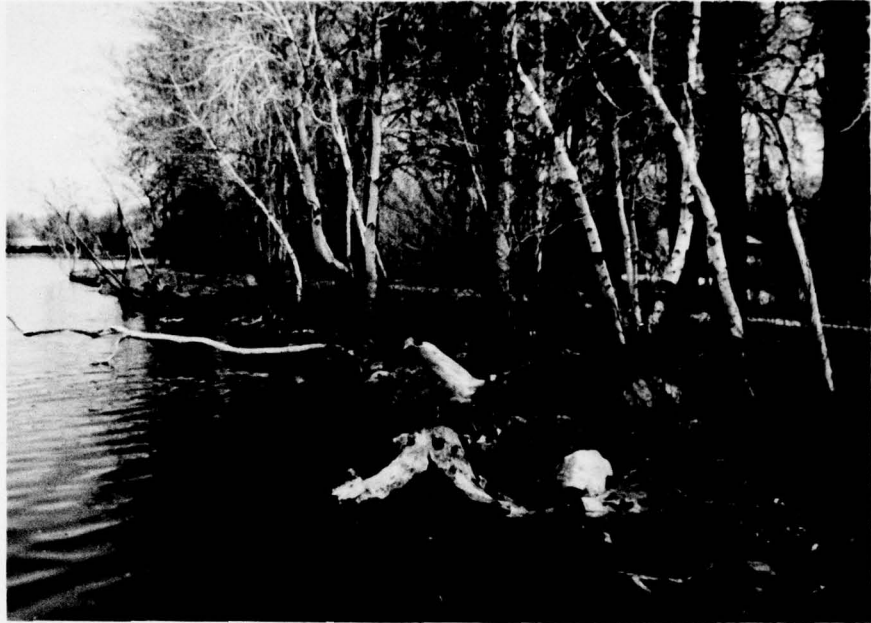
PHOTO 5

Most of the upstream face of dam is covered with riprap. The condition of the riprap appears to be satisfactory below the water line and fair to poor above the water line. In an attempt to protect the riprap, a concrete capping was placed on the upstream slope down to normal pool level. (There is no known record of this repair.) This non-uniform concrete capping is cracked extensively and is generally in a deteriorated condition.

UPSTREAM FACE OF DAM - WEST END

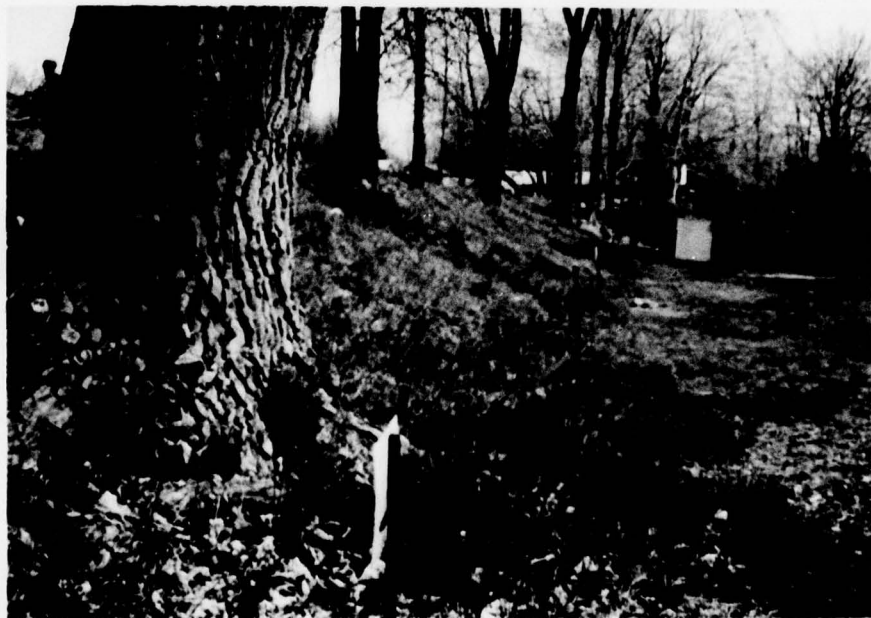
PHOTO 6

Trees and brush are allowed to grow freely on both faces of the embankment. Some of the trees are very large (caliper greater than 24 inches). Grass on the downstream face is generally sparse and eroded to form pedestrian paths except where the downstream face forms the rear of homesites. No evidence of settling or seepage was observed. No animal holes were observed.

DOWNSTREAM FACE OF DAM

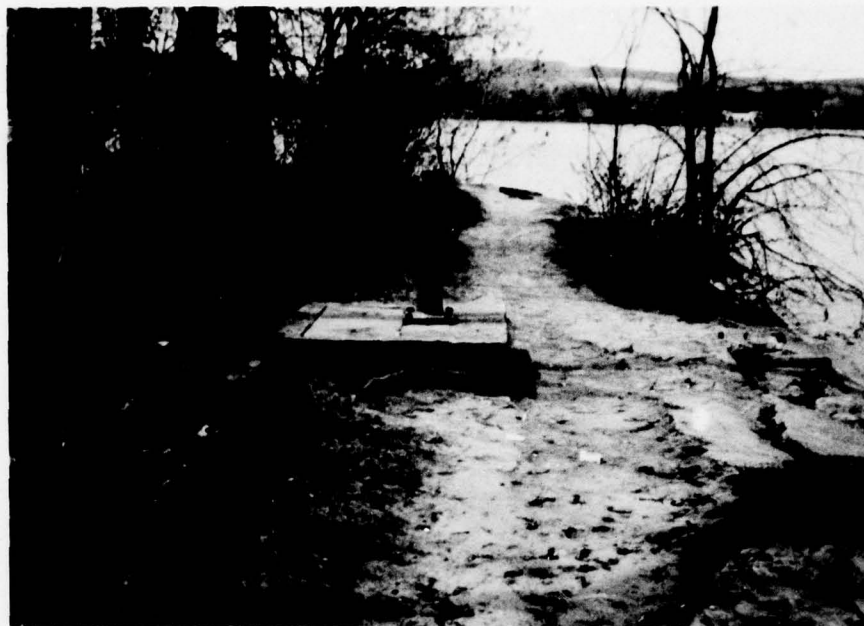
PHOTO 7

The outlet works manhole and the gate operating stem appear to be in good condition. The 24" cast iron pipe could not be observed except at the outlet which was almost totally submerged by tailwater that had very little movement. The grouted stone endwall is in deteriorated condition and the outlet channel is silted and contains accumulated debris.

OUTLET WORKS OPERATING MECHANISM

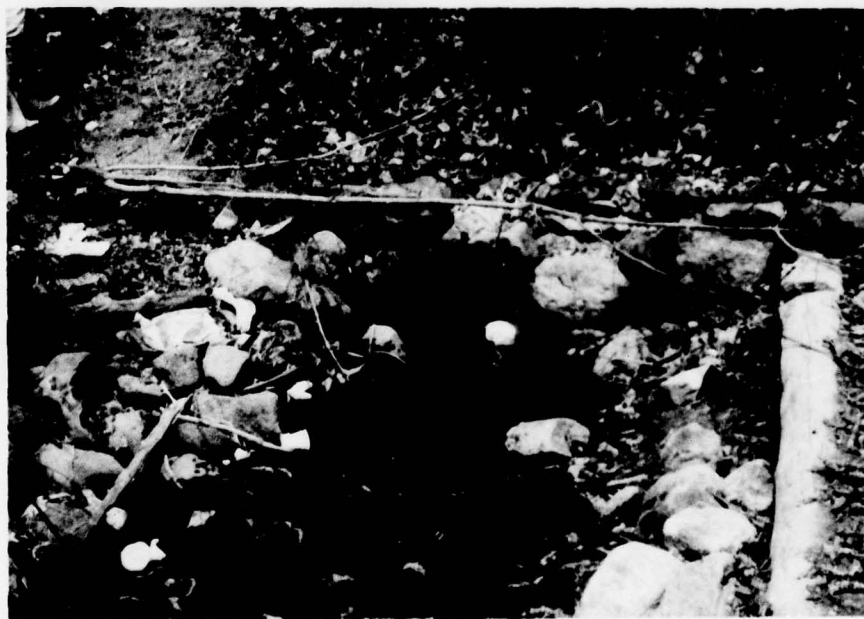
PHOTO 8

OUTLET WORKS DISCHARGE PIPE
