# PERONA LAKE DAM NO. 2 NJ 00294

## PHASE 1 INSPECTION REPORT NATIONAL DAM SAFETY PROGRAM

Perona Lake Dam Number 2 (NJ-00294)  
Delaware River Basin, Pequest River,  
Tributary Sussex County, New Jersey.  
Phase 1 Inspection Report.

PERONA LAKE DAM NO. 2 (NJ00294)

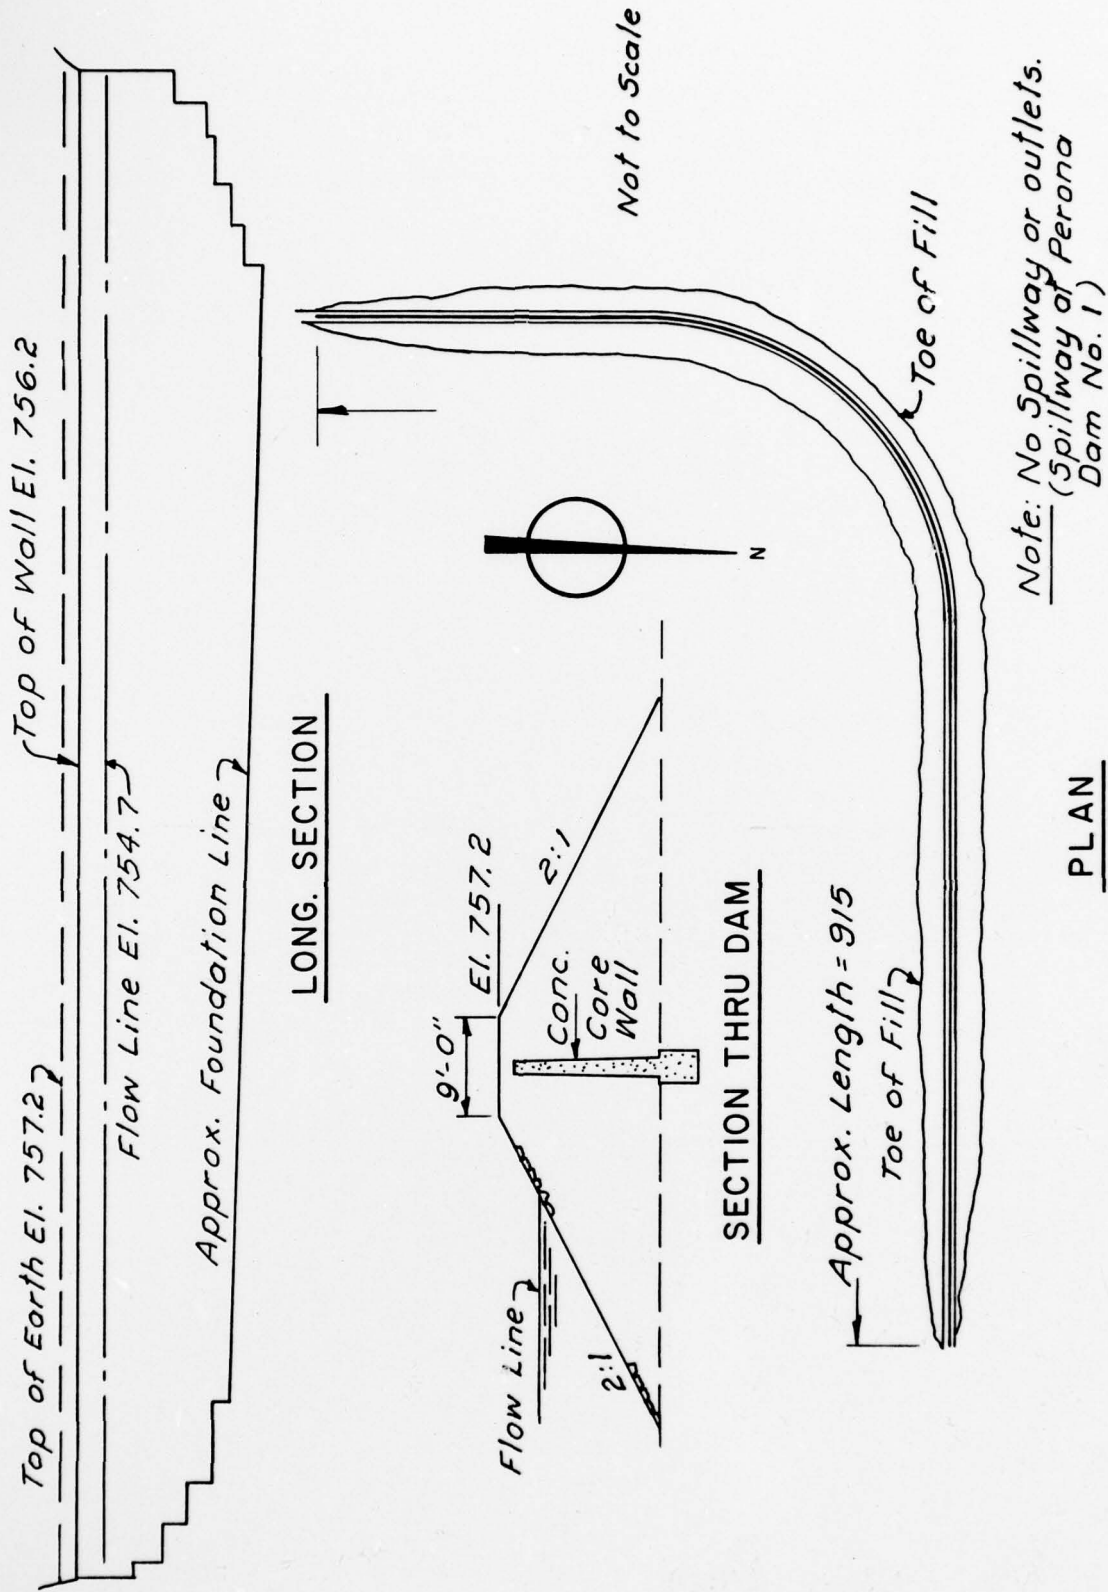
DETAILS OF DAM NO. 2  
 FIGURE 3

Perona Lake Dam No. 2 is a 915 foot long, 10 foot high earth embankment with a full length concrete corewall. The top of dam is at elevation 757.2. The corewall extends from elevation 756.2 down to bedrock or firm glacial till. In the center 700 feet of the dam, 10-foot lengths of interlocking steel sheeting have been driven to a depth nine feet below the bottom of the corewall. The face of the dam is protected by riprap between elevation 756.2 and the toe and a retaining wall has been erected to protect the owners property at the left end of the dam.
